Welch Creek Watershed Assessment

Welch Creek Watershed Assessment Report

Written and Published by the Lakehead Region Conservation Authority Summer 2006

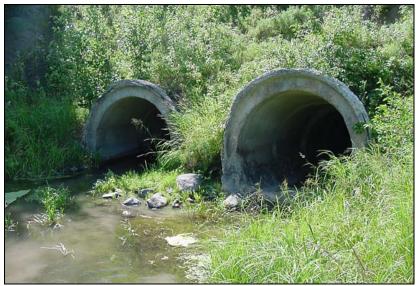
Inflow

Description: This concrete culvert system was comprised of two culverts, however during the first observation only one was transporting water. Both culverts 1a and 1b covered 38.355 metres of stream and had an opening width of 215 centimetres. During the second observation we noticed water running through both culverts. This may be due to added precipitation in late July. An abundance of vegetation surrounded the opening of both culverts, signifying that the plant life depended on the flowing water. The two culverts were flowing steadily; however a few twigs and logs inside the culverts may contribute to minor flow impediment.

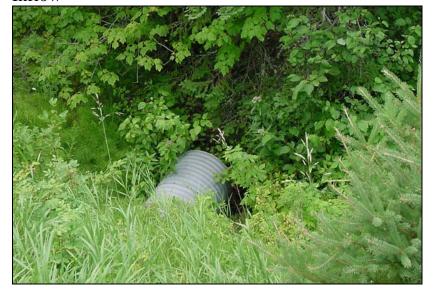
Inflow

Culvert 2 was also located on the CNR and was approximately 2.1 km northwest of Culvert 1a/1b. This culvert was dry at the time of sampling. Surrounding the location was a very diverse and thick-forested area, which made taking a photo impractical. The rust line indicated that the culvert did pass flow, although not at a very high level. Fill slope at this location was steep at 40 degrees, however was well-vegetated and showed no signs of erosion. The culvert was perched at the time of inspection

Description: This culvert was dry at the time of sampling however showed signs of previously transporting water. This culvert covered 9.83 metres of the stream and the width of the opening was 75 centimetres. At some point this culvert does pass flow as indicated by the evidence of the rust line, which is seen in the outflow picture. This culvert was difficult to find because it had many trees, shrubs, logs and rocks surrounding it. The culvert was perched at the time of inspection.

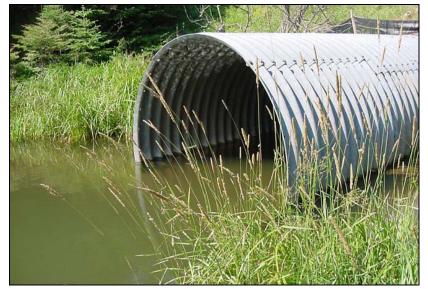
Inflow

This culvert crossed the TransCanada Highway and was the only culvert crossing at a roadway. Beaver dams were observed both up and down stream of the culvert, which meant that the outflow was a large marsh area with low flow. The surrounding area of the culvert was well vegetated and diverse. The fill slope angle was significant, but the bottom half was vegetated and the top half was filled with cobbles. The slope had no signs of erosion.

Description: This was a solid culvert system that allows traffic on Highway 11/17 to cross over Welch Creek. The culvert covered 53.29 metres of stream and an opening of 235 centimetres. An abundance of grasses and swampy ground made up this portion of Welch Creek. Both upstream and downstream of the culvert were beaver dams, causing a low stream quantity and flow velocity. The depth of the creek downstream from the culvert had widened and deepened during the summer of 2006 due to beaver activity on the creek.

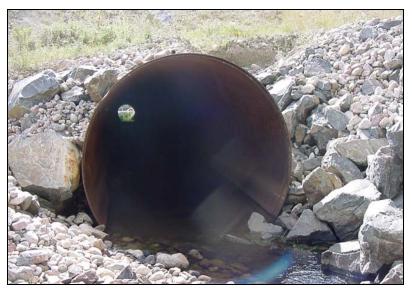
Inflow

Description: A tributary of Welch Creek flows underneath the railway line west of highway 11/17 through culvert 4. This culvert covered 54.2 metres of stream and its opening width was 235 centimetres. Large boulders and rocks made up the creek bed, and appear to have been deliberately placed along the inflow and outflow banks. The banks were protected with rip rap. The slopes surrounding the Creek are protected with mesh to prevent any further erosion from occurring, and allow vegetation to continue to grow and secure the soil. The inflow side of the creek was narrow and flowed into a large stagnant pool on the outflow.

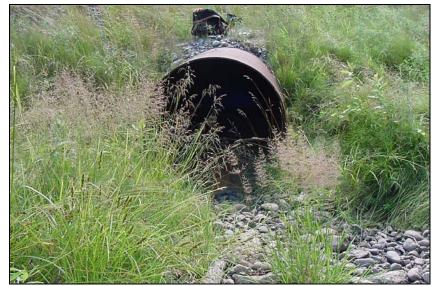
Inflow

Culvert 5 was also along the Canadian Pacific Railway lines, approximately 400 metres east of Culvert 4. This culvert was for a small branch of Welch Creek that is only approximately 1 km long. The culvert was dry during the time of sampling, and the rust line indicated high water was not measurable, showing that this culvert does not experience a significant amount of flow. The fill slope angle varied, it was 20° on the inflow side, and 60° on the outflow side. There were no signs of erosion, since there was a plentiful amount of vegetation along the slope.

Description: This culvert system is used for a tributary of Welch Creek, and at the time of observation was dry. It covered 30.6 metres of stream and had width of 118 centimetres at the opening. The rust line was not measurable, indicating that this culvert has not experienced a significant amount of flow.
