Whitefish River Watershed Assessment Report

August 2012

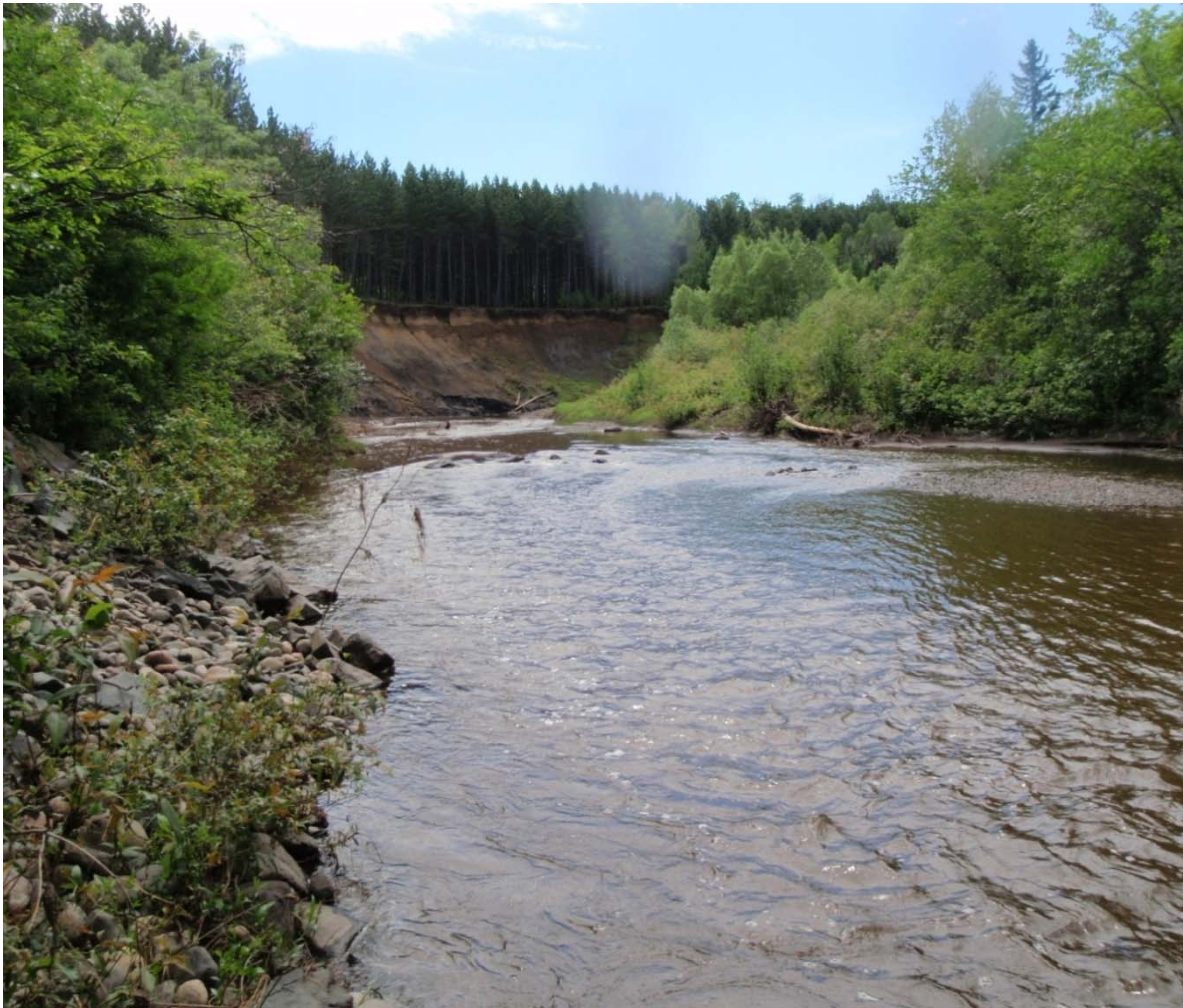
Figure 10: Bank Erosion Upstream at Site 6

Site 6 was located within the Village of Hymers in a lowland area and was characterized by a 30 metre high bank eroding into the river. The eroding river bank may have caused the change in water colour downstream. The substrate at this site was fine, silty loam with cobbles. There was little stream cover (15 percent) along the banks. The dominant vegetation observed in the lowland area was red-osier dogwood, floating arrowheads and slender willows. The dominate trees found along the river were black ash, jack pine and balsam fir. The river was one metre deep and 12.6 metre wide; compared to the majority of the sample sites in the watershed this was the second widest. The velocity at this site was very fast compared to the other sample sites. The water was a golden yellow with little to no clarity within the channel.

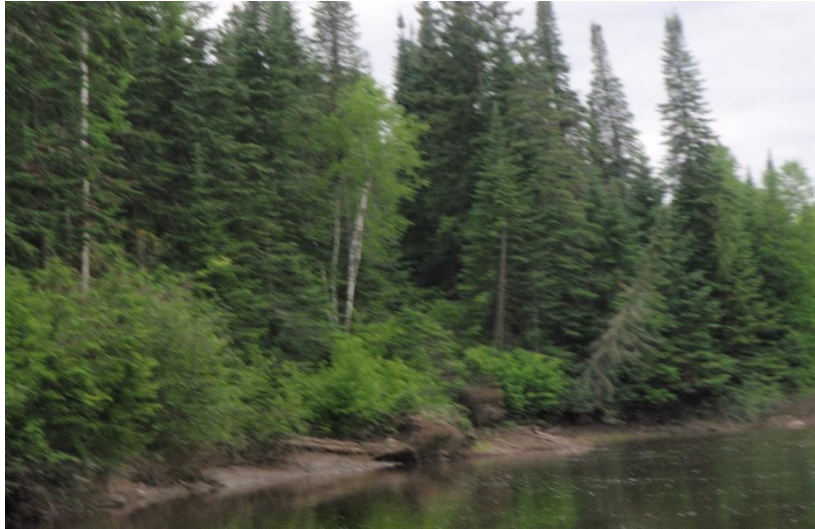
Site 1: V2 Black Ash Hardwood and Mixed wood

Description: Hardwood mixed wood stands containing black ash in the over story. The understory is typically dense and floristically diverse. Of limited areal extent; occurring in low-lying locations on deep moist to wet soils, usually non-calcareous.

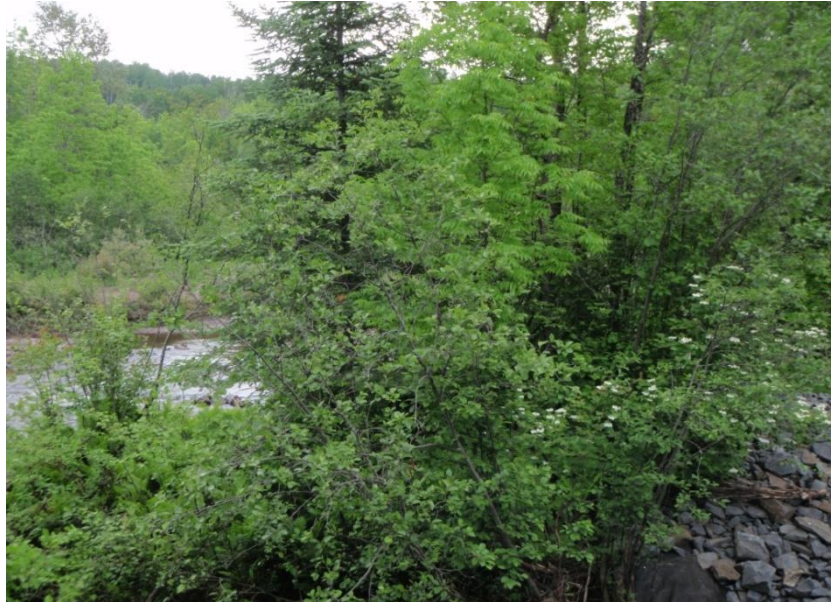
Site 2: V2 Black Ash Hardwood and Mixed wood

Description: Hardwood mixed wood stands containing black ash in the over story. The understory is typically dense and floristically diverse. Of limited areal extent; occurring in low-lying locations on deep moist to wet soils, usually non-calcareous.

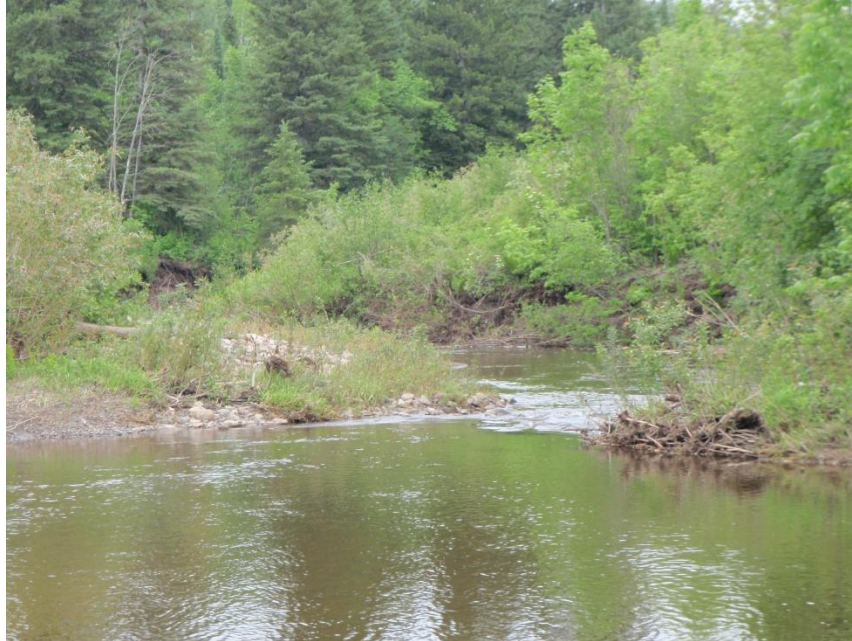
Site 3: V2 Black Ash Hardwood and Mixed wood

Description: Hardwood mixed wood stands containing black ash in the over story. The understory is typically dense and floristically diverse. Of limited areal extent; occurring in low-lying locations on deep moist to wet soils, usually non-calcareous.

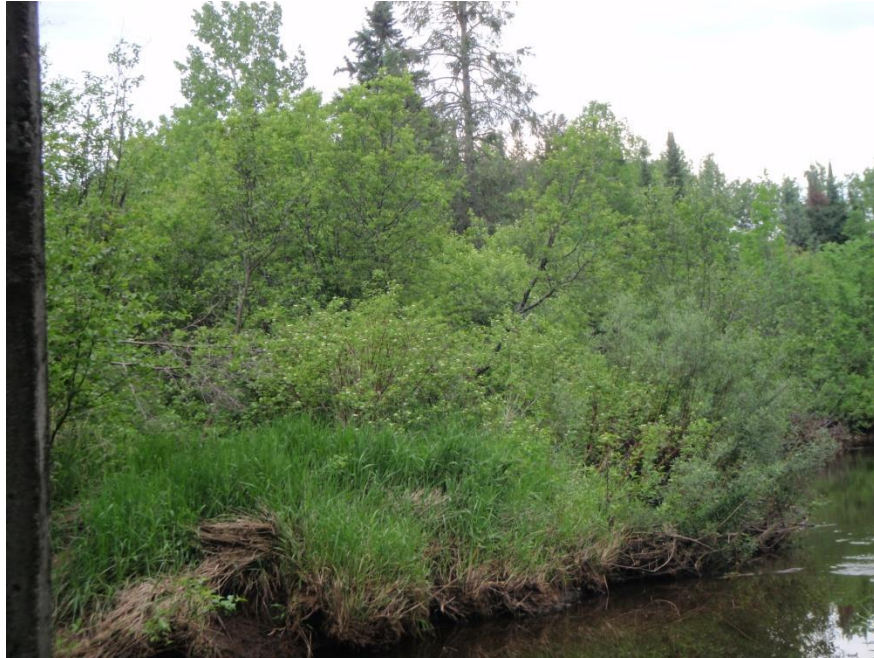
Site 4: V2 Black Ash Hardwood and Mixed wood

Description: Hardwood mixed wood stands containing black ash in the over story. The understory is typically dense and floristically diverse. Of limited areal extent; occurring in low-lying locations on deep moist to wet soils, usually non-calcareous.

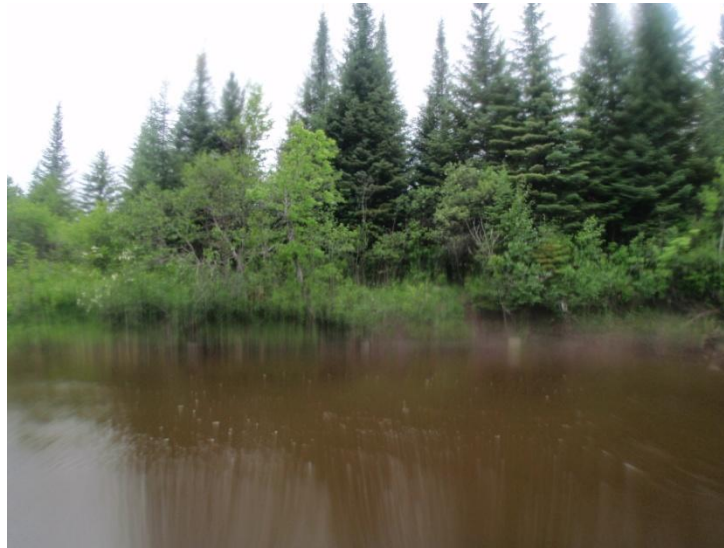
Site 5: V15 White Spruce Mixed wood

Description: A variable mixed wood type with white spruce as the main canopy species. The understory ranges from herb and shrub rich to poor, with balsam fir commonly abundant in the shrub layer. Occurring over a broad range of soil and site conditions but primarily on deep, fresh to moist, mineral soils.

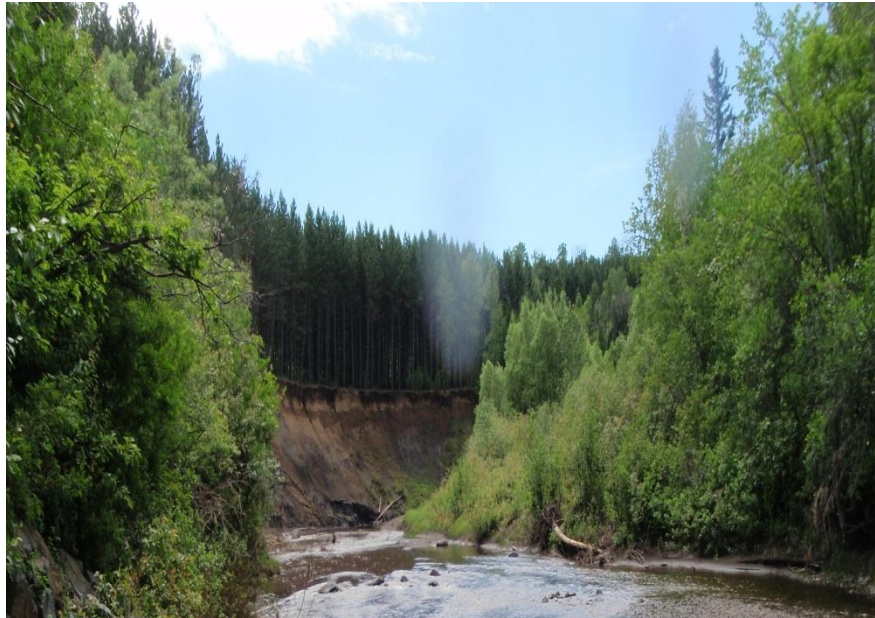
Site 6: V2 Black Ash Hardwood and Mixed wood

Description: Hardwood mixed wood stands containing black ash in the over story. The understory is typically dense and floristically diverse. Of limited areal extent; occurring in low-lying locations on deep moist to wet soils, usually non-calcareous.

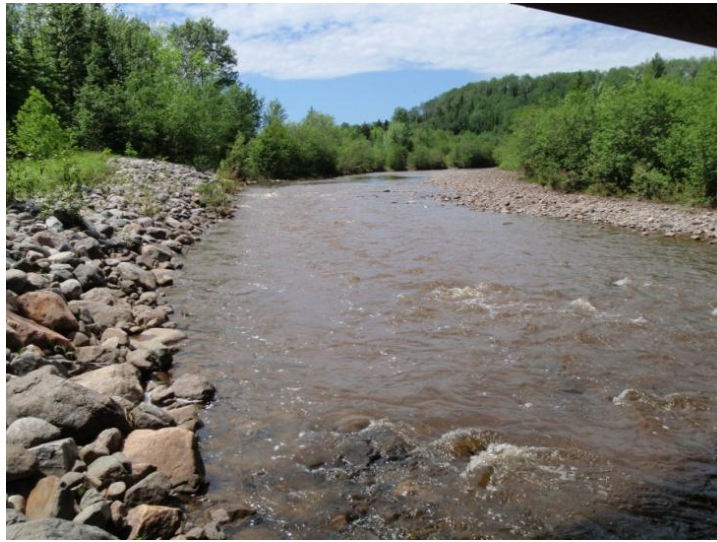
Site 7: V15 White Spruce Mixed wood

Description: A variable mixed wood Type with white spruce as the main canopy species. The understory ranges from herb and shrub rich to poor, with balsam fir commonly abundant in the shrub layer. Occurring over a broad range of soil and site conditions but primarily on deep, fresh to moist, mineral soils.

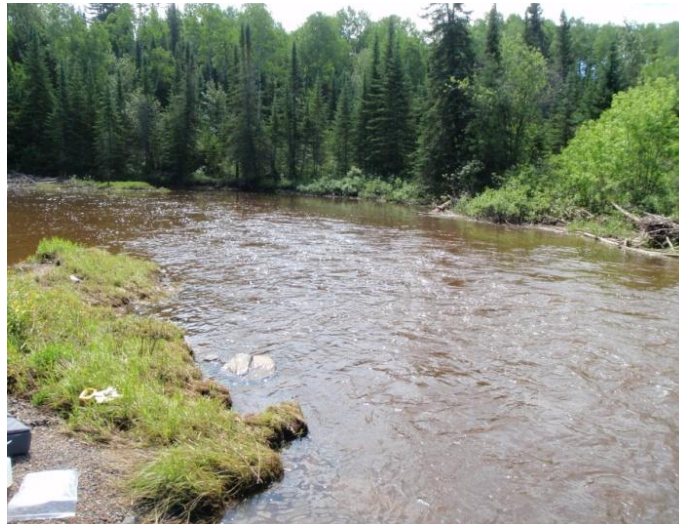
Site 9: V14 Balsam Fir Mixed wood

Description: An extremely variable mixed wood type. The canopy, comprising mainly balsam fir, may contain a mixture of several species. The understory varies from shrub rich to moderately herb and shrub poor. Usually on deep, fresh to moist, mineral soils but encompassing a wide range of soil and site conditions.

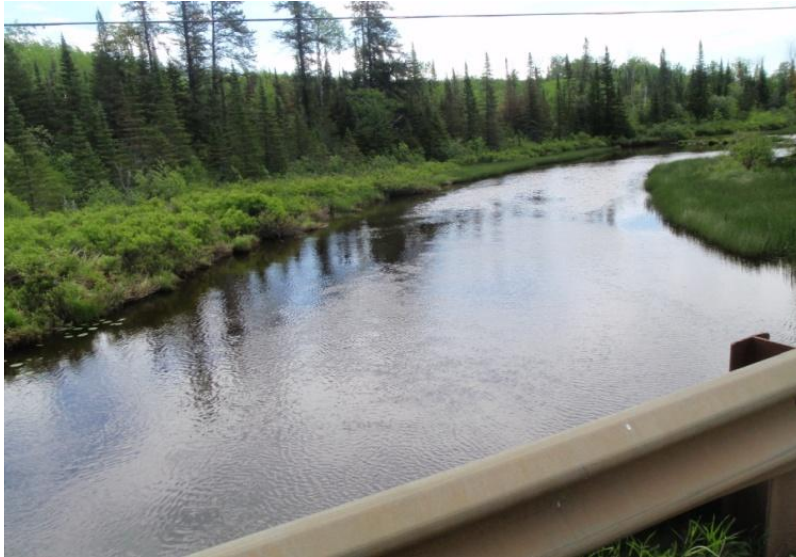
Site 10: V15 White Spruce Mixed wood

Description: A variable mixed wood type with white spruce as the main canopy species. The understory ranges from herb and shrub rich to poor, with balsam fir commonly abundant in the shrub layer. Occurring over a broad range of soil and site conditions but primarily on deep, fresh to moist, mineral soils.

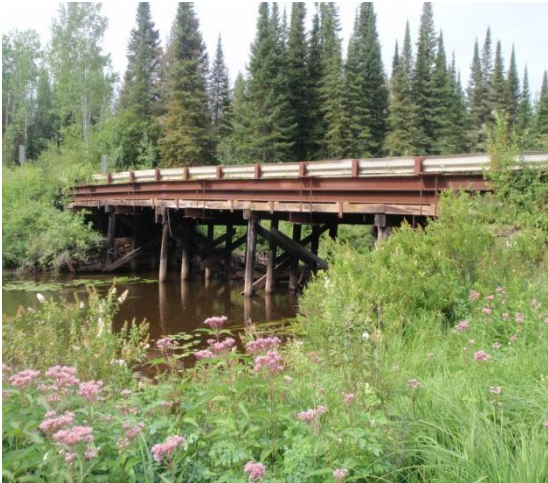
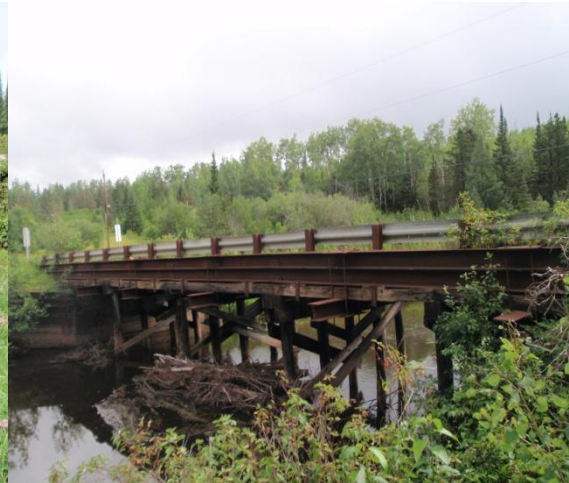
Bridge 2

Description: The bridge at Site 9 was constructed in 1976 and was composed of concrete and steel. The bridge contained two concrete guard railings which extended the entire length of the bridge. Shrubs and grasses dominated each side of the banks along with trembling aspen and white spruce. A stick dam was observed downstream of the bridge and many dead logs were observed upstream. The debris did not seem to affect the velocity of the river. Overall, the bridge was in very good condition.

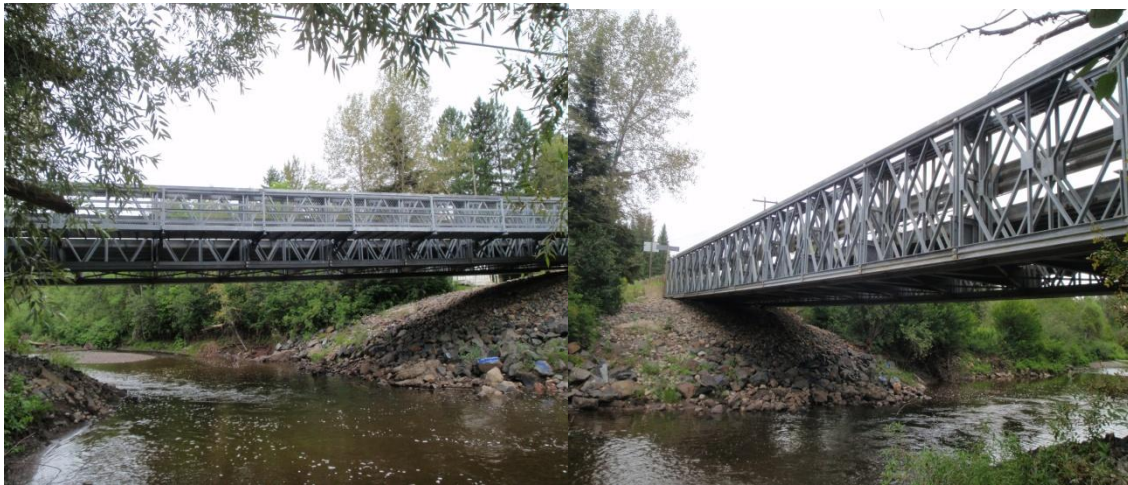
Bridge 5

Location: Highway 595, Village of Hymers (Site 6)

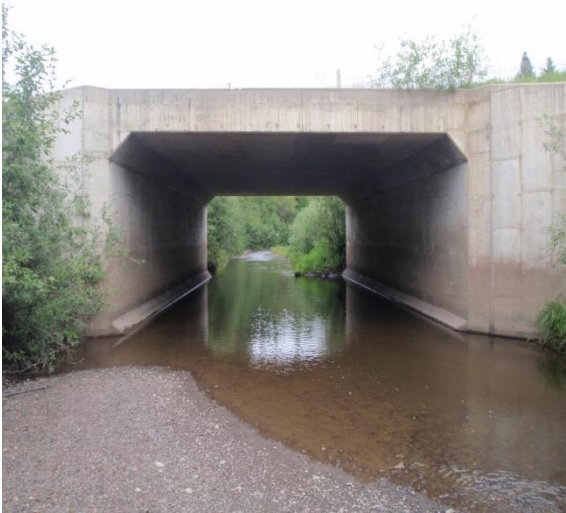
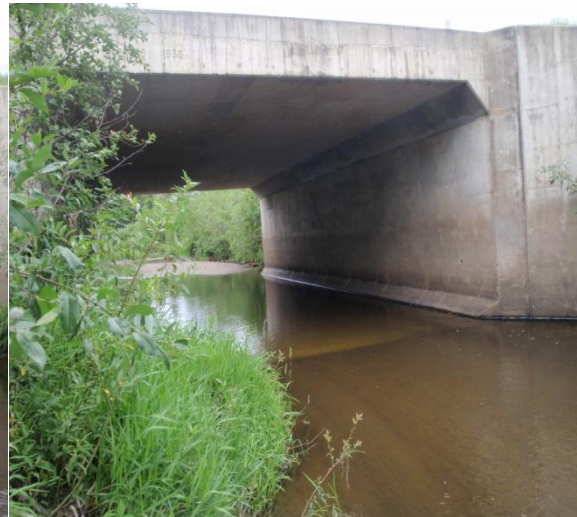
Bridge 6

Description: This simple bridge was made of concrete and appeared to be in excellent condition. The deck of the bridge was covered in gravel and appeared to have no signs of erosion. The bridge was well maintained and looked to be fairly new. Mud and gravel fill was used underneath the two ends of the bridge for support. The sides of the bridge were dominated by shrubs and grasses.

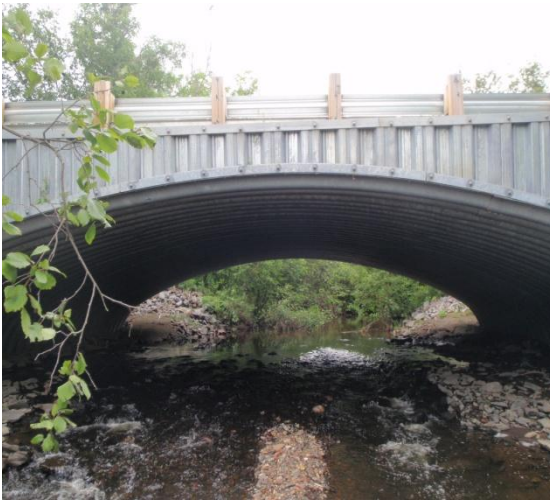
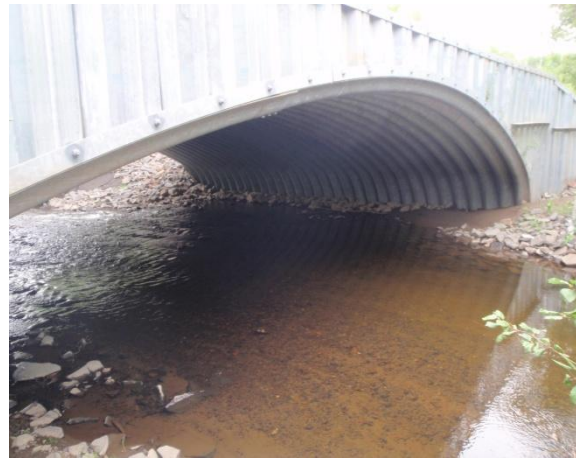
Bridge 7

Description: The water crossing at Site 2 was a steel pipe arch design. The vegetation was abundant at Site 2, with willow and trembling aspen as the dominant species that surrounded the bridge. The stream cover was the greatest of all sites (70 percent stream cover). Rock fill had been placed along the banks of the bridge. A rapid increase in velocity at the downstream side of the bridge was observed during both visits.

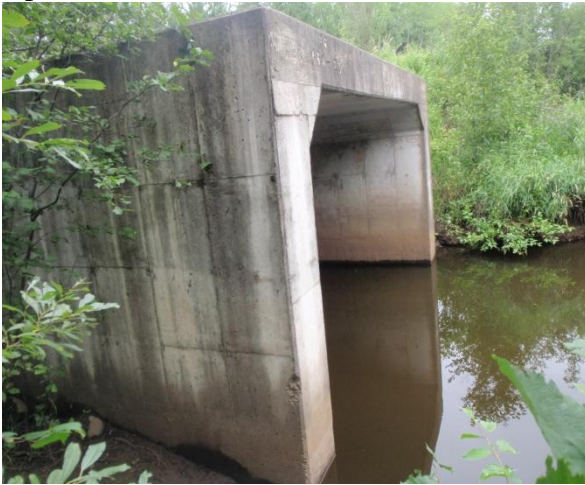
Description: The watercrossing at Site 4 was a concrete box culvert. There was a dam located on the upstream side of the bridge which made a significant difference in water depth between both sides of the bridge. Abundant vegetation growth was present around the bridge and surrounding area.

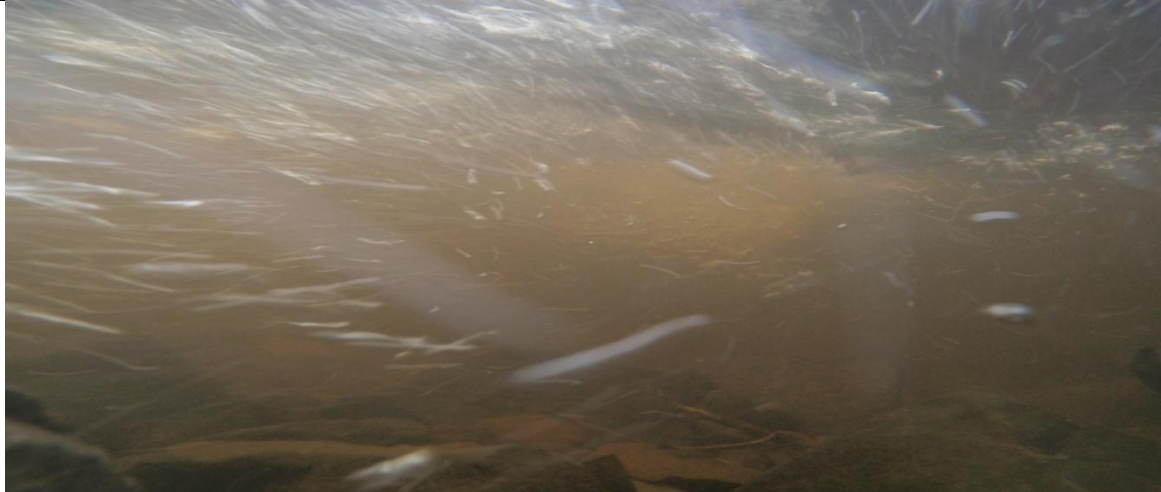
Site 2 – Cedar Creek upstream confluence with Whitefish River, Harstone Drive	
A: Upstream Photo	B: Downstream Photo

Site 2 was located on Cedar Creek just upstream of the confluence with the Whitefish River. The banks were armored with rip rap, which was placed during the bridge replacement following the 2008 rainfall event. The water was a light brown colour with a high velocity. The dominant substrate observed was cobbles with gravel. Terrestrial vegetation was abundant with many shrubs and herbs present along the banks of the river. There were many lady ferns, mountain buttercups, choke cherry and a few trees such as black ash, slender willow and white elm present along the banks and on land. The aquatic vegetation did not appear healthy; however, appeared to be in better health than the other sample sites. Logs, trees and sticks were seen along the banks.

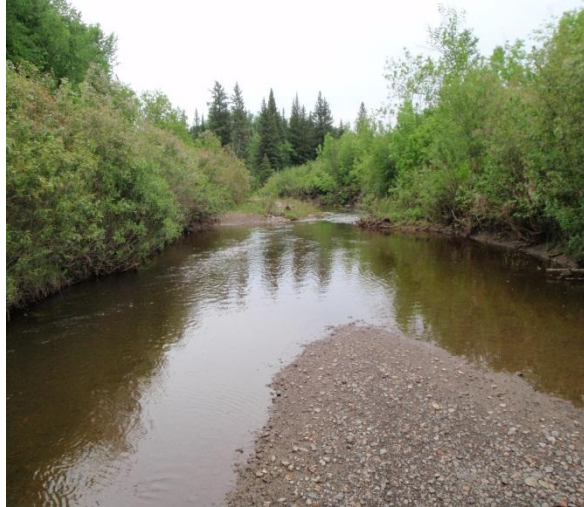
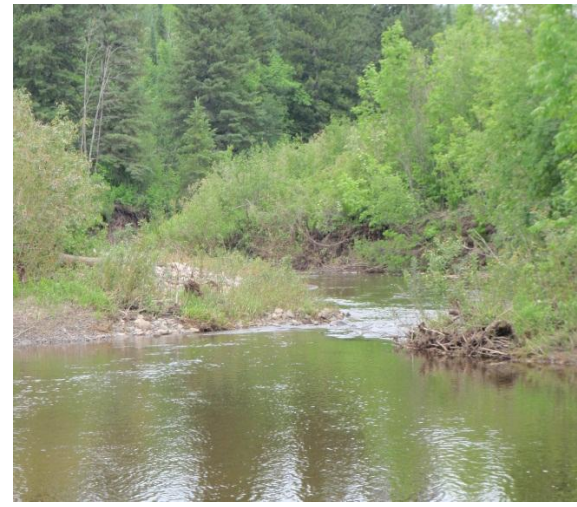
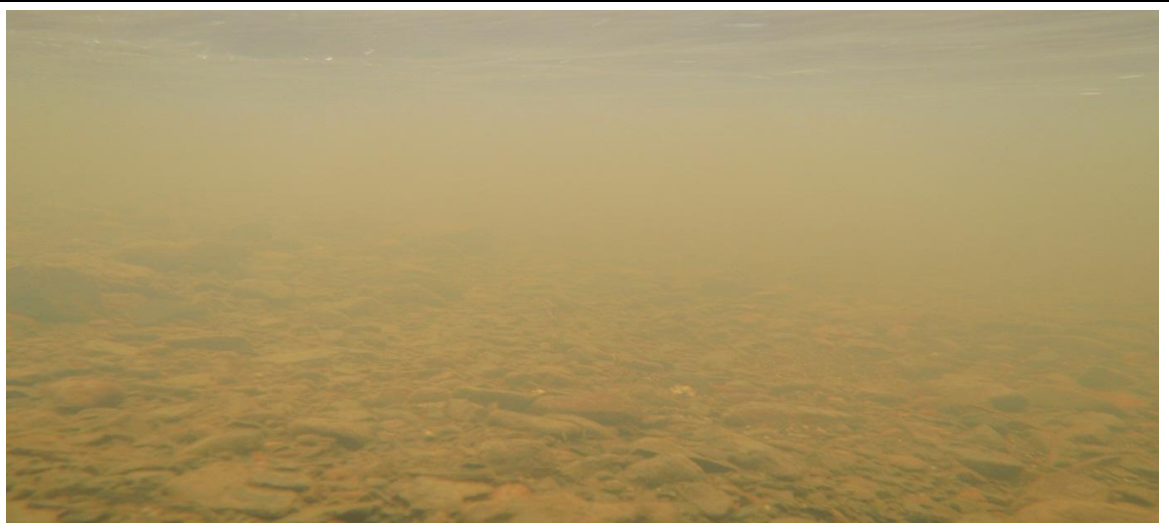
Site 3 was located on Harstone Drive and was chosen to represent the confluence of the Whitefish River with Pitch Creek. This site was downstream of the confluence of Pitch and Tinpail and Whitewood creeks. The water was flowing at a moderately quick pace. The banks appeared stable and had abundant vegetation growth along the river bank. The dominate substrate was cobbles and gravel. A small amount of woody debris was observed within the creek and along the banks. The terrestrial vegetation included black ash, jack pine, white spruce and red-osier dogwood. The soil type at this site was a sandy loam.

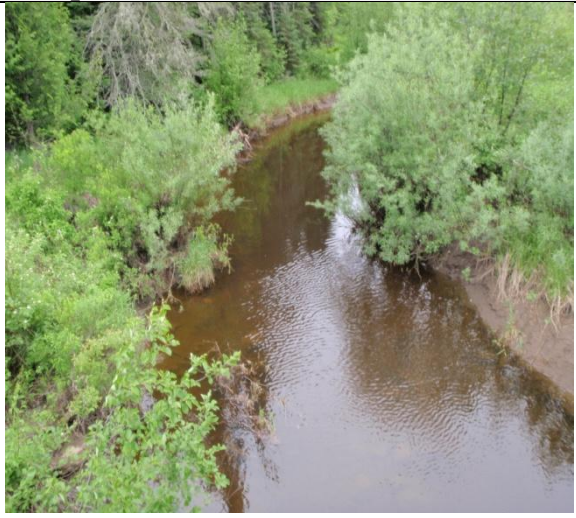
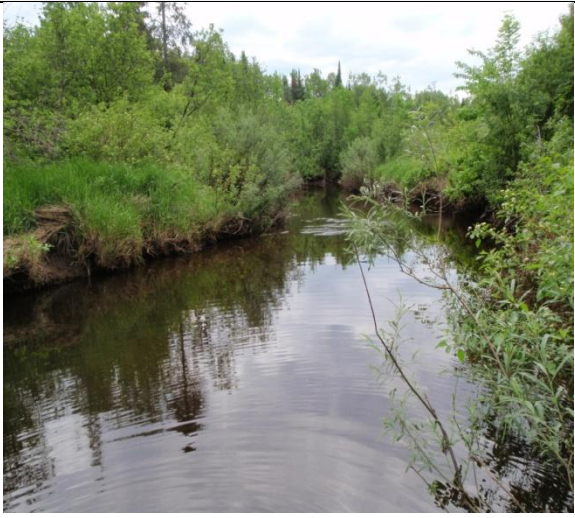
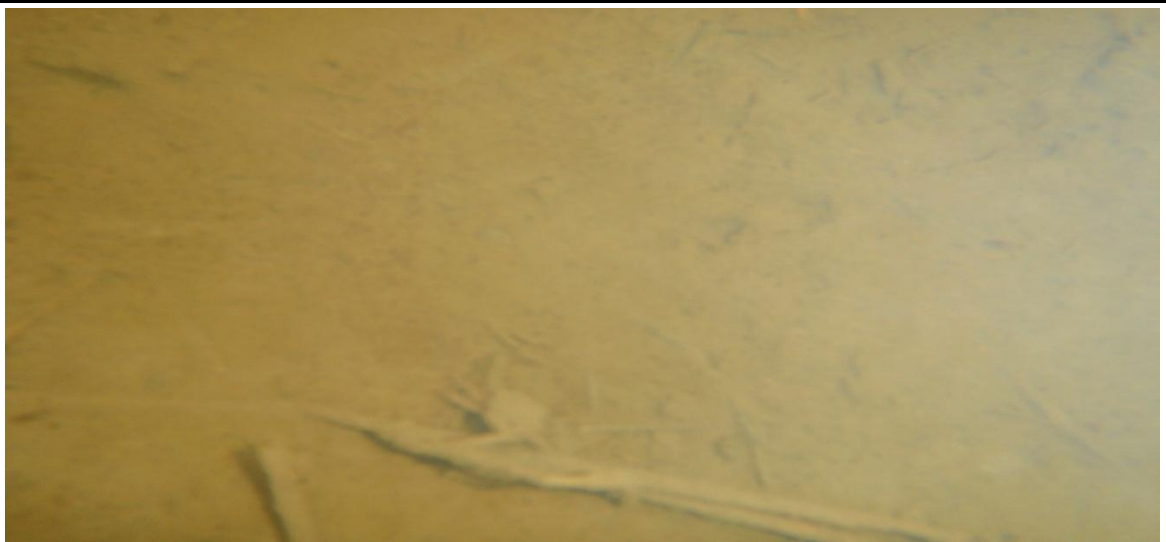
Site 4 – Highway 595, Pitch Creek	
A: Upstream Photo	B: Downstream Photo

Site 4 was located on Highway 595 at Pitch Creek and was characterized by erosion along the banks. The water at this site was a grey brown color with some clarity. The main substrate was clay. There were many soil color changes at this site during both site visits. The erosion along the banks may have caused the color change in the water. The river banks were very steep and consisted of boulders with an abundant herb and shrub growth. Two types of moss were observed at the site; fire moss and feather moss. The slope of the banks at Site 4 was at 45 degrees. No velocity was able to be recorded due to the stagnant water flow. The river was generally shallow and had a width of 7.6 meters.

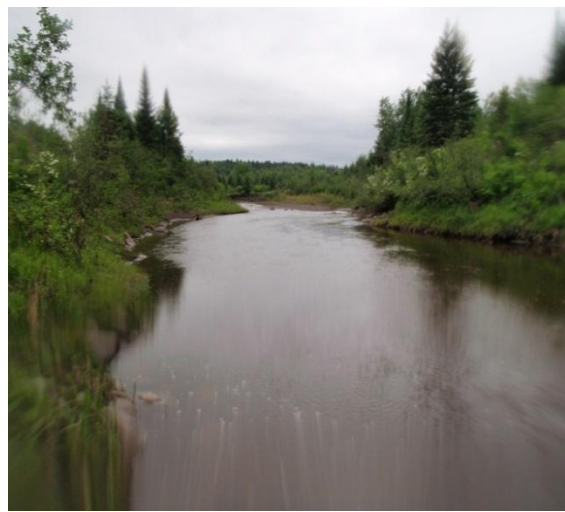
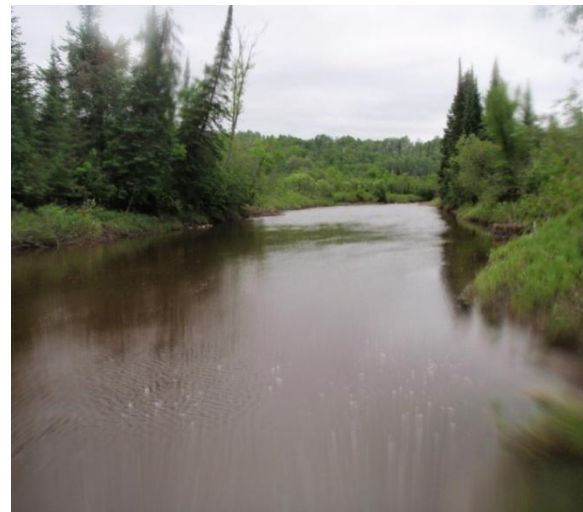
Site 5 was located on Diana Road and was characterized by a large beaver dam. The soil type was clayey silty loam, and the main substrate was clay muck and silt. The water was murky with a dark brown colour. Little aquatic vegetation was observed in the slow flowing water; however, a few floating-leaved bur reed plants were observed. There was little to no shading on this site; however, there was abundant vegetation along the sides of the river banks. There were many trees, shrubs, herbs and grasses adjacent to the river which included balsam fir, white spruce and trembling aspen. The river downstream appeared to increase in velocity.

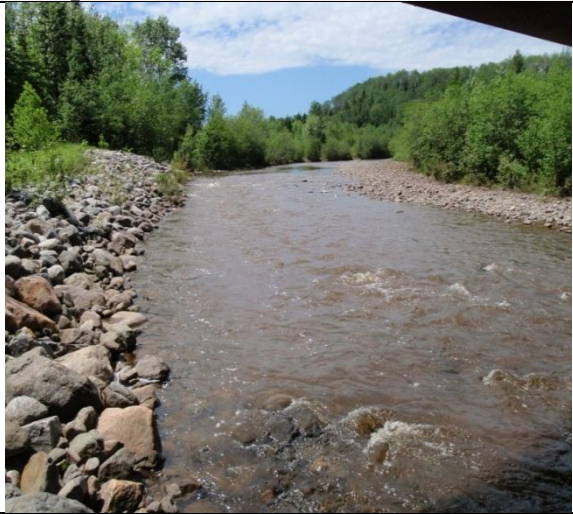
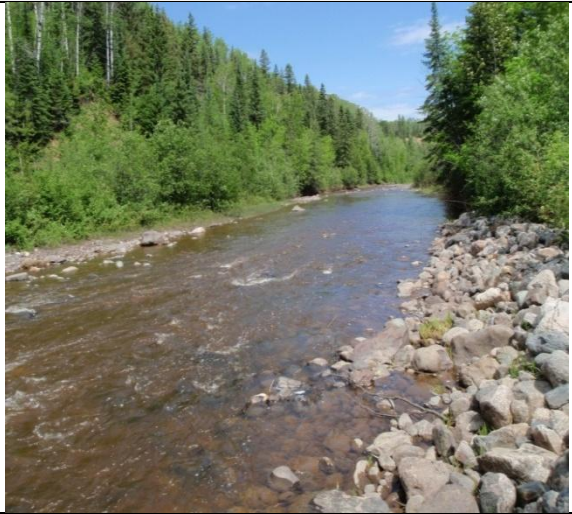
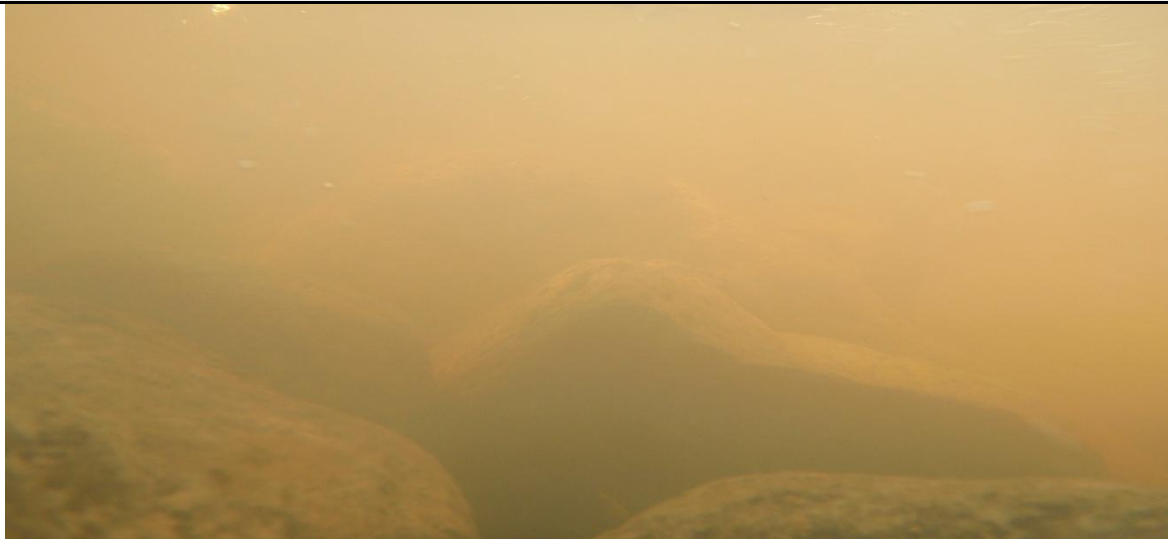
Site 7 – Highway 588 & Leeper Road	
A: Upstream Photo	B: Downstream Photo

Site 7 was located on Highway 588 close to Leeper Road. The site was characterized by having a substantial amount of boulders and cobbles along the river. The water was slightly murky with an apparent golden brown colour. The downstream water level was deeper compared to the upstream side where the water was fairly shallow. The velocity at the site was very fast compared to the other sample sites. There was no significant bank erosion observed; however, a high water mark was observed within the bank vegetation. The river had the lowest stream cover (five percent) compared to the other sample sites. The stream cover came from trees and shrubs which were growing tall enough to cover a small portion of the river.

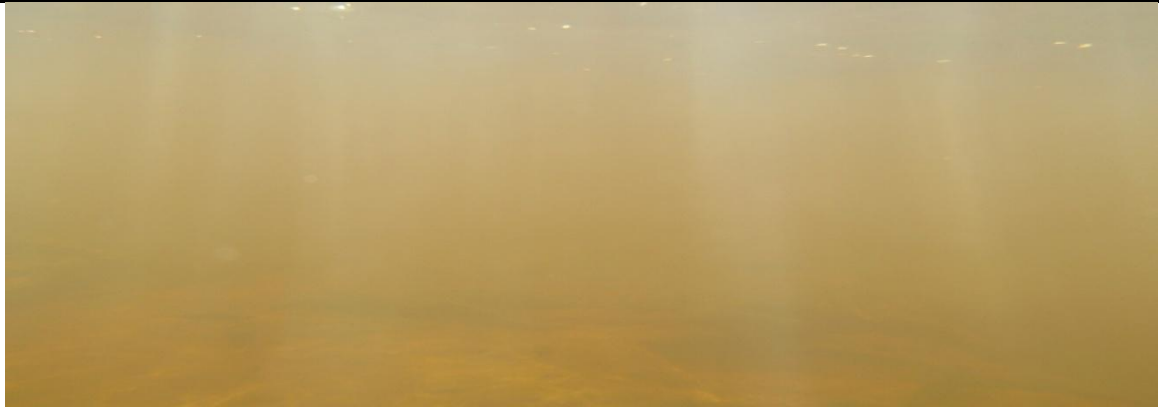
C: Substrate Photo

Site 8 was located on Old Mill Road within the Village of Nolalu. The site was characterized by the rapids underneath the clear span bridge. The water at this site was flowing over bedrock. No defined banks were observed on either side of the river. There were no apparent aquatic plants growing in the water; however, some dead trees were observed throughout the channel. Site 8 had an abundant growth of terrestrial plants including green alder, red-osier dogwood, prickly wild rose and chokecherry. Many trees such as red pine, jack pine, mountain maple and tamarack were observed along the river. There was little stream cover at this site (10 percent). The stream cover came from planted tamarack and dead trees along the river. The majority of the trees were situated further back from the river on terrestrial soil and therefore did not greatly affect the stream cover. The terrestrial soil was a sandy loam and the river channel consisted of bedrock. The water had a high velocity and had an apparent golden bronze colour. The Environment Canada/LRCA stream flow and precipitation gauge was located at this site adjacent to the bridge.

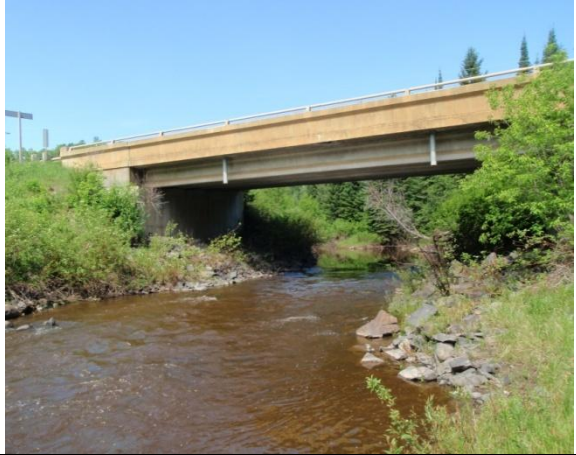
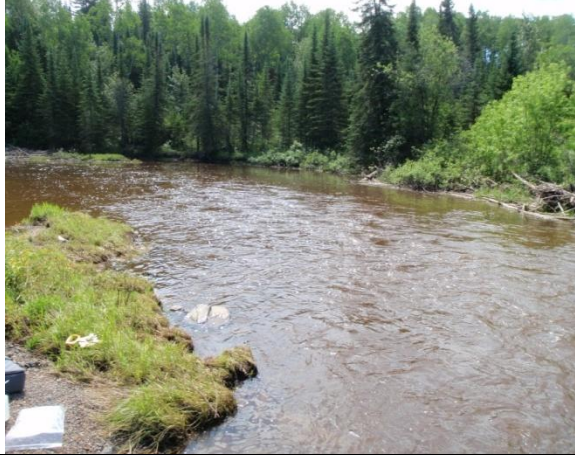
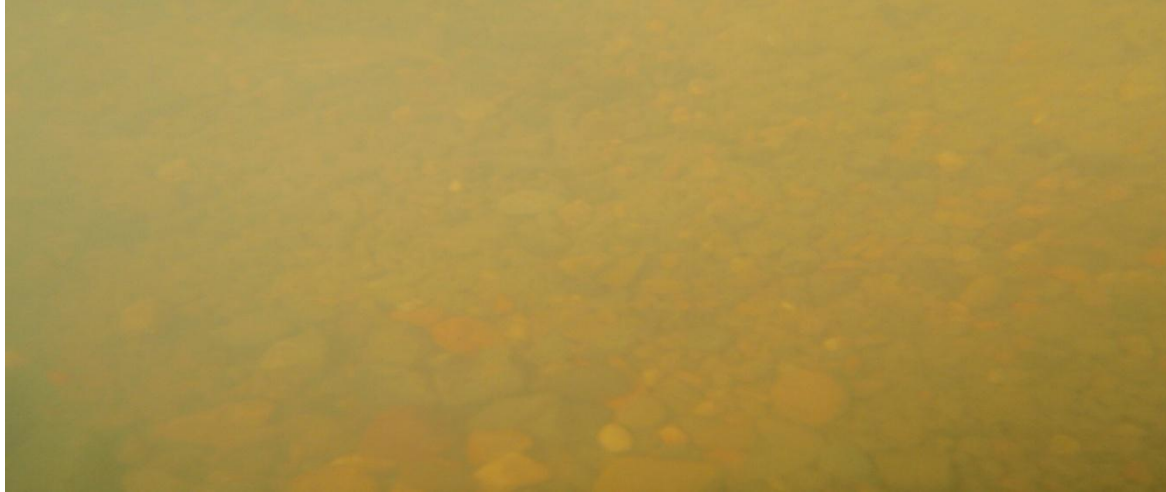
Site 9 – 5 th Side Road	
A: Upstream Photo	B: Downstream Photo

Site 9 was located near the 5th Side Road outside the Village of Nolalu. The site was characterized by a bridge constructed in 1976 and the remains of the previous bridge. There did not seem to be significant erosion present and no aquatic plants were observed within the channel of the river. There was dead brush and logs scattered along the channel. The buildup of both the brush and logs caused a minor stick dam downstream. Site 9 had little to no shading; however, there was an abundance of terrestrial vegetation which included herbs, shrubs and grasses. The terrestrial vegetation included creeping butter cups, red-osier dogwood, slender willow and green alder. The dominate substrate observed was muck and gravel. The velocity of the river was the fastest velocity recorded at 1.06 metres per second. The water had an apparent clear golden colour. The soil type at this site was a silty loam.
