PINE RIVER WATERSHED Assessment Report

Pine River Watershed Assessment Report

August 2011

Lakehead Region
Conservation Authority
Conserve Today...For A Better Tomorrow

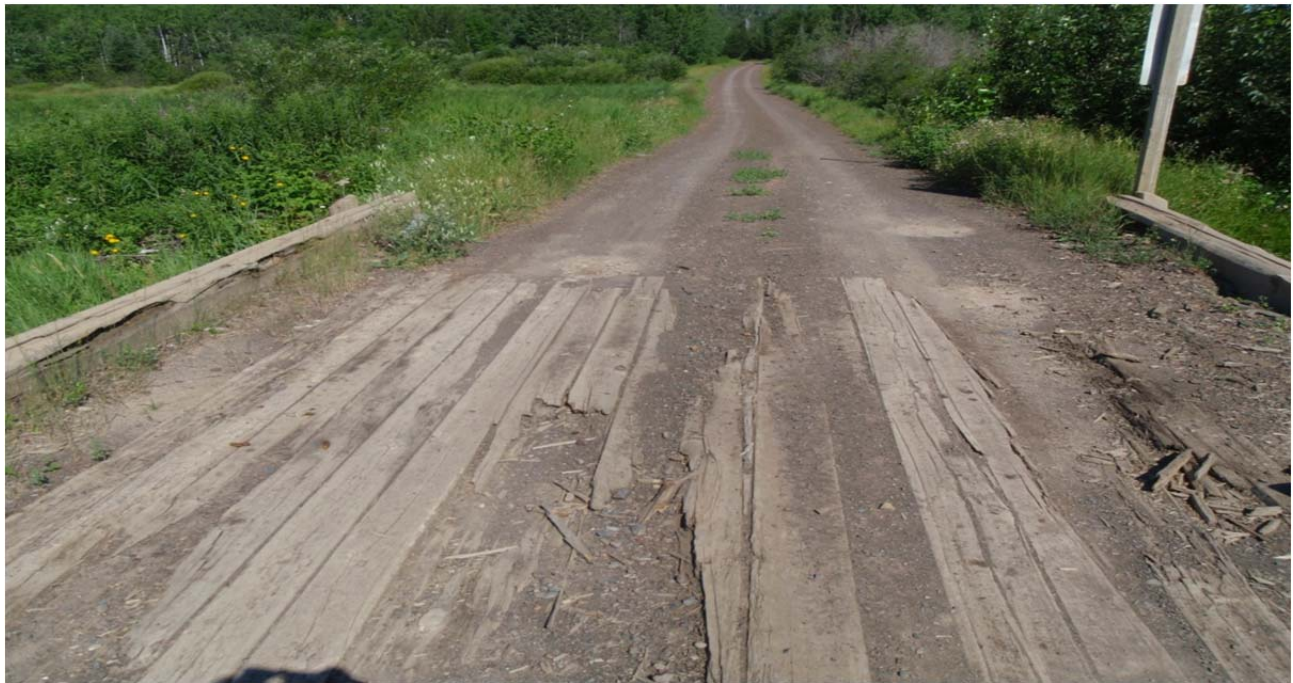
Figure 12: Degrading and Splintering Wood on Deck of Bridge 6

Description: This bridge was composed of wood. The wooden planks were starting to degrade as could be seen by the splintering and breaking apart of the wood. On each side of the bridge timber cribs were used as support. There was a dam located on the upstream side of the bridge which made a significant difference in water depth between both sides of the bridge. Abundant vegetation growth was present around the bridge and surrounding area. Fish and other aquatic life could be seen in the water and there was clear evidence from the beaver dam that one or more beavers were present in the area.

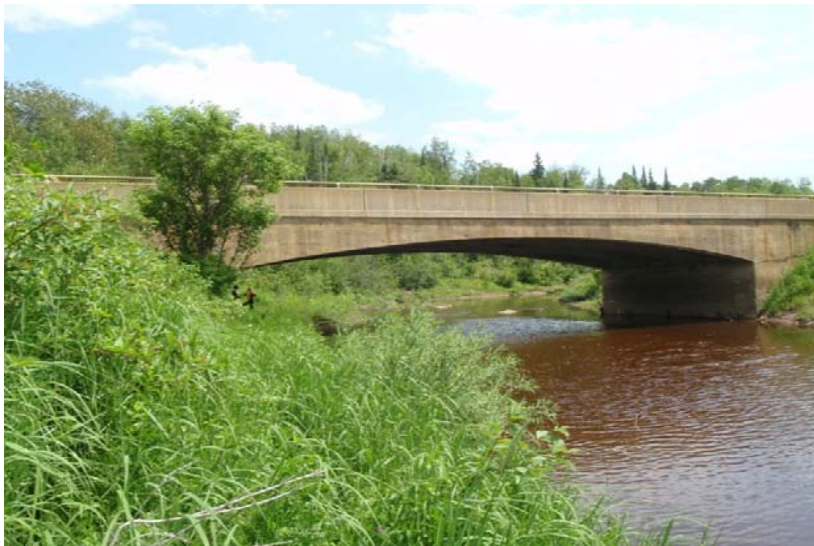
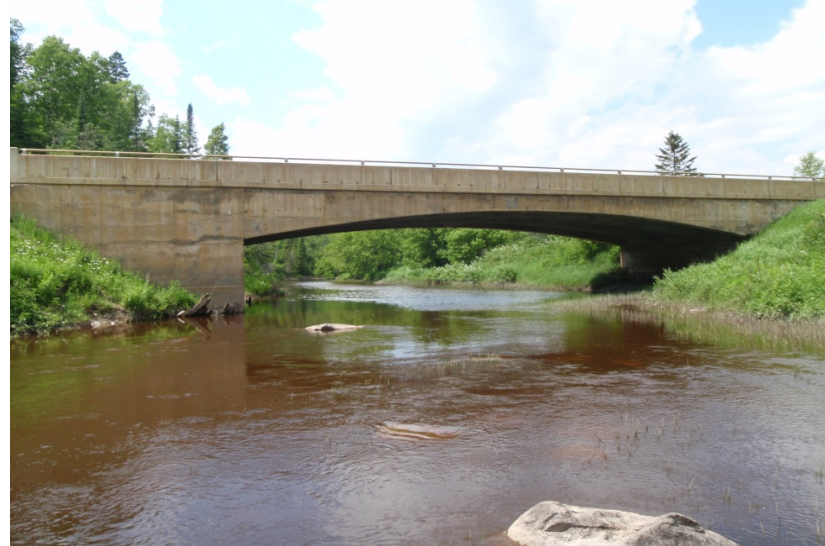
Description: This bridge was located on a major highway. It was built by reinforced concrete and appeared to be in good condition. The height of the bridge did not appear to alter natural channel characteristics; however, the width of the bridge came into contact with the water on the west side. There was no visible stabilizing fill for this bridge. The banks surrounding the bridge were fairly steep, yet appeared to be stable due to the density of vegetation. A number of swallows nest were noted beneath the deck of the bridge.

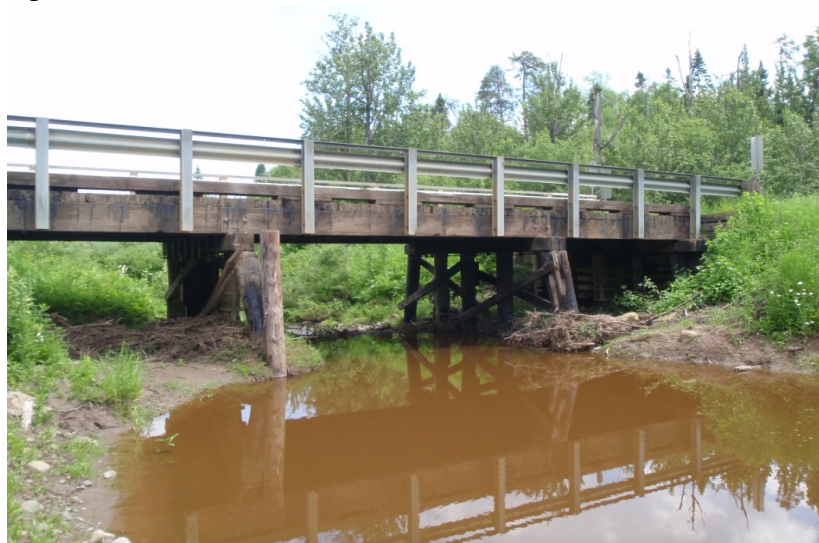
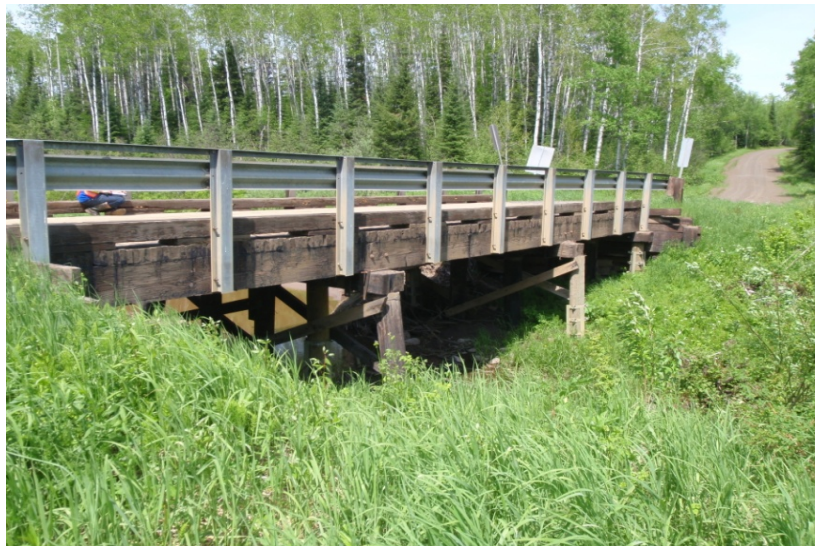
Bridge 2

Description: This was a steel framed bridge with wooden planks for the base and deck. A new layer of wood was laid on top of the older layer. A wooden retaining wall on both ends of the bridge was used as support on each side of the water. There were two guard rails running along the length of the bridge. Ten wooden posts, five on each end of the bridge, were used for support. Wooden planks were crossed over these posts for additional reinforcement. Shrubs and grasses dominated each side of the banks. A beaver dam on the downstream side of the bridge restricted water flow and resulted in a higher water level on the upstream side of the bridge. Overall, the bridge was in fairly good shape but regular maintenance should be conducted as this bridge was located in an area where high water levels cause visible bank erosion.

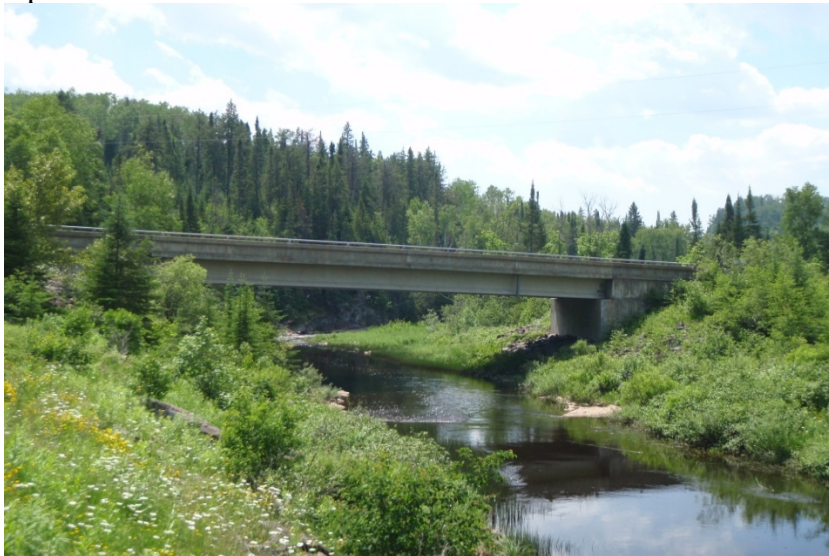
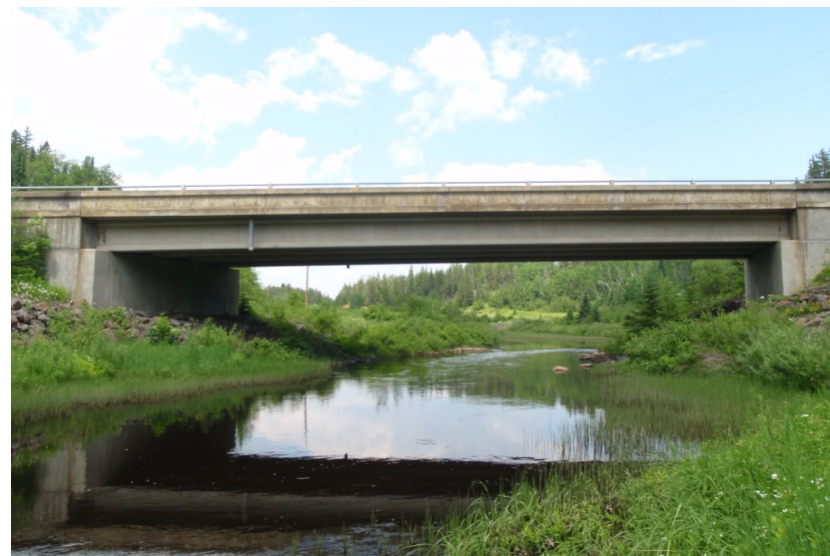
Bridge 3

Description: This bridge was made of concrete and included a metal rail on each side of the bridge. Large concrete slabs supported and covered by rip rap were located on each side of the bridge. The bridge was still in fairly good condition. There were a few minor concrete filled patches on the deck of the bridge.

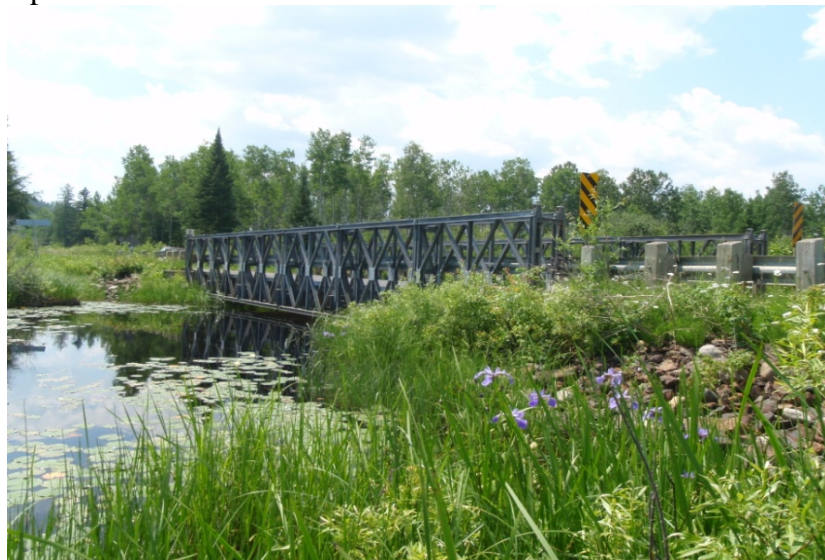
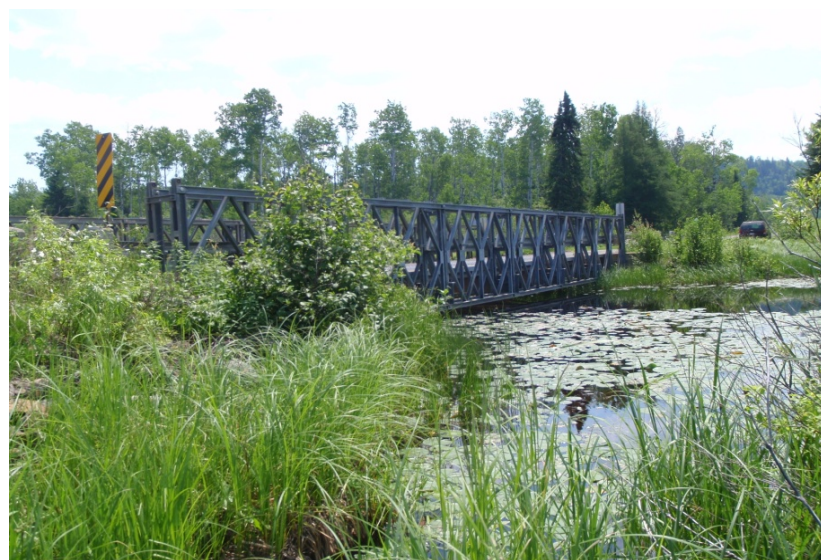
Bridge 4

Description: This bridge was a Bailey Bridge design: lattice steel designed for rapid assemble from prefabricated standard parts, and was in excellent condition. The bridge deck was steel grating with open holes which would be beneficial during times of high water because the bridge surface will not deteriorate collapse. There were concrete slabs on both sides of the bridge providing the support. There was a metal guard rail located on each side of the bridge. This bridge was located in a very marshy area and was dominated by many aquatic plants as well as terrestrial shrubs and grasses.

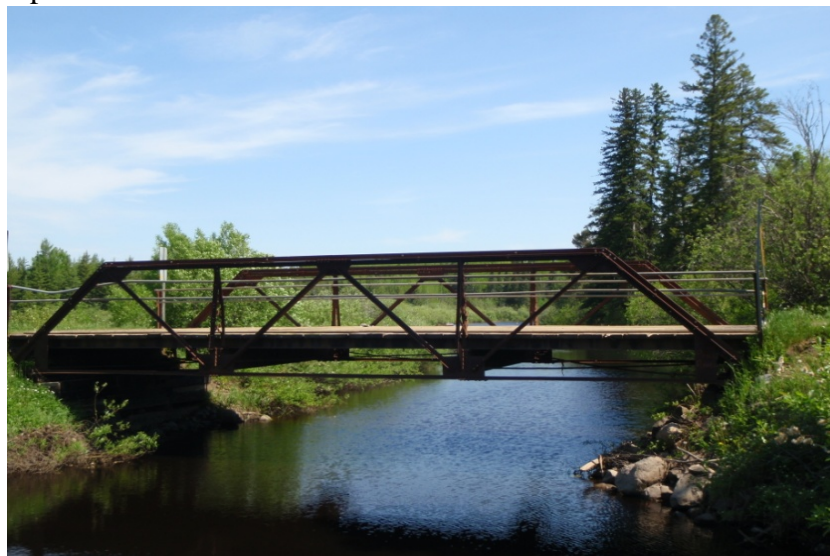
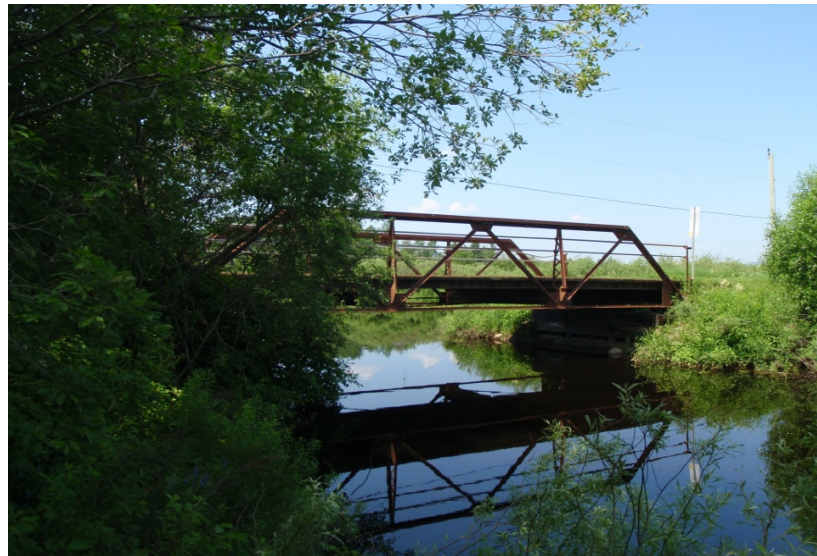
Bridge 5

Description: This was a steel framed bridge which had wooden planks on the deck. A new layer of wood had been laid down on top of the older layer. The steel frame was covered in rust but still appeared to be in good condition. The supports on the side of the bridge were built in a triangular shape. Two steel guard rails were present along the frame. The sides of the bridge were dominated by thick shrubs and grasses.

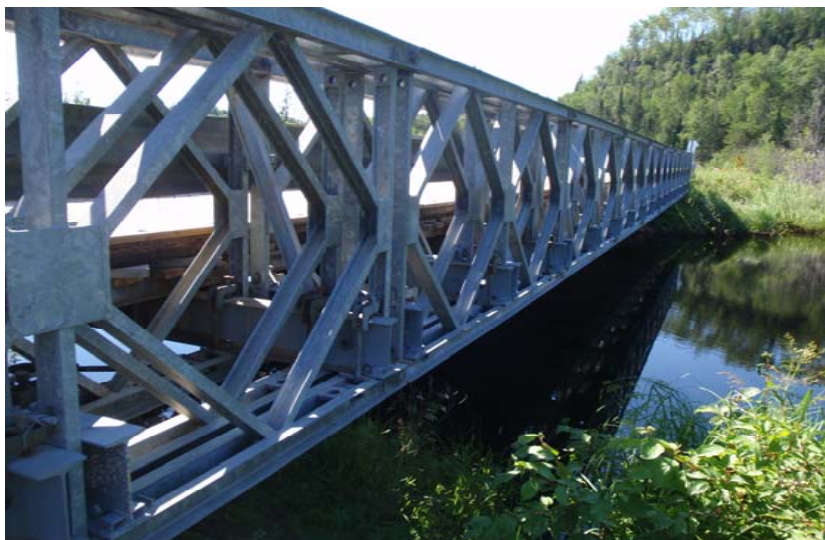
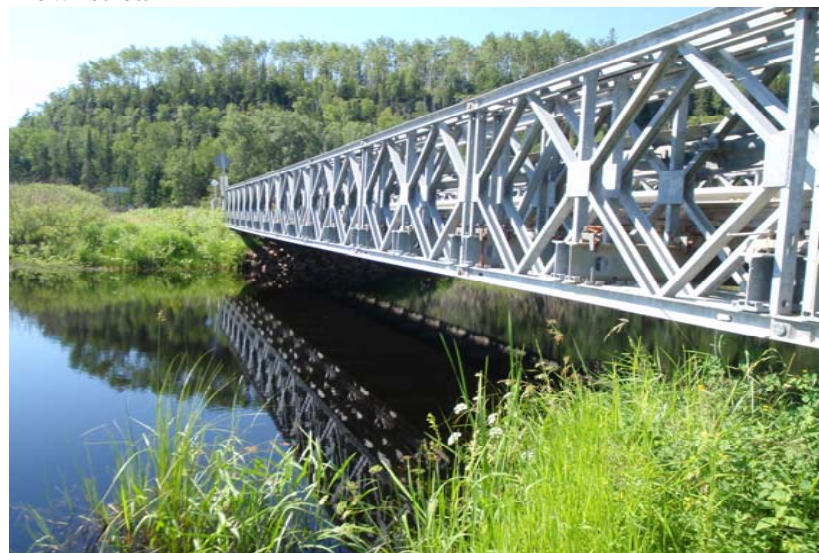
Bridge 7

Description: This bridge was a Bailey Bridge design: lattice steel designed for rapid assemble from prefabricated standard parts, and was in excellent condition. The deck of the bridge was made of wooden planks. The bridge was well maintained and looked to be fairly new. Rock and gravel fill was used underneath the two ends of the bridge for support. The vegetation on the sides of the bridge was shrubs and grasses. The bridge was in a lowland area.

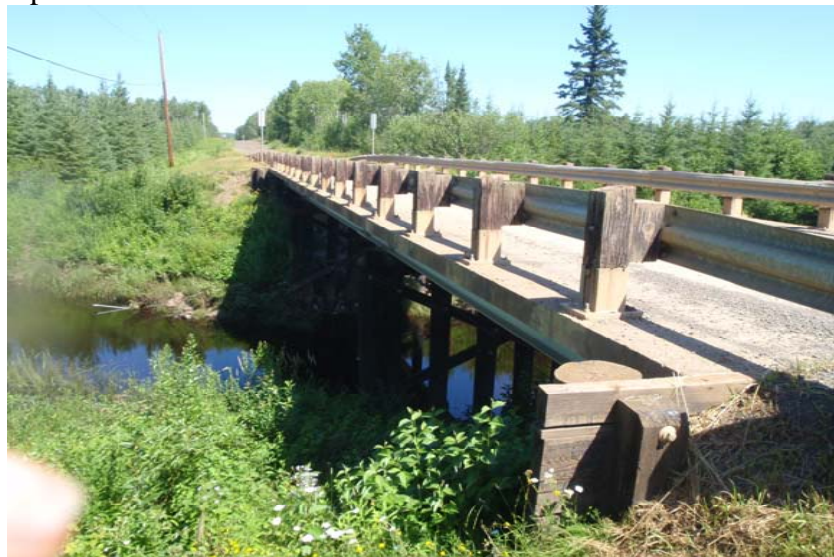
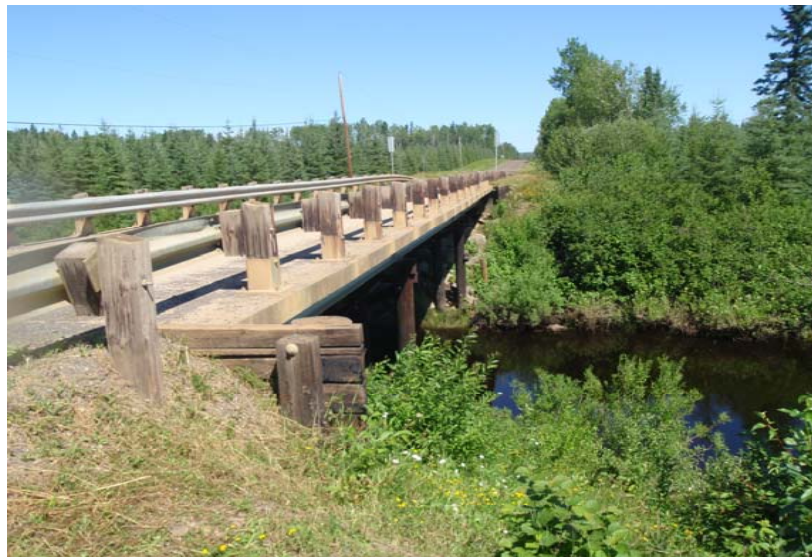
Bridge 8

Description: This bridge consisted of a concrete deck with metal and wood guard rails. There were four wood posts, one on each end of the bridge. Wooden support beams were used beneath the bridge in a triangular shape. Large boulders were used underneath the ends of the bridge for support. Willow and alder were the dominant species which surrounded the bridge.

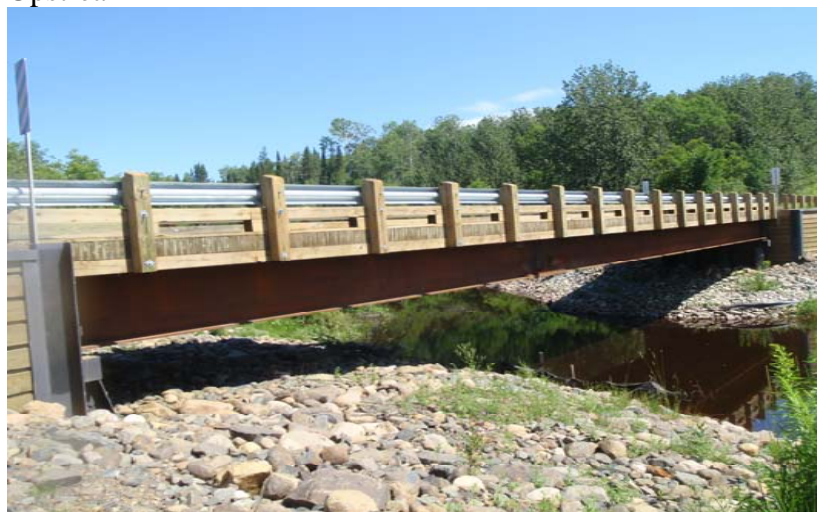
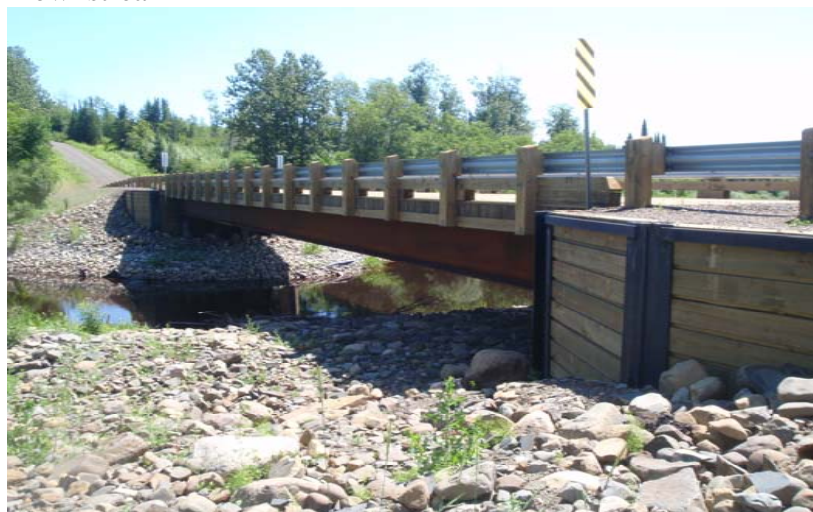
Bridge 9

Description: This was a new bridge built in 2010 and was in excellent condition. It consisted of wood and had metal guard rails and wooden cribs held together by metal on either side for support. Rip rap was placed around the wooden cribs to prevent erosion and to support the cribs. There was no vegetation directly underneath the bridge because of the presence of the rock fill. A metal beam was placed underneath the wood deck of the bridge for further support.

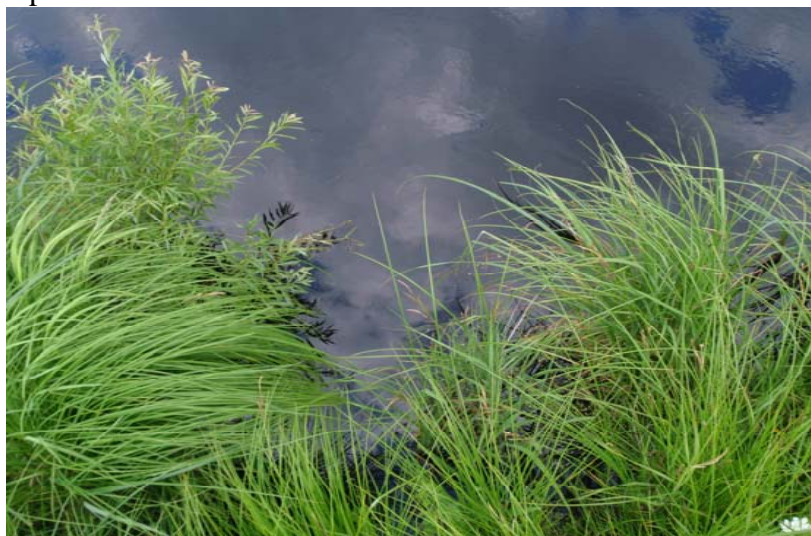
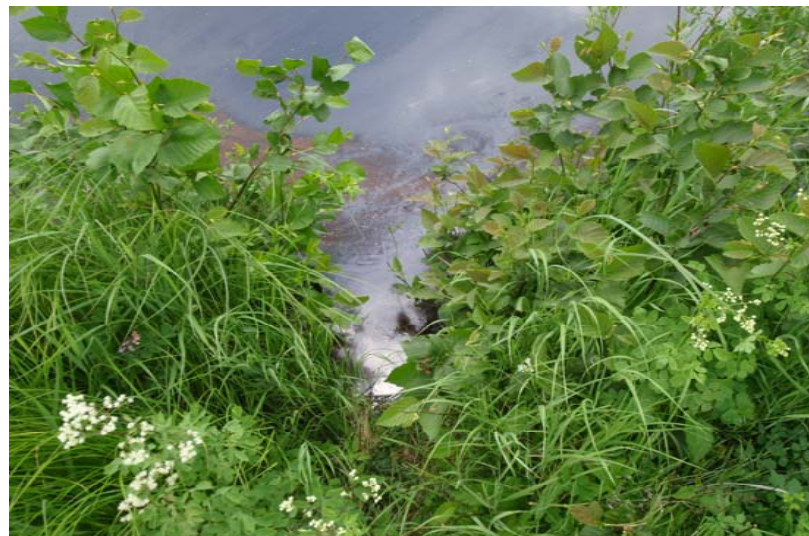
Description: This culvert was located in an area which resembled a wetland as opposed to a river. The culvert did not appear to have any damage or clogging that would restrict water flow, although the current water level was high enough to completely submerge both ends of the culvert. This culvert may not be able to handle the larger volume of water on either side of the road and the road may be at risk of washing out. As shown in the photograph, the culvert was difficult to locate due to its submersion. Flow rate was stagnant and the surrounding vegetation was dominated by grasses and herbs. Regular monitoring of this culvert is recommended as a larger one may need to be installed.

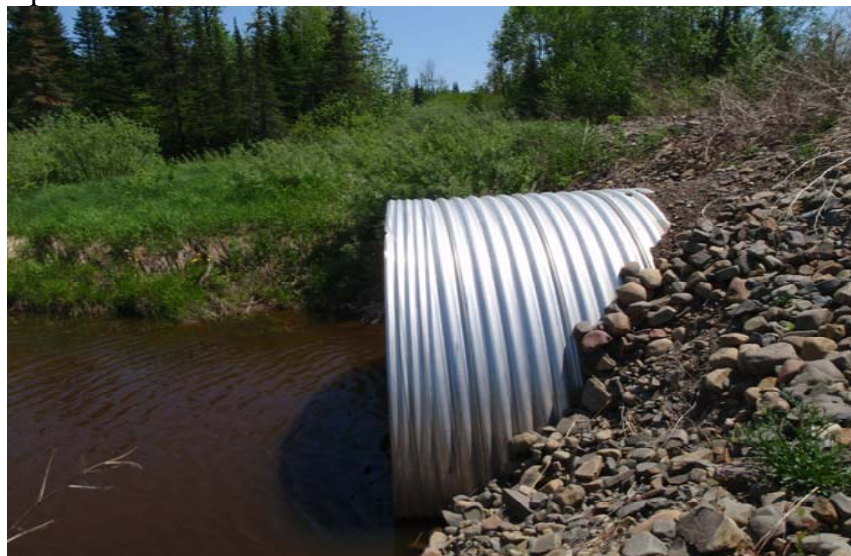
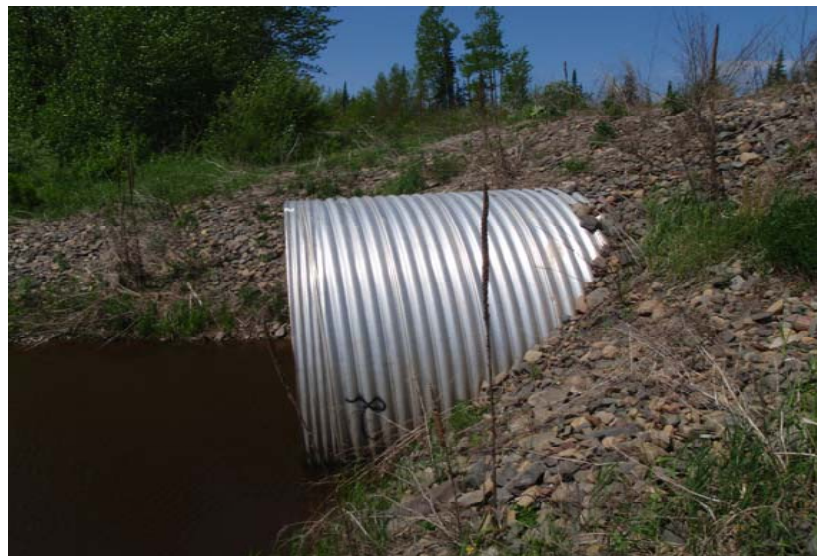
Culvert 2

Description: This was an aluminum culvert that appeared to be in excellent condition and seemed large enough to be able to support water flow during times of both high water level and low water level. No rust line was observed during either month. The water level was relatively low compared to the size of the culvert opening, but the culvert was not perched. Rip rap was used to prevent erosion around the culvert

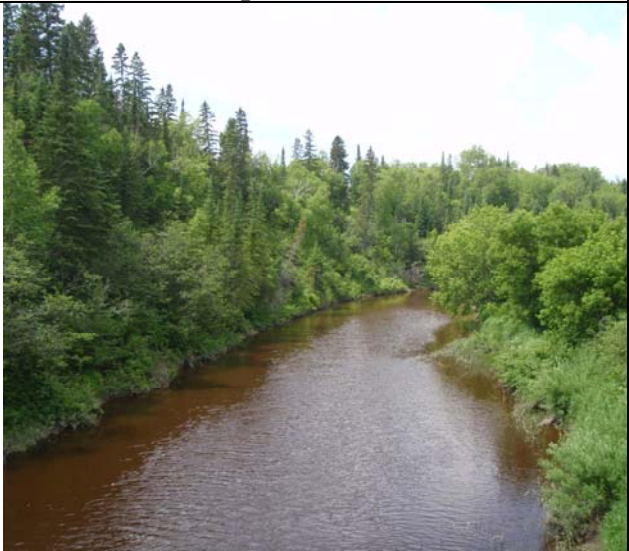
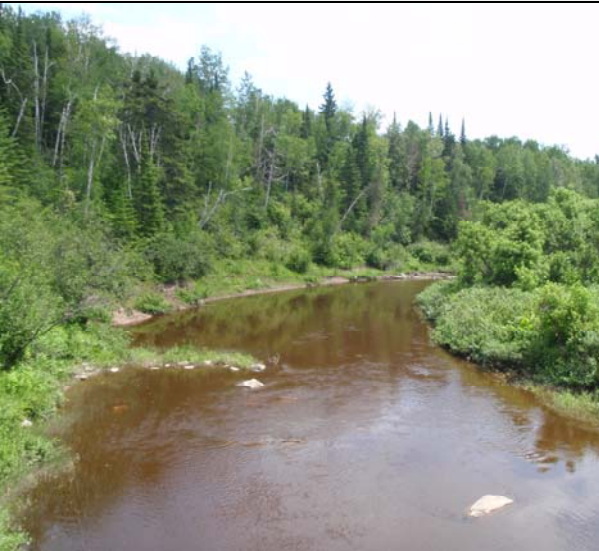
Site 2 – On Highway 61 south of Memory Road	
A: Upstream Photo	B: Downstream Photo

Sample Site 2 was located on Highway 61 south of Memory Road and was characterized by a large cement bridge. The water was murky with a subtle orange colour. The dominant substrate observed was muck and cobbles with boulders visible above the surface of the river. Aquatic and terrestrial vegetation was abundant both, with many shrubs and herbs present along the banks of the river. There were horsetails, arrowheads and green algae present in the water. Wolf tracks were observed under the bridge in the silty clay soil near the side of the river. There were many swallows observed at the site with seven swallows' nests underneath the bridge.

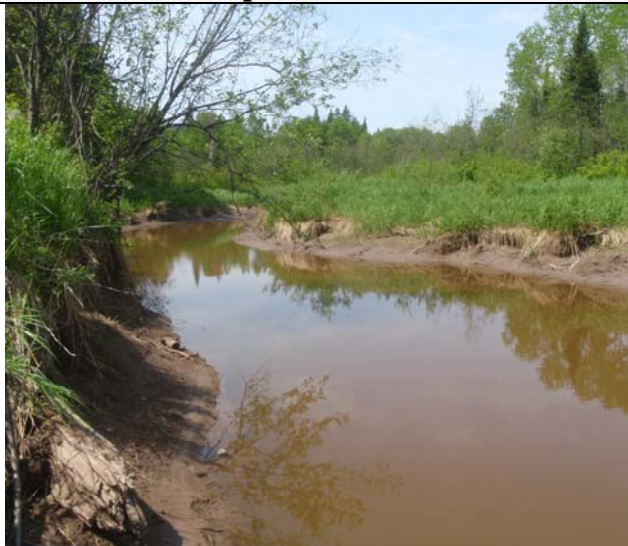
Site 3 – On Pardee Road west of Crystal Creek	
A: Upstream Photo	B: Downstream Photo

Site 3 was located on Pardee Road west of Crystal Creek and was characterized by a thick clay soil with murky brown water flowing slowly due to a beaver dam directly underneath the bridge. There was evidence of erosion at this site on each side of the bridge. The beaver dam beneath the bridge appeared to be affecting the water depth on the upstream and downstream sides of the bridge. The upstream water level was deeper and nearly stagnant compared to the downstream side where the water was shallow with some movement. An accurate velocity could not be recorded due to wind interference. A high water mark was observed on both sides of the exposed banks, indicating a fluctuating water level. Vegetation along the banks was primarily grasses, herbs and shrubs. The soil was silty clay and erosion on the banks of the river on the upstream side of the bridge was apparent. The downstream side did not appear to be eroding; however, vegetation along the banks was abundant which was likely aiding in bank stability. No substrate photo was available for Site 3 due to insufficient water clarity.

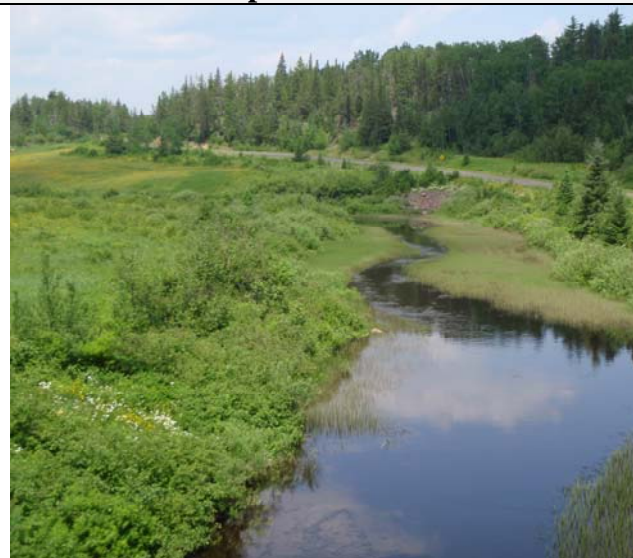
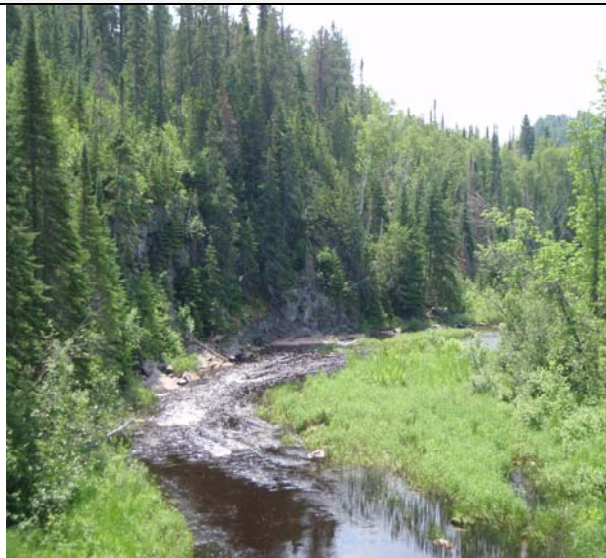
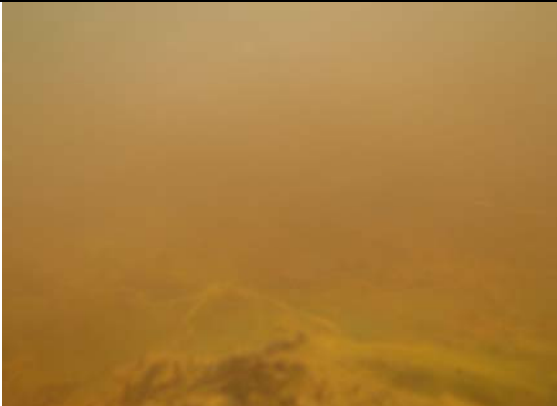
Site 4 – Intersection of Highway 595 and Highway 597		
A: Upstream Photo		B: Downstream Photo

Site 4 was located at the intersection of Highway 595 and Highway 597 and characterized by a large concrete bridge. The water at this site was clear and shallow flowing over bedrock and boulders. There were many wood ticks observed at this site during both site visits. There was no apparent erosion as the banks, although steep, consisting of boulders with shrubs and herbs growing abundantly. The velocity of the river at this site increased from the first visit to the second, likely a result of higher water levels due to rain events prior to the second site visit.

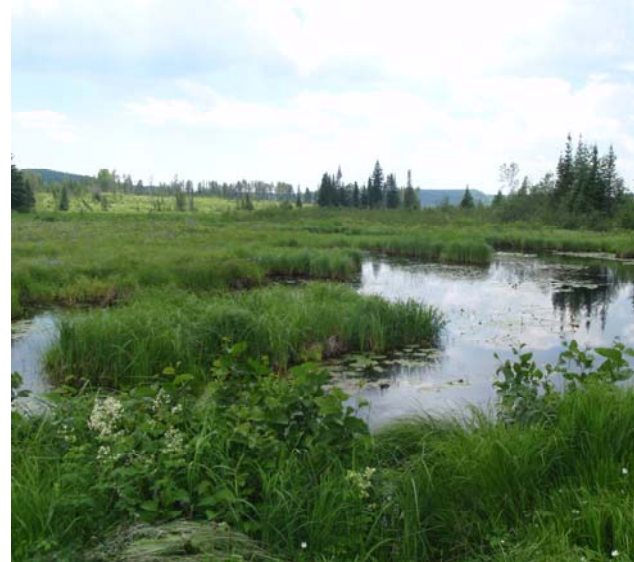
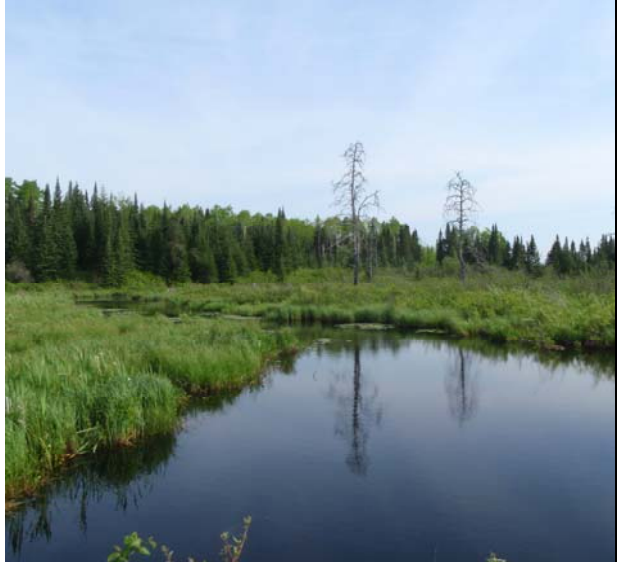
Site 5 – On Highway 595 west of Coulson Road	
A: Upstream Photo	B: Downstream Photo

A photograph showing a narrow, shallow waterway flowing through a lush green marshy area. The water is calm, reflecting the sky and surrounding vegetation. The banks are covered in tall grasses and other aquatic plants. In the background, a line of trees and distant hills are visible under a cloudy sky.

A photograph showing a similar view of the waterway from a downstream perspective. The water is still, creating clear reflections of the surrounding greenery and the sky. The banks are densely vegetated with tall grasses and shrubs. A line of trees is visible in the background.

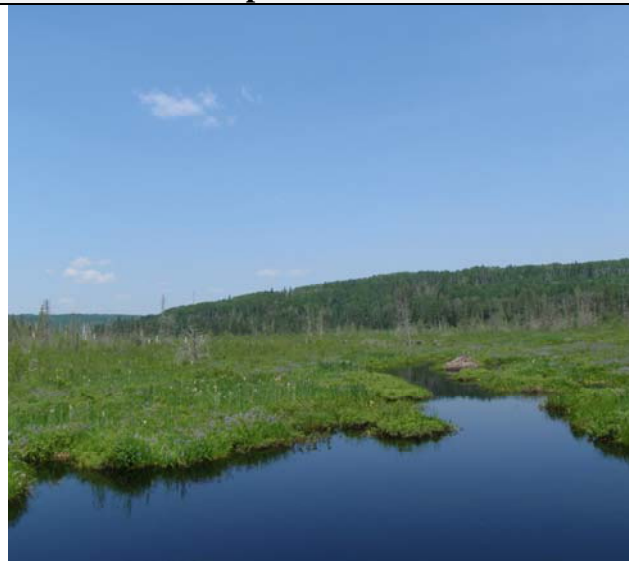
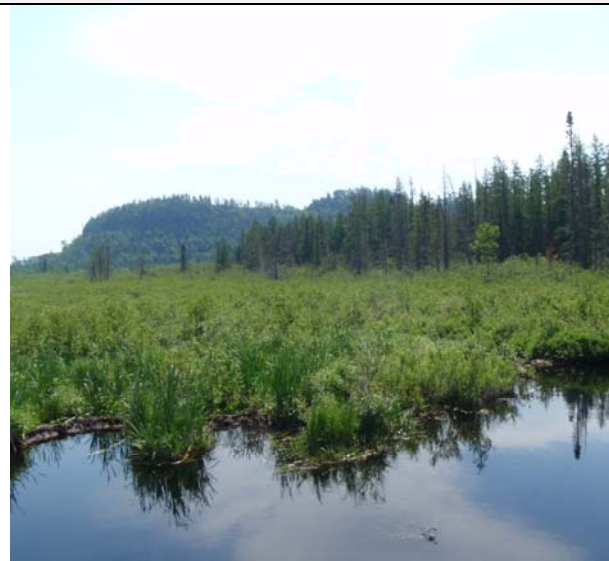
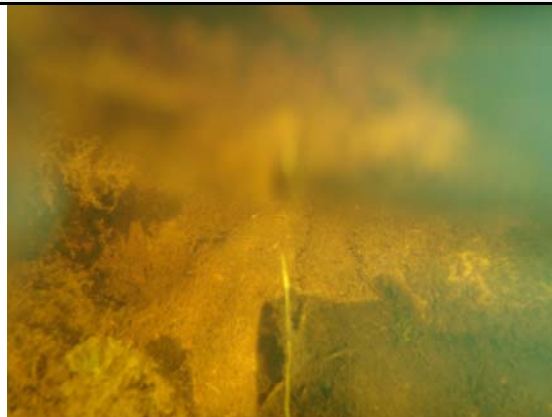
Site 8 – On Wamsley Road adjacent to northern part of the Pine River	
A: Upstream Photo	B: Downstream Photo

Site 8 was located on Wamsley Road adjacent to the northern part of the Pine River. This site was distinguished by a marsh which surrounded the road and culvert, with no defined banks observed on either side. There were aquatic plants growing in the water which included cat tails, common reed and fragrant white water lily. Dead trees scattered throughout the swamp were observed. There was little stream cover at this site. The little amount of stream cover came from the dead trees which were present in the water which covered a small portion of the river. The majority of the trees were situated further back from the river on terrestrial soil and therefore did not greatly affect the stream cover. A soil type could not be identified due to the lowland area submerged by water. Water at this site was almost completely stagnant (except for minimal wind influence on the surface) and velocity was therefore not determined.

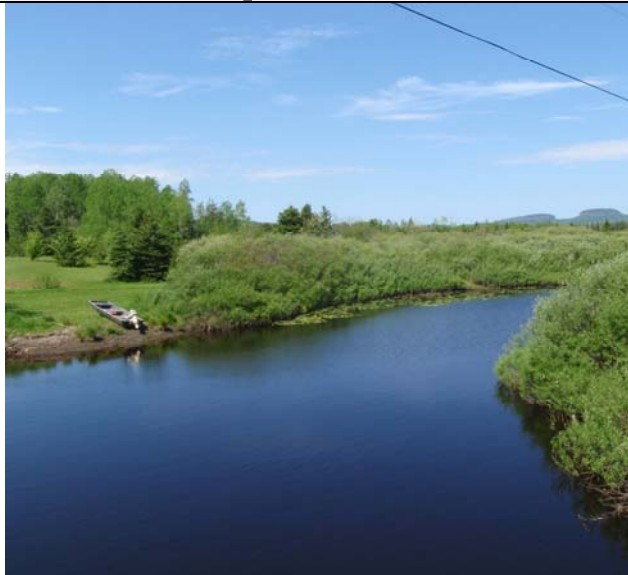
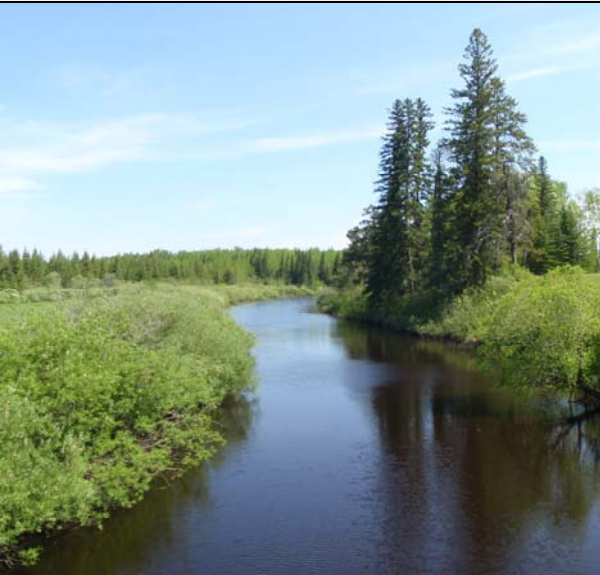
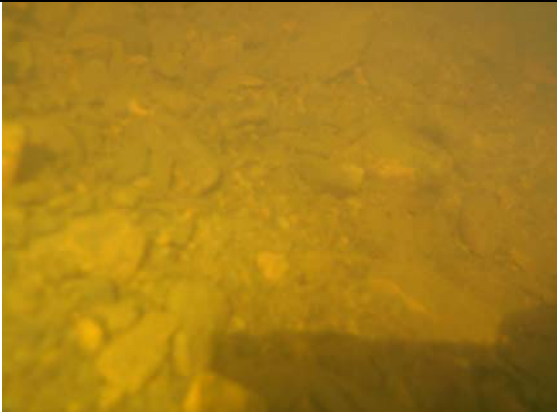
Site 9 – On Lankinen Road		
A: Upstream Photo		B: Downstream Photo

Site 9 was located on Lankinen Road near two residences. There was shrub growth right to the water's edge which made it difficult for photo documentation and sampling. There did not seem to be significant erosion present, however, any erosion present would have been difficult to see due to the abundant shrub growth covering the banks. There was a cleared portion of the bank on the upstream side of the bridge which was located on private property. Site 9 had a fairly deep channel with no measurable flow. There was approximately 15-20 percent stream cover from the shrub growth along the both sides of the water. Stream cover was mainly located on the downstream side of the bridge and was covered by the trees and shrubs present in the area. The soil type at this site was a clay loam.
