# **2010 Cedar Creek Watershed Assessment Update**

## **September 2010**

**Lakehead Region  
Conservation Authority**  
Conserve Today...For A Better Tomorrow

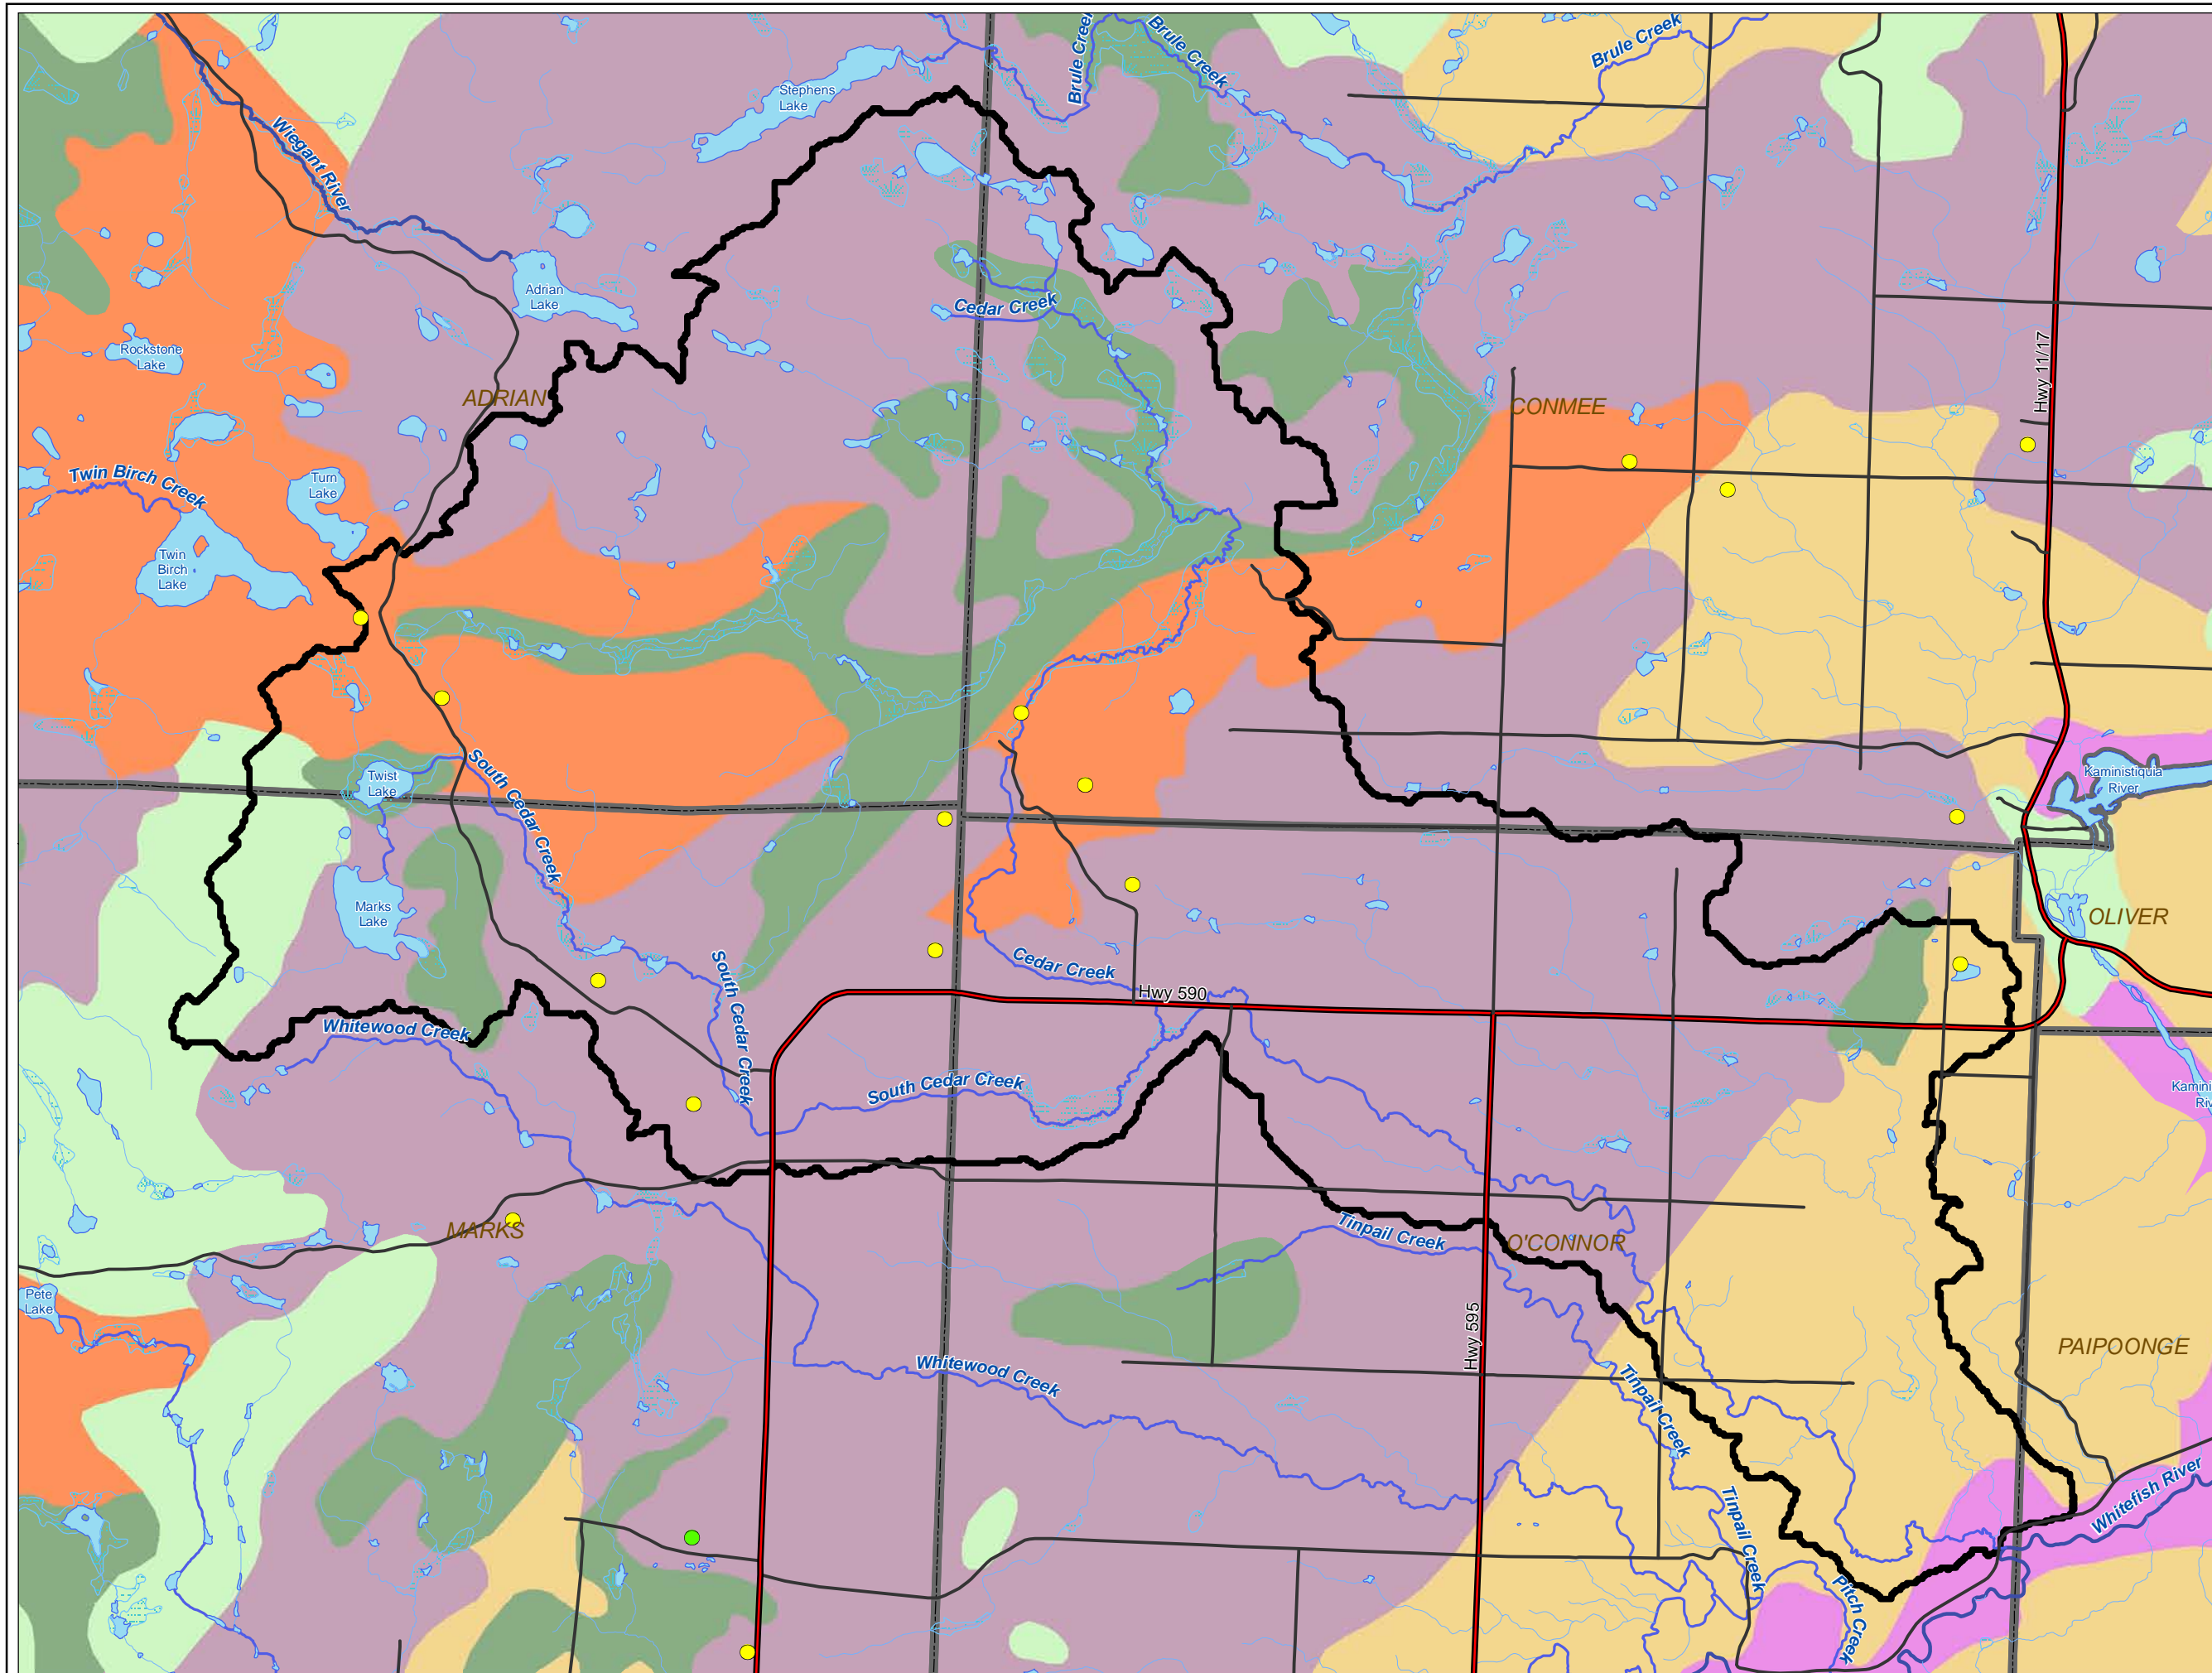
M-6: Soils

The Cedar Creek watershed is composed of 12 different soil types. The three most abundant soil types are Rockland, Jarvis and Nolalu. The distribution of soils throughout the watershed can be found on map M-6: Soils.

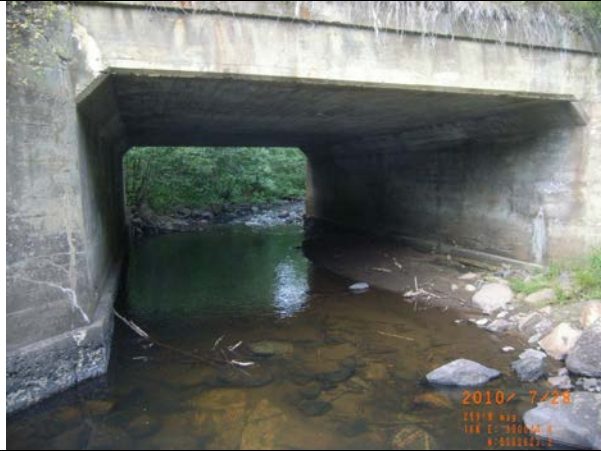
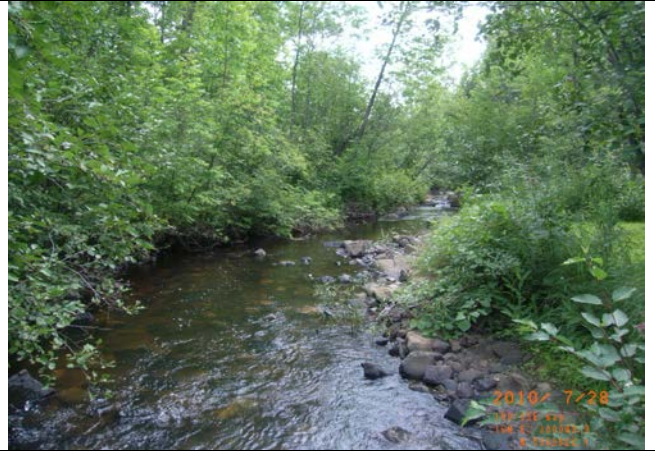
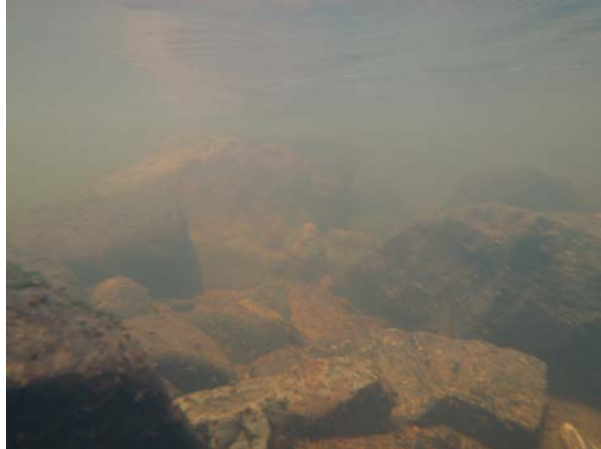
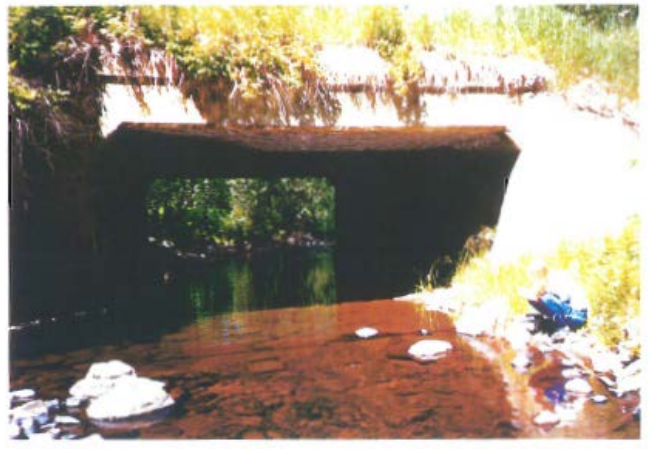
**Site 4- Highway 595, before Cronk Road, Downstream**

Site 4 was located off Highway 595 with relatively easy access and parking at a nearby church. The south bank had a manicured lawn with only a small patch of vegetation in the center of the property. The north bank consisted of a dense wooded area, with thick shrub growth on the stream bank. Water flow in the stream was fairly swift with no apparent obstructions upstream or downstream. When compared to the culvert photo taken in 1998 there were no obvious physical changes. The substrate appeared unchanged with large boulders and cobble. The concrete structure appeared to have remained unchanged as well.

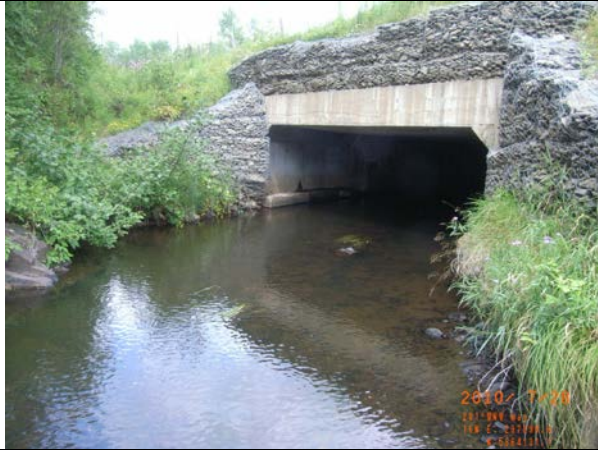
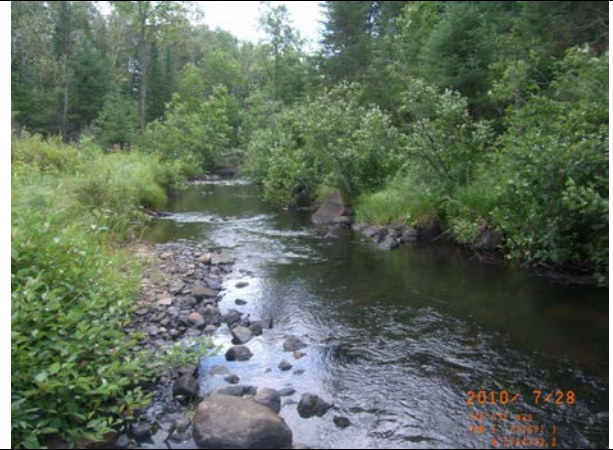
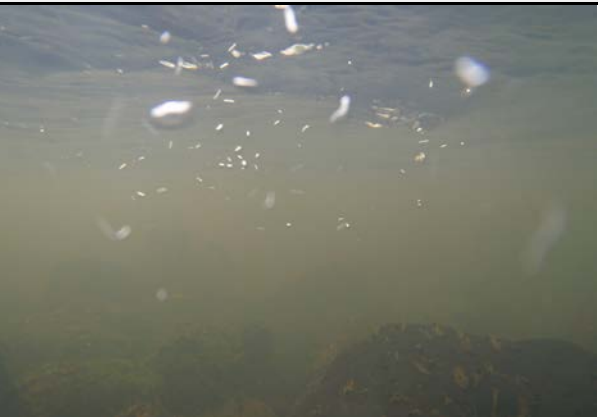
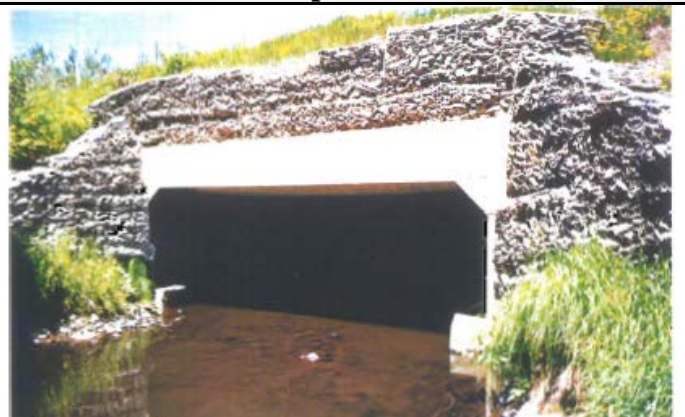
**Site 5 – Highway 590, before Pool Road , Downstream**

When comparing structure photos from 1998 and 2010, this site appeared to have undergone little physical change. Grasses remain the dominant species on the north bank and the bridge appeared to be in similar physical condition with no obvious deterioration. The substrate was also remained unchanged, with cobble continuing to be the most abundant grain size.

Site 5 was located downstream of Highway 590, east of Site 6. This site was characterized by bedrock outcrops, cobble shore and abundant vegetation. The concrete structure upstream was considerably large and in relatively good shape with no visible decay. Gabion baskets had been placed on top of the structure in order to prevent erosion. The vegetation at the site was dominated by low lying shrubs, herbs and grasses on the north bank, and larger shrubs and conifers dominating the south bank. The substrate was mostly cobble and bedrock, and flow was relatively swift. With the exception of algae, there was no aquatic vegetation present. When compared to the culvert photo taken in 1998 there appeared to be little physical change. Grasses continue to dominate the north bank.

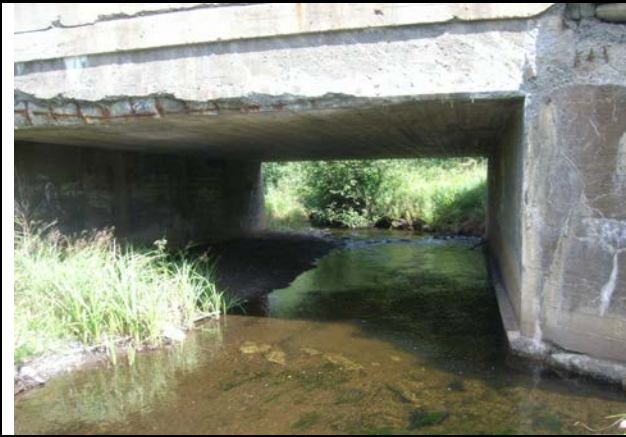
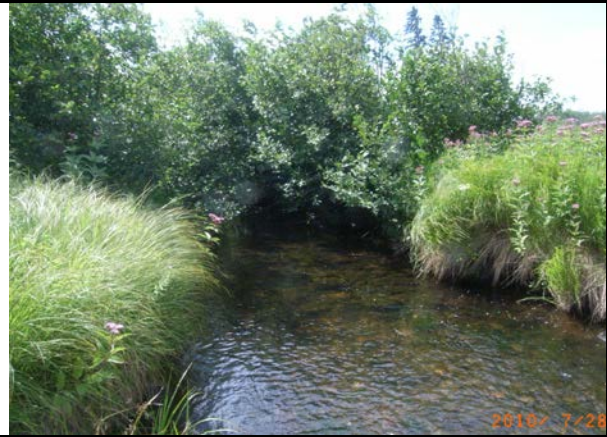
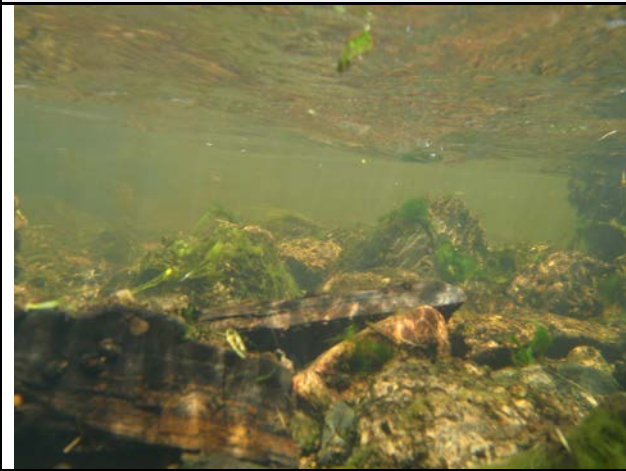
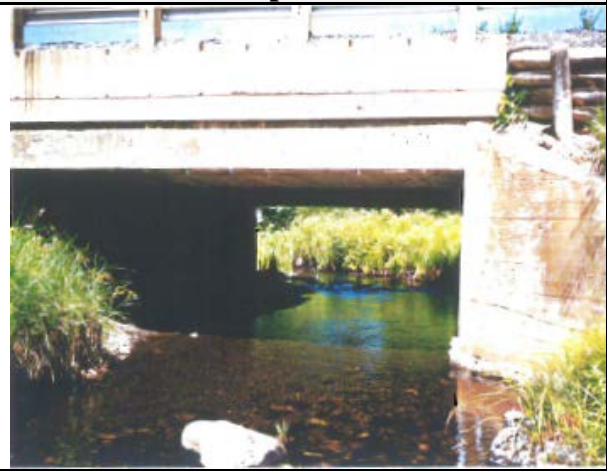
**Site 6 - Highway 590, before Strom Road , Downstream**

Site 6 was located off Highway 590 directly downstream of the 590 bridge. The channel was fairly shallow and produced a moderate flow. The bridge upstream was decaying, with concrete fragments landing into the stream bed below (Appendix H). There was agricultural activity in close proximity to the south side of the stream. The vegetation on either side of the creek was dominated by tall grasses and herbs. The vegetation provided little to no shade for the sampling site. In contrast, further downstream the vegetation was dominated by alder, which provided almost complete shade. The substrate was mostly shale and cobble, with abundant amounts of algae. The water was shallow and very clear relative to other sites. Soil was characterized by a thin organic layer of approximately four centimetres, with silty clay for approximately 20 centimetres. Photo documentation of 2010 observations can be found in Appendix H.

When comparing the 1998 and 2010 photos, Site 6 appeared to have changed very little. The bridge had noticeably decayed since 1998, with cracking concrete on the top north portion, exposing rebar. The substrate of this site appeared to have changed significantly as well, with the 1998 photo displaying what appeared to consist of cobble and the 2010 photo displaying what appears to be sand in the same location. The substrate likely altered during a significant flood event which occurred in June 2008.

Site 6 was located directly downstream of Highway 590, west of sampling Site 5. The channel was fairly shallow with moderate flow. Vegetation on both sides of the creek was dominated by various grasses and herbs. This provided little to no shade over the stream. Further downstream vegetation was dominated by alder, creating considerably more shade over the channel. The substrate was mostly composed of cobble and sand, with abundant algae growth. When compared to the 1998 photo there are some obvious changes. The bridge had noticeably decayed since 1998, cracking and degradation of the concrete on the top exposing rebar.

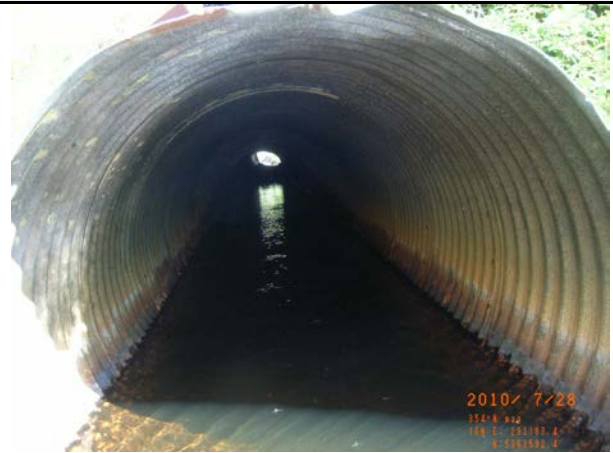
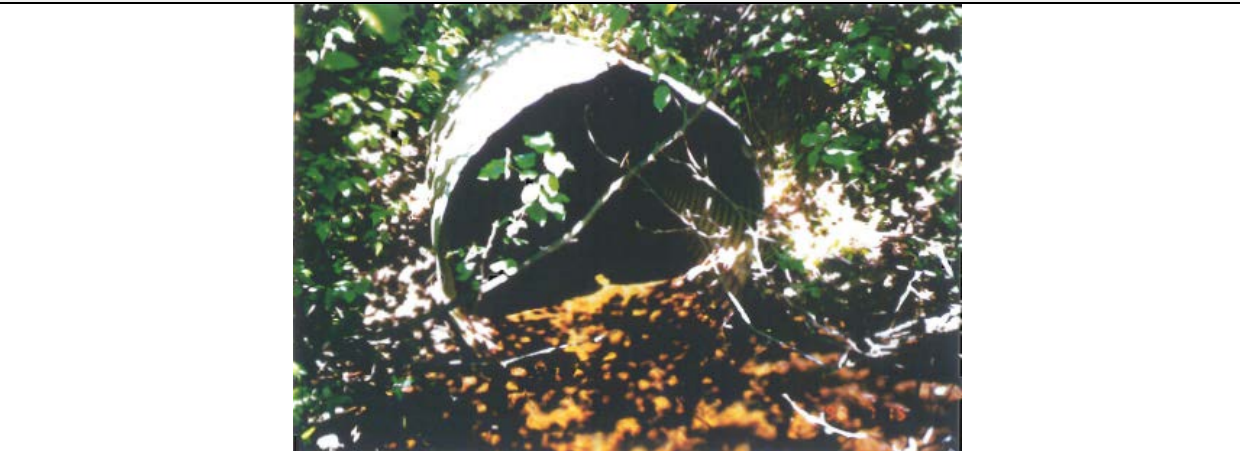
**D: 2010 Culvert Photo**

The culvert photo taken in 1998 displayed no noticeable changes; however, changes in both the colour of the water and vegetation were apparent. The colour of the water in 1998 appeared orange in colour when compared to the water observed in 2010. It is important to note that colour change can be subjective and may be a result of camera quality and not a change in the quality of the water itself. Vegetation appeared denser in 1998, with shrub growth on the banks adjacent to the culvert, where no shrub growth was observed during the 2010 survey.

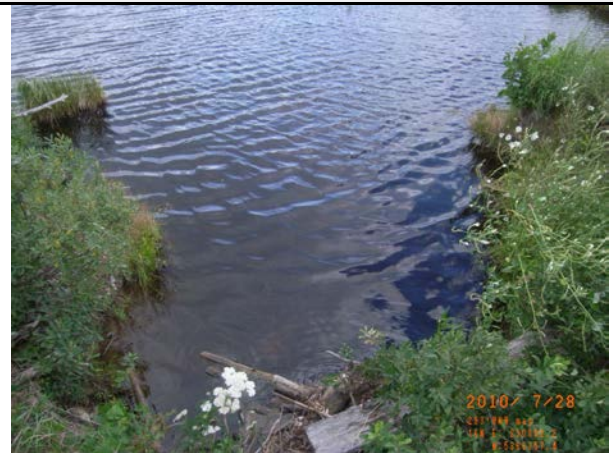
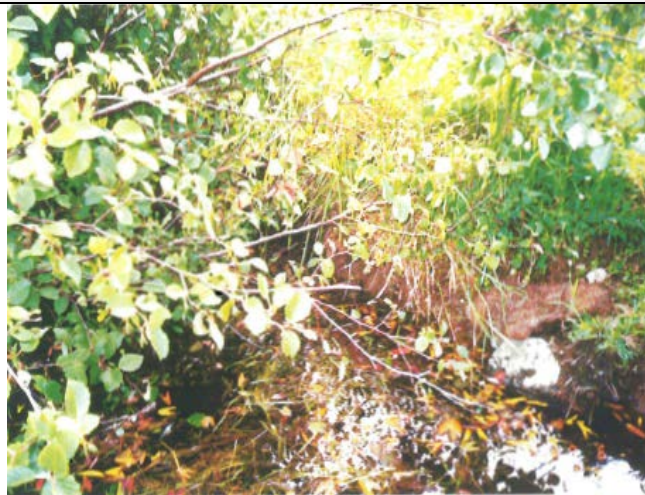
**D: 2010 Culvert Photo**

The muck substrate appeared to be orange in colour, with abundant submergent and emergent plants. Terrestrial vegetation in the area was mostly grass and herb dominated, with speckled alder and slender willow shrubs. Surrounding the sampling site was a conifer mixedwood stand of black spruce, balsam fir and white birch. The culvert downstream of the site had been completely buried.

When comparing 2010 observations to the culvert photo taken in 1998 it is evident that the culvert had been blocked for a considerable period of time, since both 1998 and 2010 noted the blocked culvert. It was also noted that sweet gale, the most dominant shrub observed in 2010, was also present in 1998.

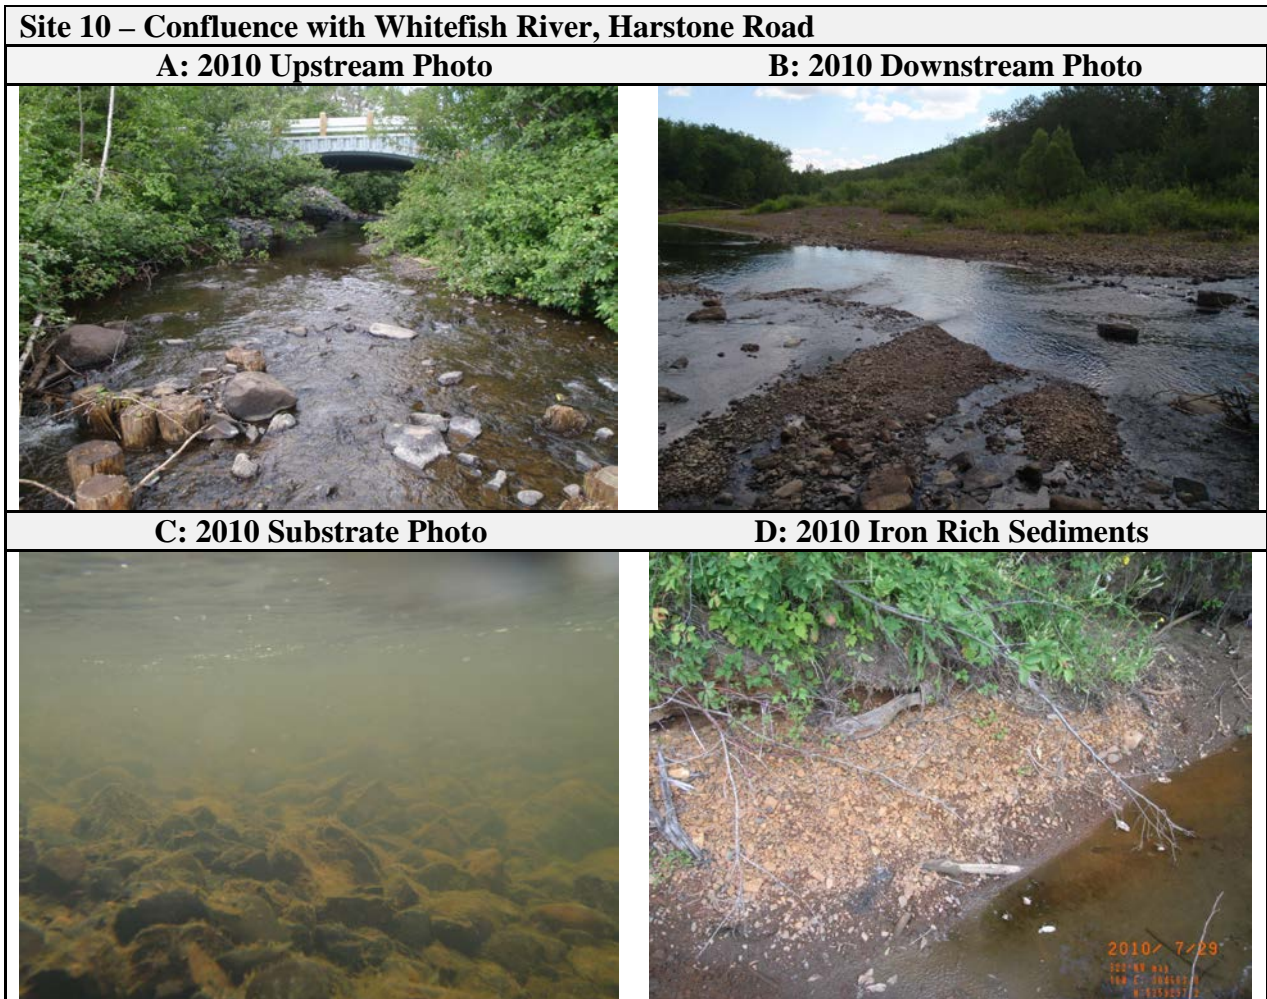
Site 10, the confluence of Cedar Creek and Whitefish River, had easy access off Harstone Road and parking on the south side of the creek. Vegetation at this site was highly abundant along the shoreline, composed mostly of shrubs. The confluence was characterized by the dispersion of the main creek channel into several independent flowing channels. The flow was relatively swift in the shallow channel and there were large amounts of cobble deposits at the mouth of Cedar Creek. The substrate was mostly composed of small cobble with some larger boulders distributed throughout. Remnants of an old bridge were observed at the sampling site, downstream of the current pipe arch location. The bank on the north side of the creek was characterized by a dark red to orange colour, indicating iron rich sediments were present. Photo documentation was not completed at this location in 1998.

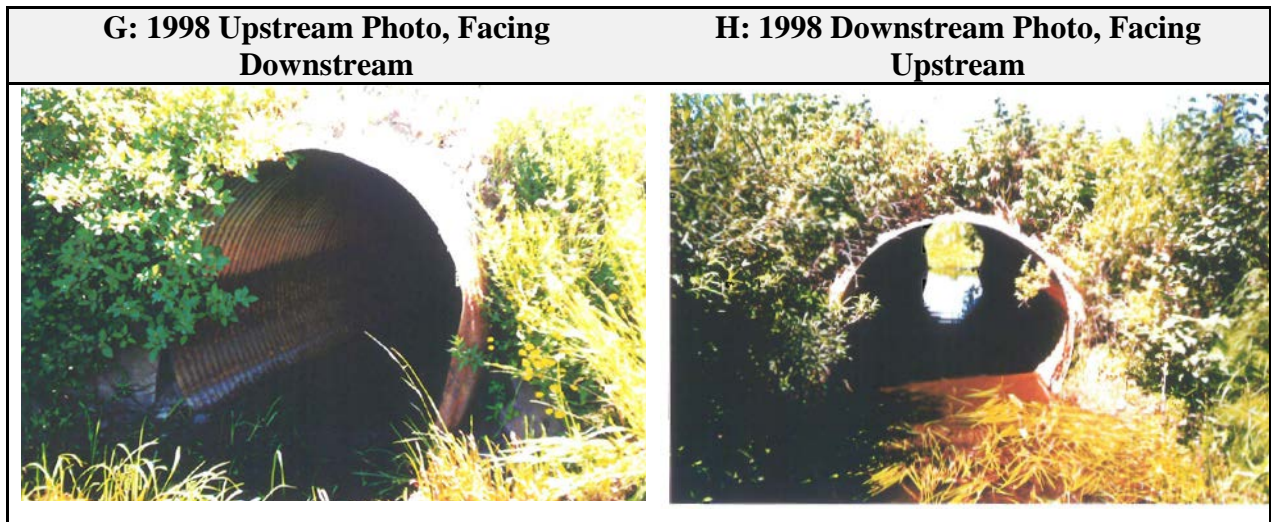
<b>E: 2010 Upstream Photo; Blockage</b>	<b>F: 2010 Downstream Photo; Blockage</b>

Site 11 was located off of Garbutt Road in a rural area adjacent to agricultural activity. Sampling was completed adjacent to the road. The water at the site was stagnant on the upstream side of the culvert with vegetation growth. A portion of the culvert was completely dry and had become rusted and cracked.

Upon arrival, two horses were observed standing in the stagnant pool downstream of the sampling location. The substrate consisted mainly of organic/muck with boulders and some cobble. Vegetation along the stream bank was thick, predominately composed of shrubs and herbs which provided some shade. The dominant vegetation at the site was bog willow and wild red raspberry. A wetland was located upstream from the culvert.
