Corbett Creek Watershed Assessment Update

2010 Corbett Creek Watershed Assessment Update

September 2010

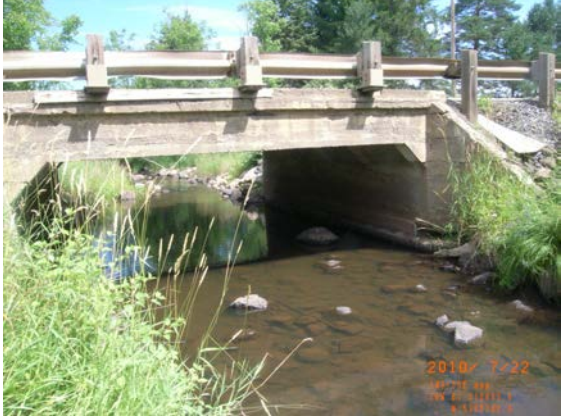
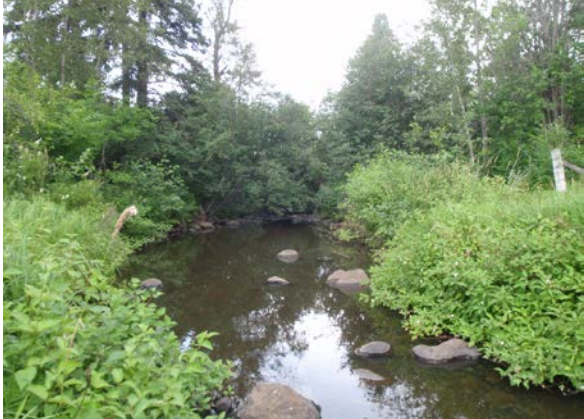
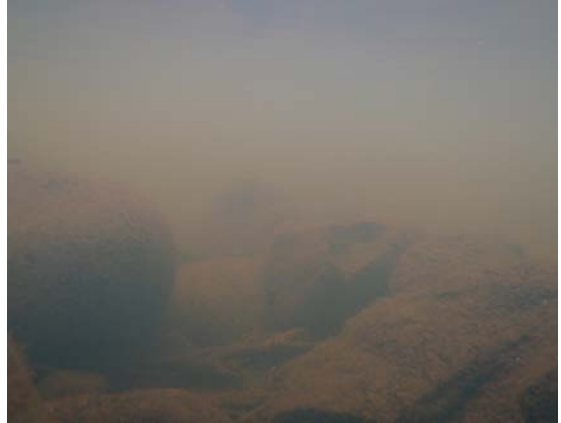
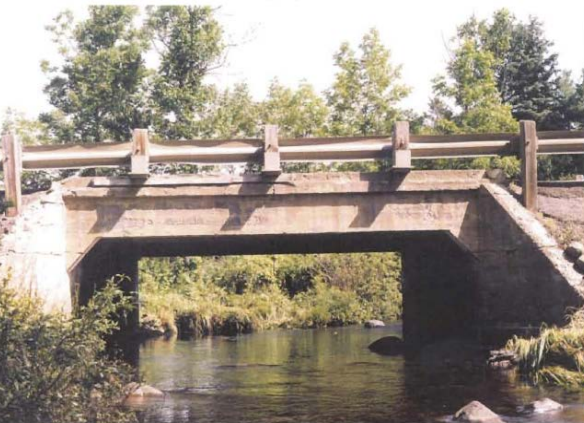
Site 7 – Oliver Road, Downstream	
A: 2010 Upstream Photo	B: 2010 Downstream Photo

Site 7 was located downstream of Oliver Road in a rural area with private property both upstream and downstream. Traffic was high at the time of sampling and close-by parking was unavailable. The terrestrial vegetation was very thick extending over into the channel itself. Vegetation was mostly characterized by dogwood, reed canary and an assemblage of herbs. The substrate was mostly cobble with large boulders distributed throughout, with very little organic material was present. The site was highly turbid, with slow flow. When comparing the 1997 culvert photo to photos taken in 2010 there are almost no observable changes. The bridge was in good condition in both 1997 and 2010 photos with no observable changes to its structure. The substrate also appears to have changed very little from 1997 to 2010 with boulders and cobble apparent during both periods.

When comparing the 1997 culvert photo to photos taken in 2010 there were no observable changes. The bridge was in the same condition and did not appear to have undergone any significant alterations. The substrate had a similar composition of large boulders and vegetation that appeared to have undergone very little change.

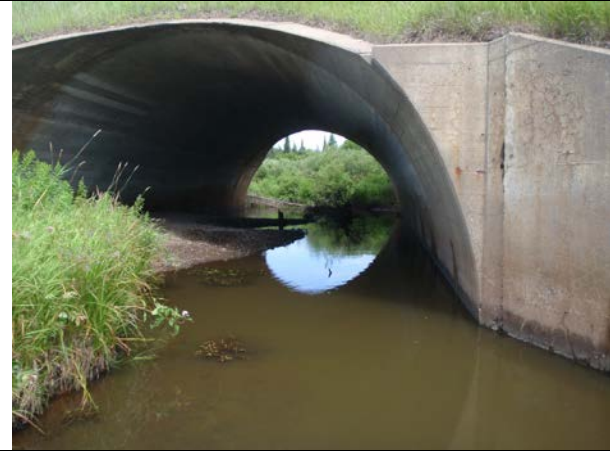
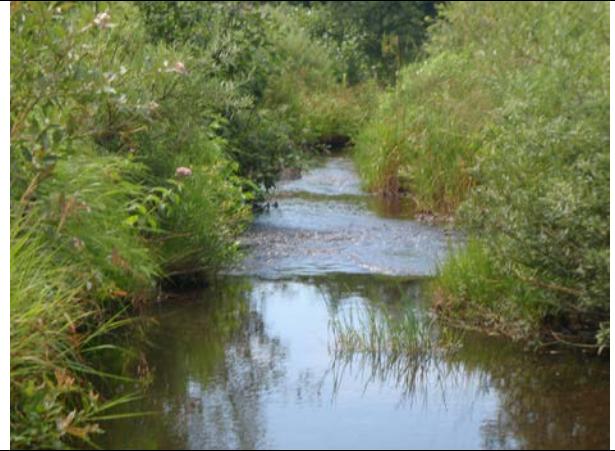
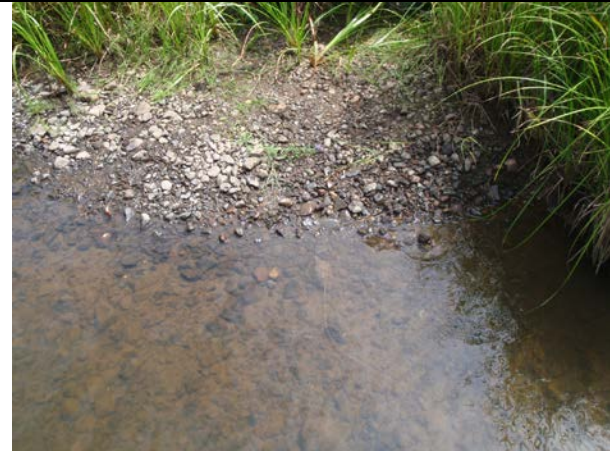
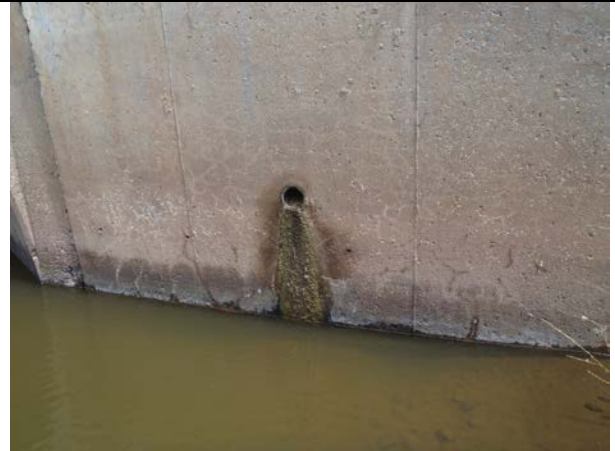
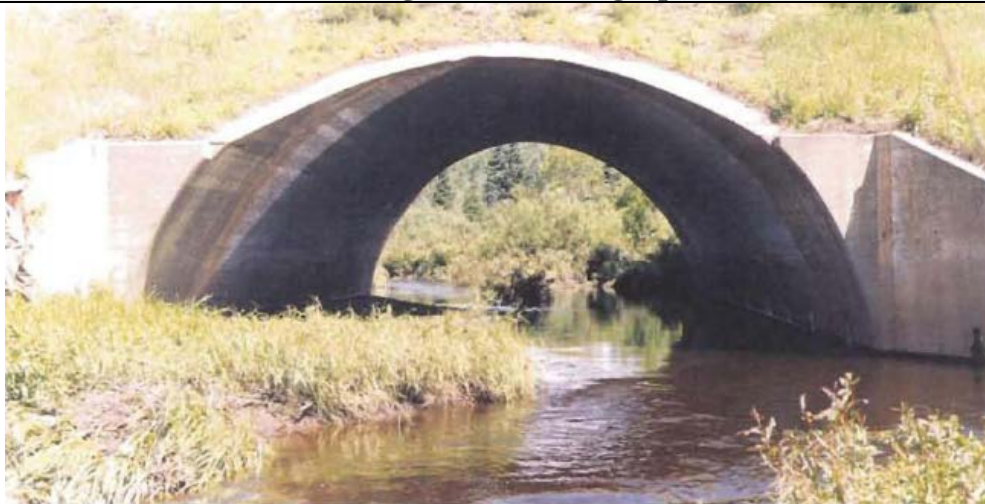
Site 10 - Highway 11/17, Downstream

Site 10 was located off Highway 11/17 was sampled in 1997, and was also the former stream rehabilitation site facilitated by the LRCA in 1987. Fencing and cattle passes were installed to restrict cattle from trampling the creek bed and banks, however, in 2010 there were no cattle on site. The bridge at this site was the largest of all sampling locations and appeared to be in good condition. The surrounding area was rural, with a residence adjacent to the sampling site. The vegetation of the area was characterized by abundant herbs and grasses, with shrubs dominating downstream. There were very few trees within the area. The flow of the creek was relatively slow given the large width and shallow depth of the stream. The water was highly turbid, only a stream bank photo could be taken. There appeared to be to be a high level of sedimentation at the site. There were also a large number of fallen trees within the channel upstream which did not appear to disrupt overall flow substantially, but caused small pockets of slow flow. A roadside runoff drain from the bridge was located upstream of the site with a considerable buildup of sludge appearing on the outside of the drain.

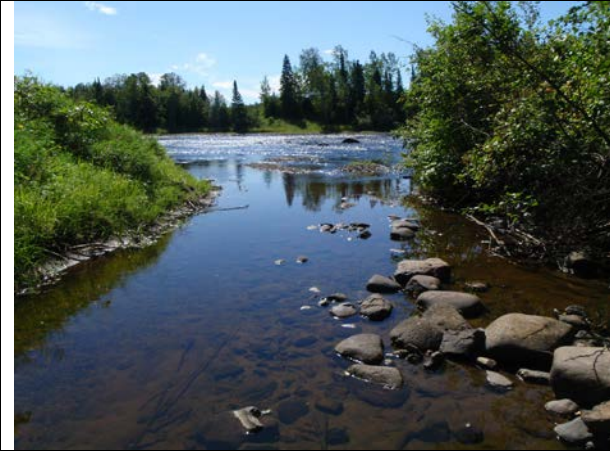
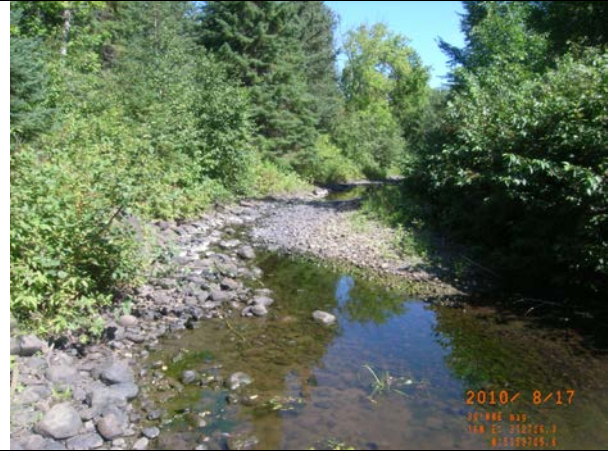
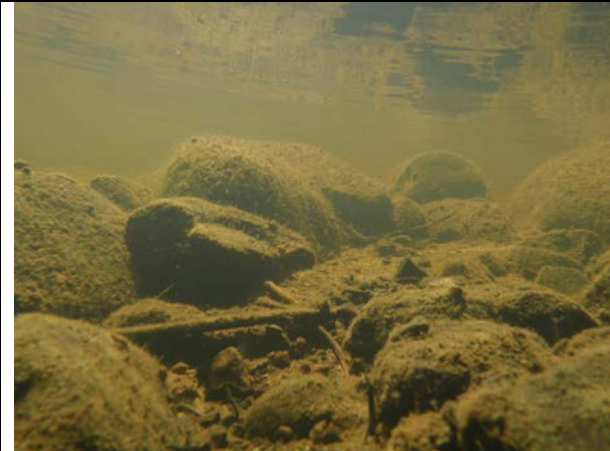
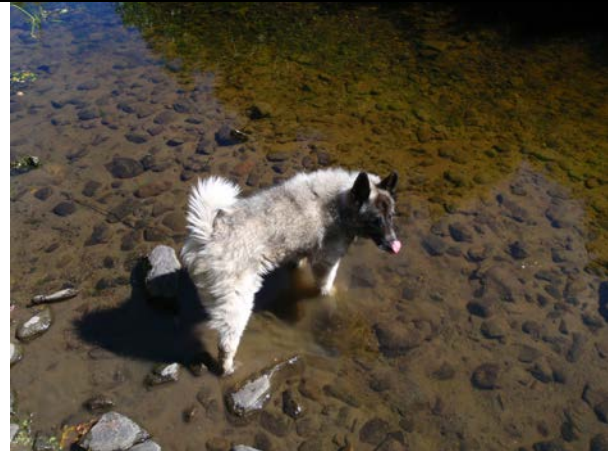
Site 13 – Corbett Creek and Kaministiquia River Confluence

Site 13, the confluence of Corbett Creek and the Kaministiquia River, was located off Harstone Drive adjacent to private property. The residents of the area were fully cooperative and allowed us to gain access through their property. The flow of the site was very slow (no flow could be recorded) with a cobble beach up stream, narrowing the channel width significantly. The Kaministiquia River appeared to be forcing water upstream into the creek, concentrating the flow from Corbett Creek to a small section to the east. The substrate was mostly cobble with boulders throughout. A thin layer of sediment had built up on the substrate with some algae present. There were no site photos taken from this location in 1997.

Site 13 was the confluence of Corbett Creek and the Kaministiquia River. This site was adjacent to private property off of Harstone Drive. The flow of the creek was nearly stagnant upstream of the sampling site and flow from the Kaministiquia River was rushing into the mouth of the creek which caused some backflow. Water levels within the creek channel appeared to be low and could not overpower the flow of the river. The adjacent property was manicured, with adequate buffer vegetation from the mowed grass to the creek bed. Vegetation on the creek banks was abundant, with the west side dominated by grasses and thick slender willow growth farther from the water's edge. The west side of the creek was shrub and herb dominated, with hawthorn, lady's thumb and alder present.
