# 2010 Pennock Creek Watershed Assessment Update

## September 2010

**Lakehead Region  
Conservation Authority**  
Conserve Today...For A Better Tomorrow

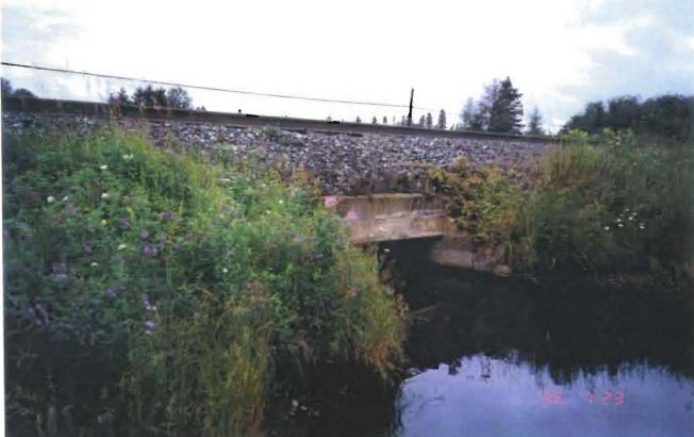
<b>E: 1996 Photo of Culvert, Facing Downstream</b>

When compared to the photo taken in 1996 (Appendix H), some change to the site location is apparent. The culvert in 1996 did not have a grating to prevent beaver activity and similarly no beaver activity adjacent to the culvert was evident. The predominately herb vegetation observed in 2010 appears to be consistent with the vegetation shown in the 1996 photo.

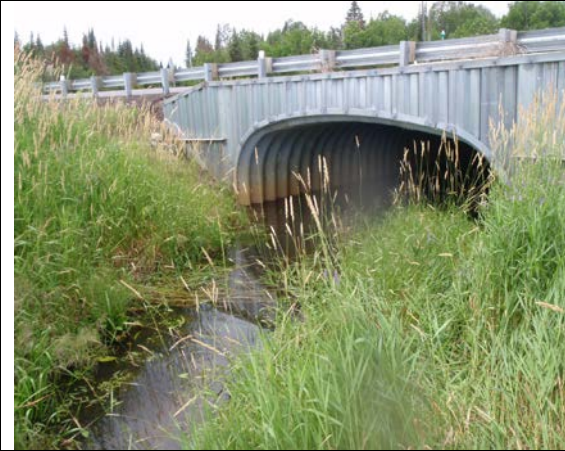
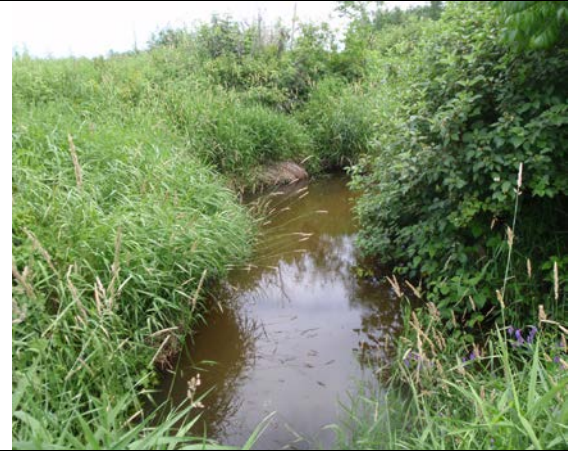
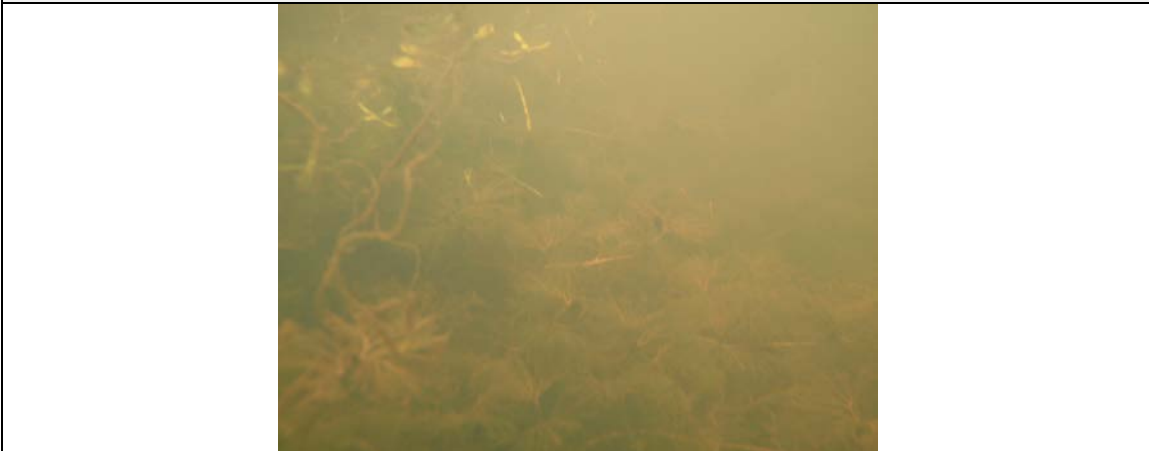
Site 2 was located off of Vibert Road, downstream of Highway 11/17. The bridge for Vibert Road just upstream of the sampling was new from the realignment of Highway 11/17 in recent years. The flow of the creek was perpendicular to the road. This narrow sampling site was abundant in both riparian vegetation such as reeds and canary grass; as well as aquatic plants such as wild calla and starwort. The substrate of this site was characterized by a cobble and organic mix, with a highly murky water column evident. The channel was relatively narrow and shallow with what appeared to be slow subsurface flow. The channel was partially shaded, with no vegetation tall enough to provide shade throughout the day.

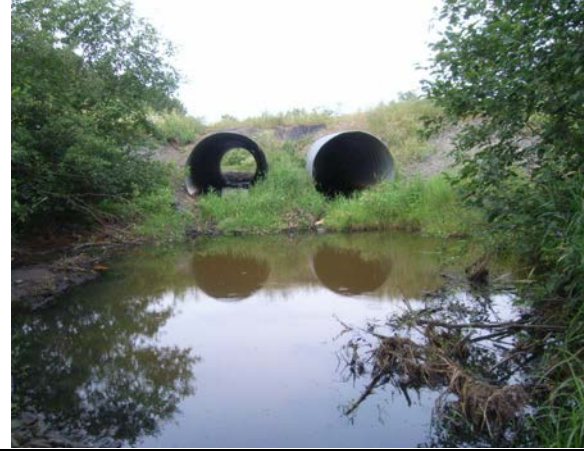
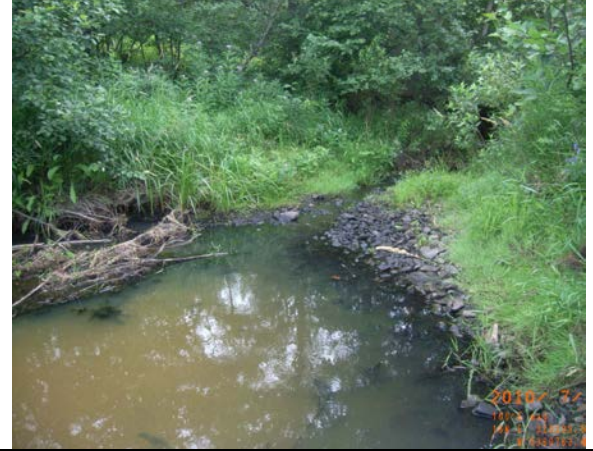
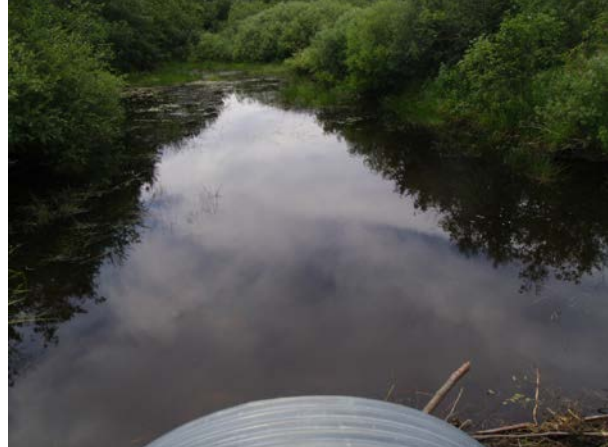
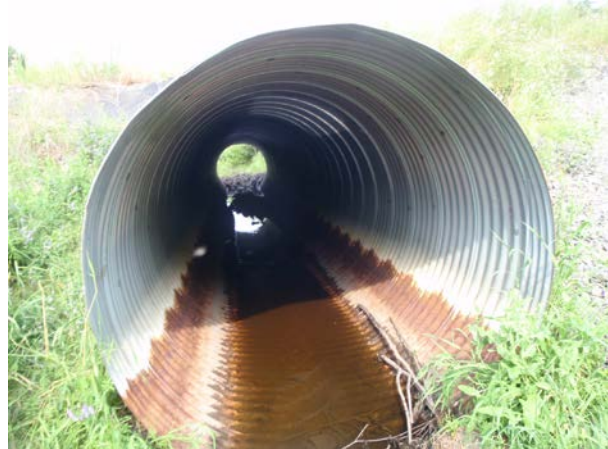
Site 3 was located at the end of Cooper Road; adjacent to an industrial sector. This site appeared to be considerably disturbed relative to all site locations. Both culverts were dammed on the upstream side, by what was observed to be beaver activity, and both culverts were perched on the downstream side. Low water levels in the culvert can be observed by looking at the waterline of the culvert on Plate E. This beaver dam had created a small stagnant pond downstream of the culverts. Upstream of the dam, all qualitative parameters including colour, depth, width, flow and vegetation the creek appeared remarkably different. Plate A shows considerable vegetation established on the downstream side of the culverts, suggesting the dams presence through an extended period of time. The water was highly turbid, with a cobble and muck substrate. Abundant aquatic vegetation had established, with abundant emergent plants along the edges of the pond and submergents in the middle of the small water body. What appeared to be floating mats of iron bacteria and iron rich soil were observed as well (Plate F). The culverts themselves did not appear to be compromised by the blockage and the road was still sufficiently wide for vehicle transport. Site 3 should be investigated in the summer of 2011 to ensure that water quality and the roadway have not further degraded.

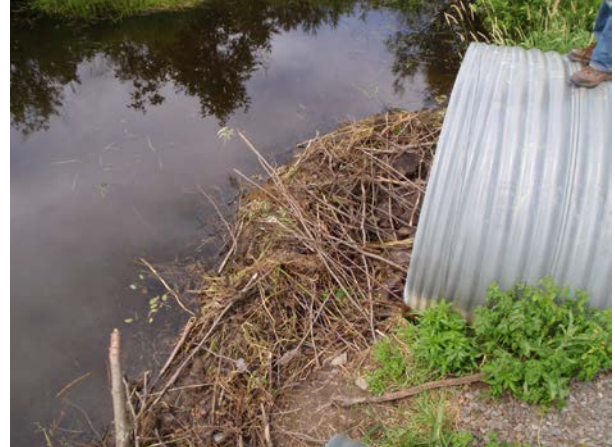
**D: 2010 Beaver Dam Upstream Photo**

Iron concentrations increased significantly between the 1996 and 2010 studies. Iron exceeded PWQO criterion (0.3 mg/L) in the 1996 report with a concentration of 0.425 mg/L on August 9, 1996 and a concentration of 0.308 mg/L on August 20, 1996. The 1996 iron concentrations are considerably lower than those observed in 2010. This may be due to the lack of flow and subsequent decrease in the flushing of sediments and nutrients from the sampling site.

The damming of the stream appears to have greatly affected depth as well. The greatest depth reported from 1996 was 0.17 metres; where the depth observed on July 14, 2010 was 0.48 metres. This increased depth may have drastically affected many parameters, including aquatic vegetation and DO levels. DO concentrations in 1996 were on average 4.57 mg/L, exceeding required PWQO criterion (minimum of 5 mg/L). The 2010 measurements from Site 3 significantly decreased from 1996, with a DO concentration of 1.60 mg/L.

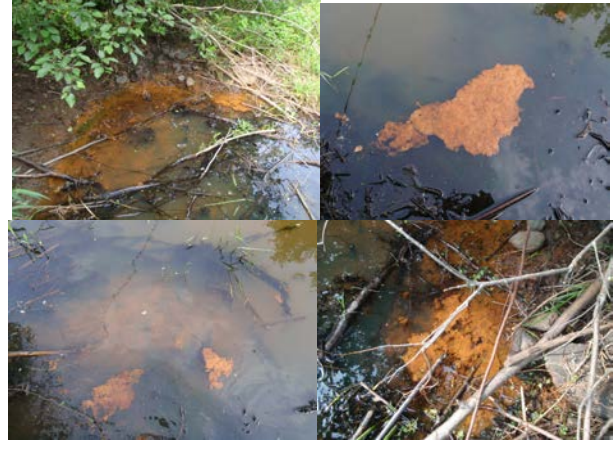
**F: 2010 Iron rich Soil, floating orange mats**

Site 3 exceeded three PWQO parameters on July 14, 2010. Relative to other 2010 sampling locations, Site 3 had the highest concentrations of both iron and total coliforms. Iron concentrations exceeded PWQO criterion (0.3 mg/L), with a concentration of 2.13 mg/L. Although there are several industries, including concrete and culvert manufacturers, located in close proximity to the creek, higher than average iron concentrations were likely of geologic origin. This was indicated by orange/red soil observed adjacent to the pond (Plate F Appendix H). This reddish orange tinge may be indicative of iron rich soils.

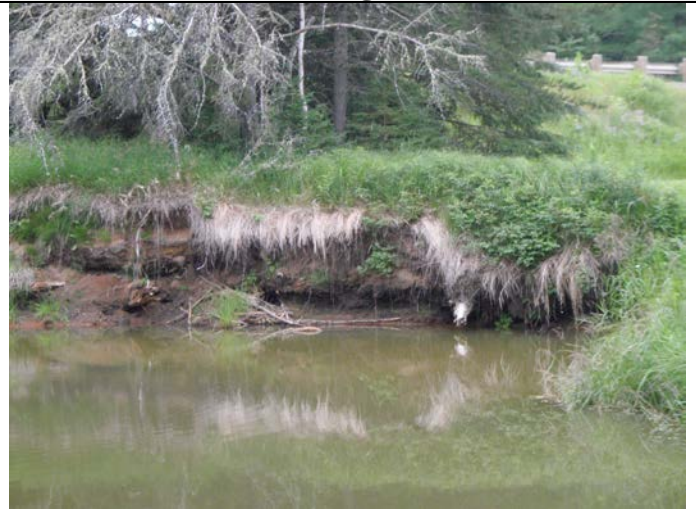
**D: 2010 Eroding Bank Photo**

When comparing the 1996 and 2010 photos this site appeared to have some observable changes. The vegetation from the 1996 photo adjacent to the culvert appeared to be composed of dense shrub growth where the vegetation adjacent to the culvert in 2010 was shrub which was significantly less dense, with spruce trees which had become newly established. Erosion observed in 2010 appears to have already been present in 1996, but worsened slightly in regard to the degree of slumping. The culvert itself appears to have undergone little change.
