# Slate River Watershed Assessment Report

## August 2008

**Lakehead Region  
Conservation Authority**  
Conserve Today...For A Better Tomorrow

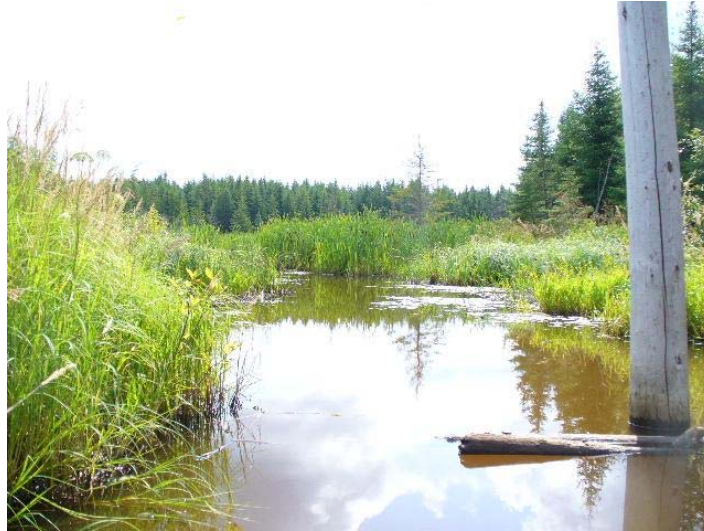
### Site 1: V15 White spruce mixedwood

**Description:** A variable mixedwood Type with white spruce as the main canopy species. The understory ranges from herb and shrub rich to poor, with balsam fir commonly abundant in the shrub layer. Occurring over a broad range of soil and site conditions but primarily on deep, fresh to moist, mineral soils.

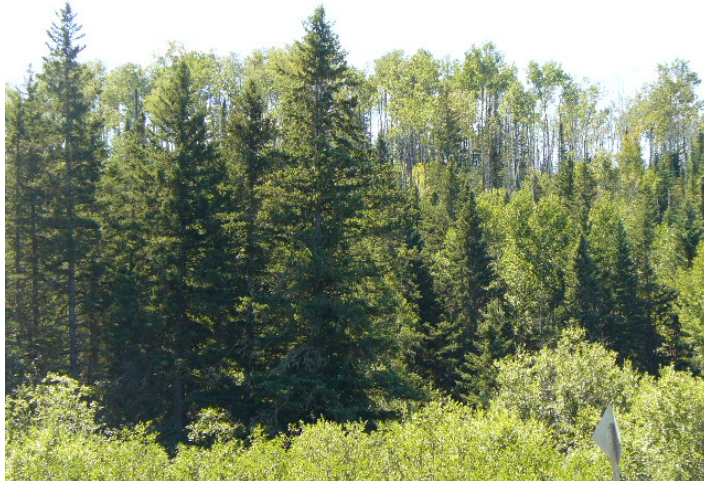
**Site 2: V16 Balsam fir – white spruce mixedwood/ feathermoss**

**Description:** A variable mixedwood Type with balsam fir and/or white spruce as the main tree species. The understory generally lacks an abundance of broadleaved species but balsam fir can occur in dense thickets. Extensive feathermoss mats cover the forest floor. Occurring on a broad range of soil and site conditions but primarily on fresh to moist, upland mineral soils.

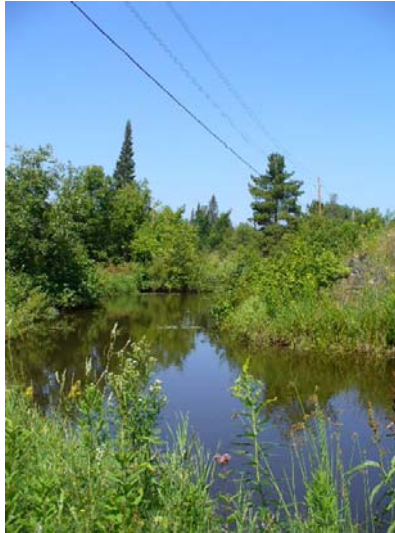
Hardwood mixed woods, typically with a two tiered canopy. In general, trembling aspen constitutes the overstory with balsam fir in the secondary canopy. Understory development is variable with balsam fir, *Aralia nudicaulis* and *Diervilla lonicera* often abundant. This occurs mainly on deep, fresh, well-drained, fine-textured mineral soils.

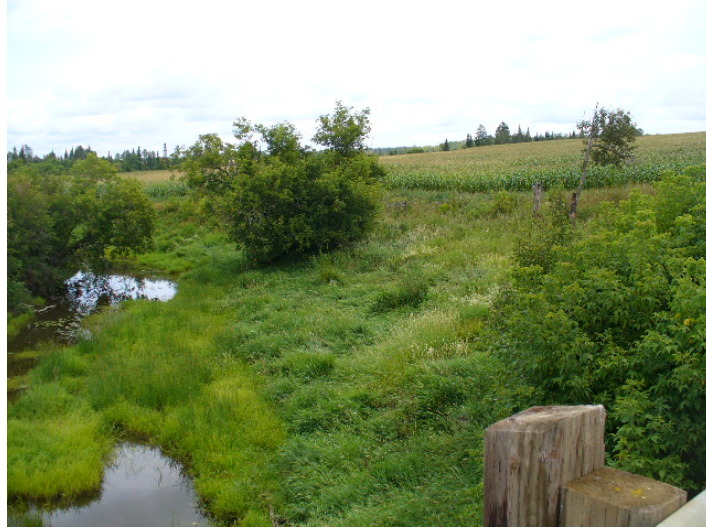
**Site 4: No V-Type classification**

**Description:** The surrounding landscape is cleared for agricultural activity such as corn, wheat and dairy cattle.

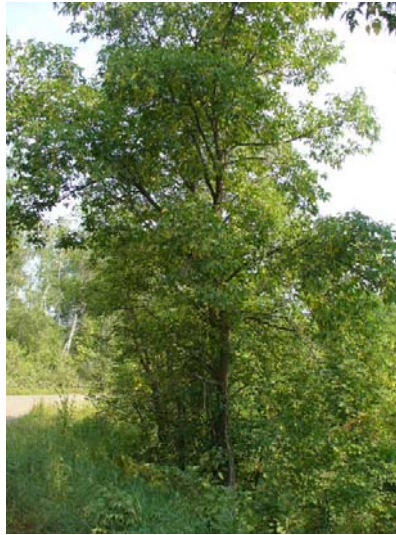
**Site 5: V8 Trembling aspen (white birch) / Manitoba maple**

**Description:** Hardwood mixedwood stands with an abundance of broadleaved herbs and shrubs in the understory. Although this V-Type is characterized by dense thickets of Mountain maple (*Acer spicatum*), this location is predominately Manitoba maple (*Acer negundo*). Occurring mainly on deep, fresh to dry, well to rapidly drained mineral soils.

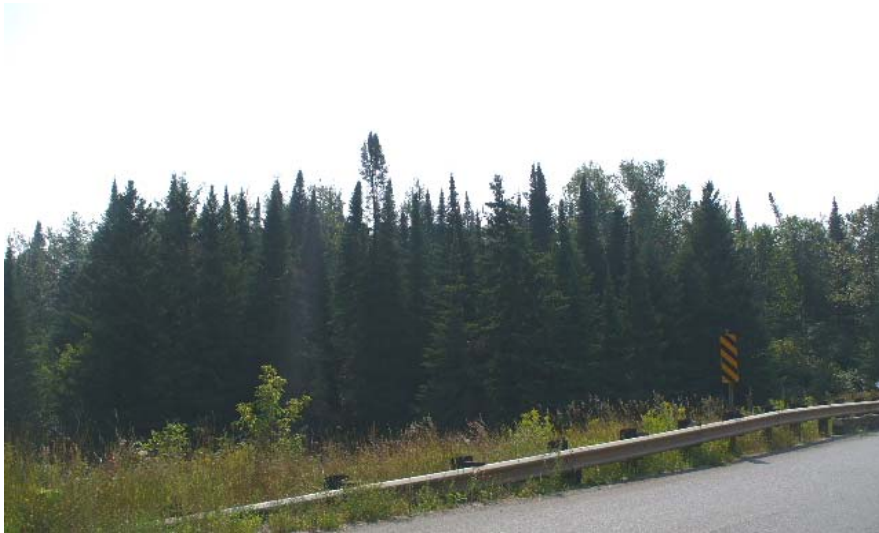
**Site 6: V19 Black spruce mixedwood / herb rich**

**Description:** A black spruce mixedwood type with several potential species in the overstory. The understory is typically dominated by a rich herb/dwarf shrub layer. The shrub stratum ranges from dense to open, usually with balsam fir and black spruce as important components. Forest floor cover varies from moss rich to mainly broadleaf litter. Occurring on a range of site conditions although mostly on fresh to moist, mineral soils.

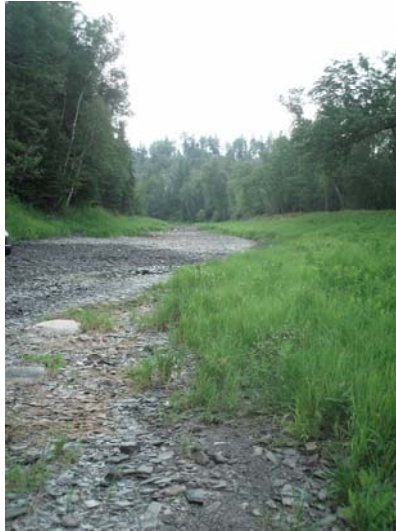
**Site 7: V21 Cedar (incl. mixedwood) / Mountain maple**

**Description:** A diverse white cedar Type consisting of both conifer and mixedwood stands. Numerous species combinations are possible in the overstory. The shrub layer is usually dominated by balsam fir, white cedar and *Acer spicatum* but is rarely dense. Species diversity in the herb layer is often high. Occurring across a range of site and soil conditions from wet, organic lowlands to rich, fresh uplands.

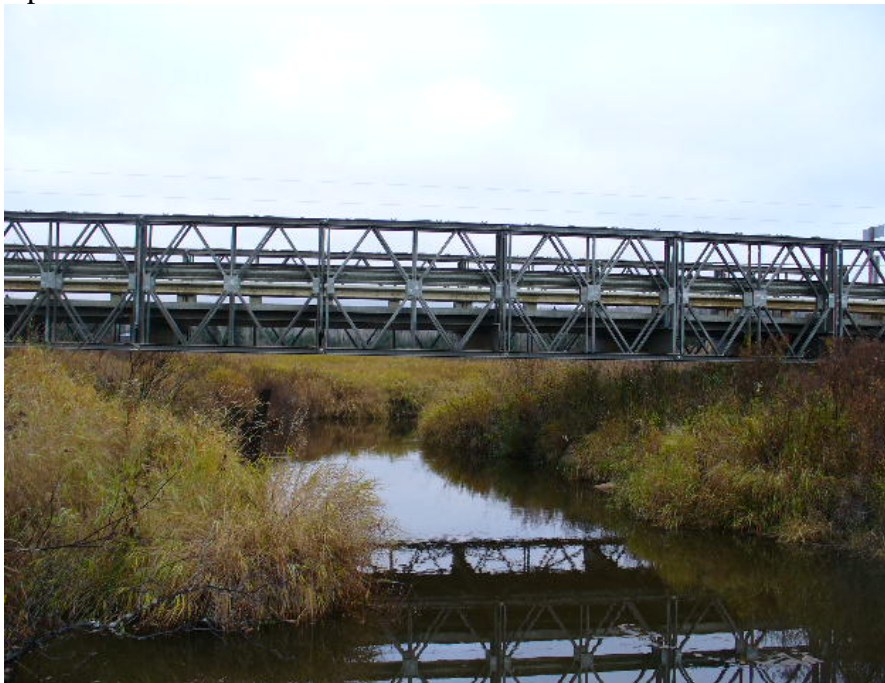
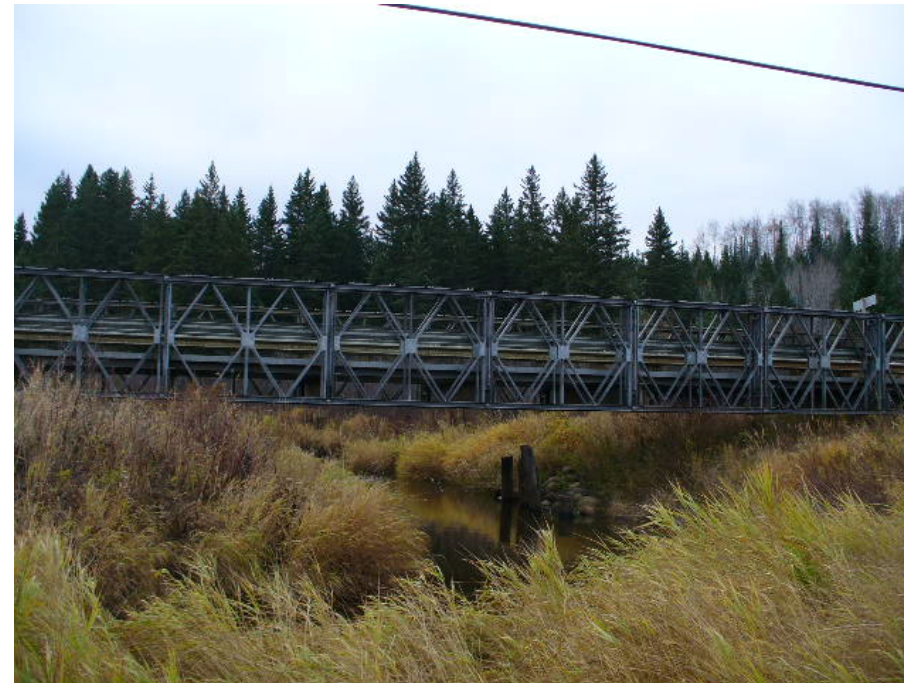
Description: This bridge was a Bailey Bridge design: lattice steel designed for rapid assembly from prefabricated standard parts and it was in good condition. The foundation was supported with concrete beams and the road surface was steel grating. Having an open road surface may be beneficial during times of high water (spring flooding) because the road surface will not wash away or collapse. The fill was mainly large boulders that were stabilized by opportunistic species. The riparian zone slope was gradual and there was no evidence of active erosion. Both upstream and downstream had no/minimal stream cover. Further up the floodplain, the vegetation was dominated by Balsam fir and White spruce. Upstream, cattle had access to the river on the adjacent rural residential property.

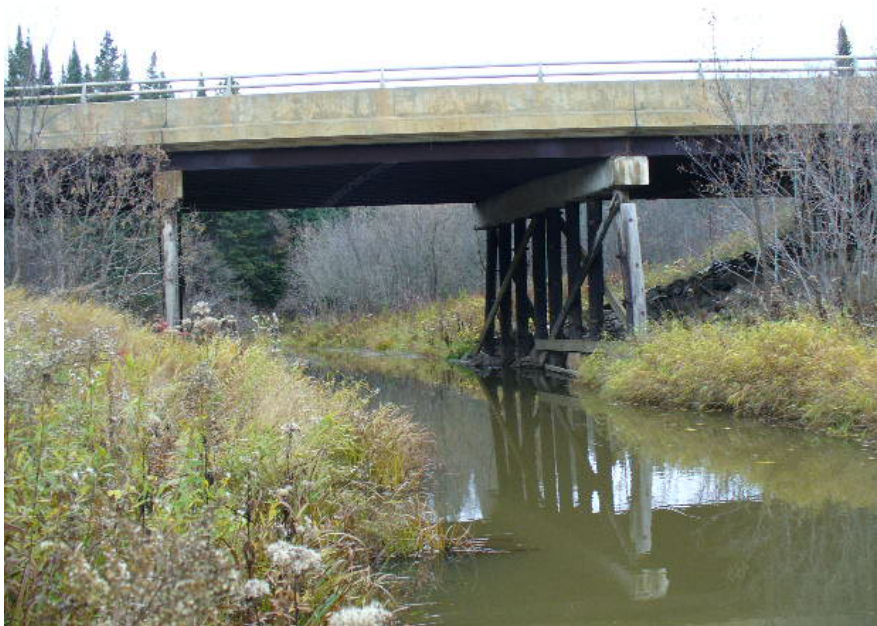
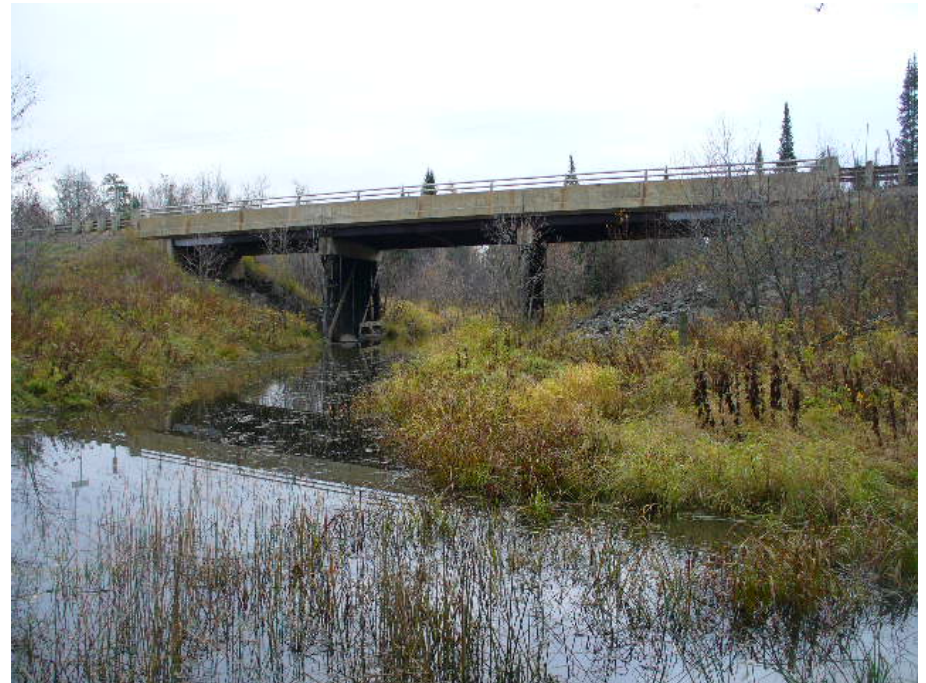
## Bridge 2

Description: The bridge was built in 1975 and was supported by two concrete pillars on either side of the streambed and several wooden posts with cross beams that stand in the streambed. There was no visible high water marks on the wooden posts, yet high water marks were visible on the west side upstream bank 3 metres above the water surface. Underneath the bridge, there was a significant pile of woody debris (logs, branches) but it was not restricting flow. The fill was mostly boulders. Higher up on the west side downstream bank, sand/silt fill was sloughing but it did not appear to reach the water's edge. Further downstream, there was evidence of active erosion from bank undercutting as the river meanders. The original farming settlement property line down to the river's edge was marked by an old fence and mature trees (birch, spruce) separating the road from the field.

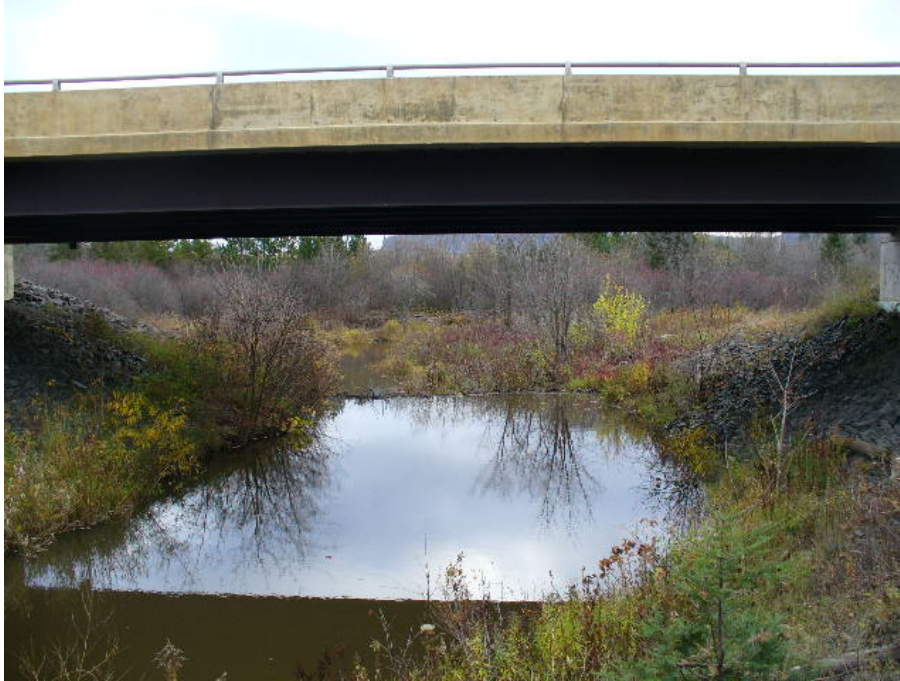
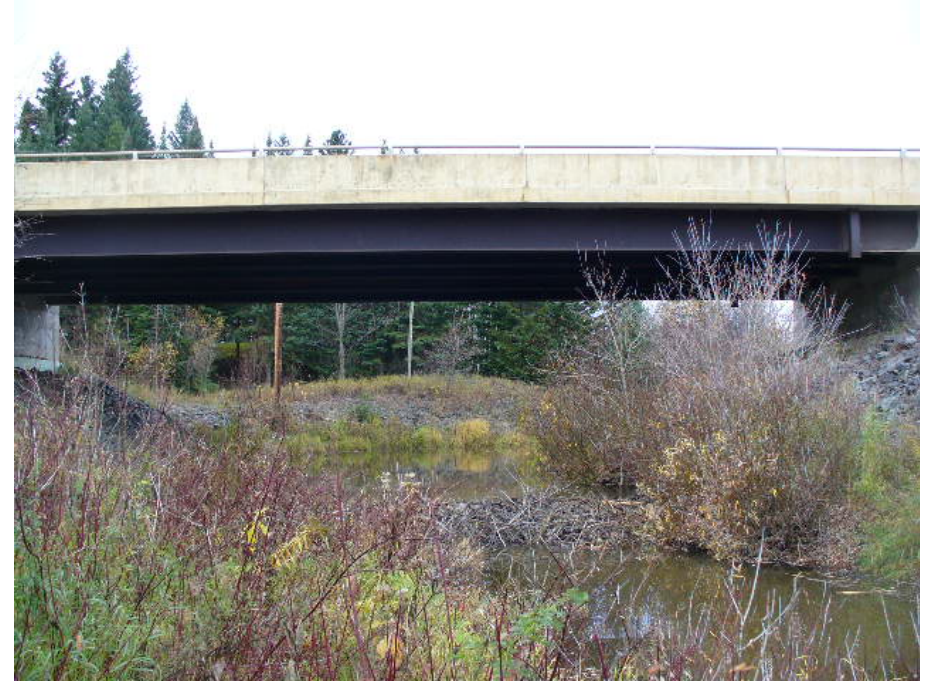
### Bridge 3

Description: This bridge was built in 1994 and carried a significant amount of two-lane highway traffic. It was built with reinforced concrete and steel and appeared in good condition. It was the highest bridge above the water surface documented at 6.5 metres. Large blast rock/boulders were used as fill that extends down to the water's edge with little riparian vegetation or streamcover. Upstream on the north bank, there was an extra cement block retaining wall which created a very steep slope from the road surface to the water. The bridge did not appear to restrict flow in any way, the high water mark being approximately 3.5 metres from the water surface as the time of assessment. However, a beaver dam downstream has prevented the river from flowing (below the dam the streambed was dry/exposed).

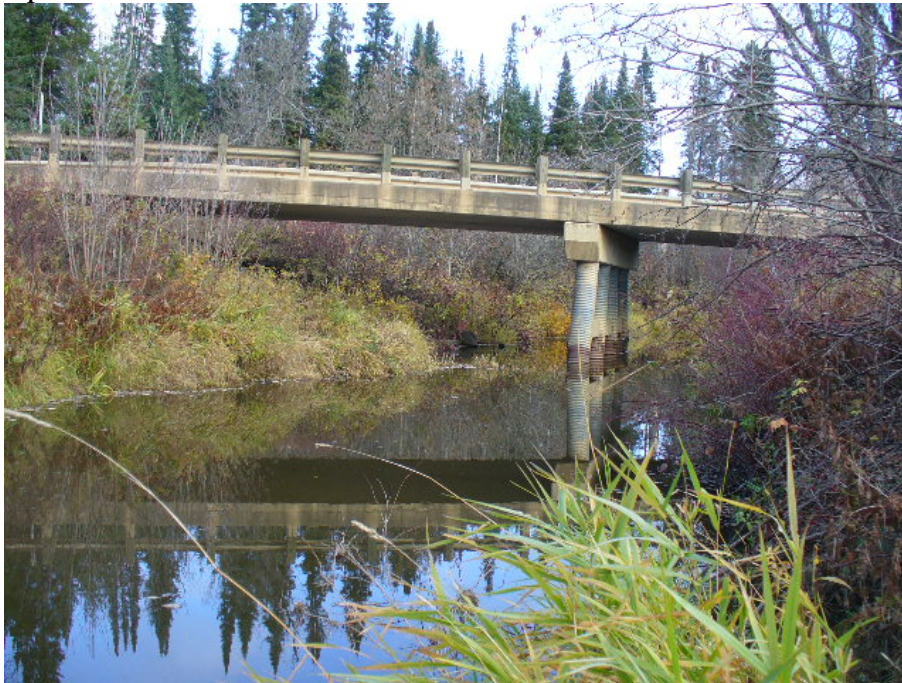
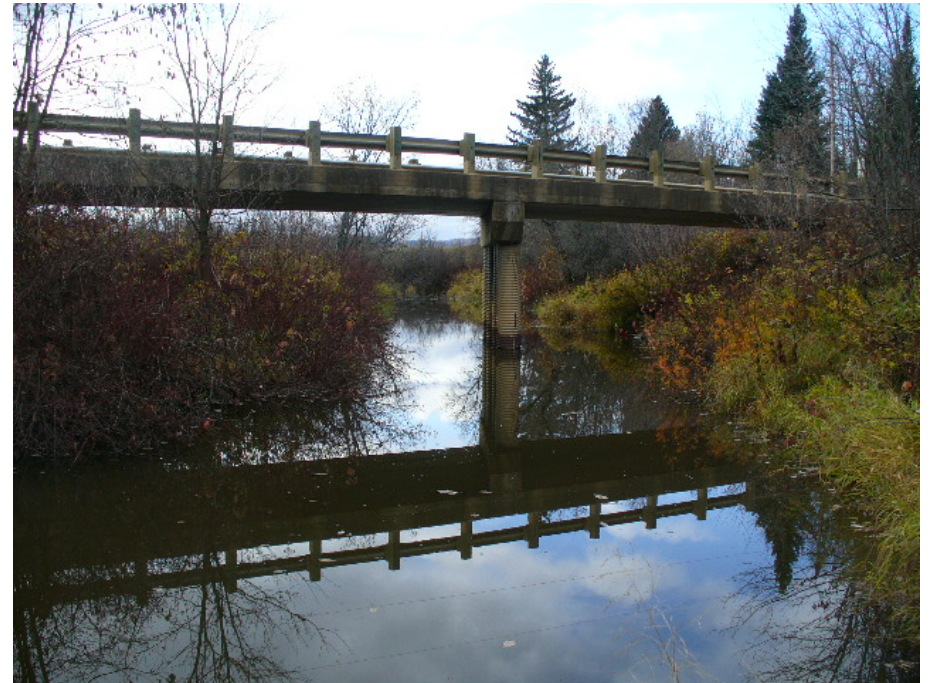
## Bridge 4

Description: This concrete bridge supported single-lane dirt road traffic. The corrugated steel wrapped around the concrete support pillars was cracked. Underneath the bridge, there were large boulders on the east bank right down to the water's edge. Upstream, the riparian zone was well established with approximately a 10 metre buffer between the river and a farmer's field. As well, downstream, there was a significant amount of stream cover (mixed hardwood trees/shrubs) right to the water's edge. A nest of new-born cedar waxwing chicks and a woodpecker were documented at this site.

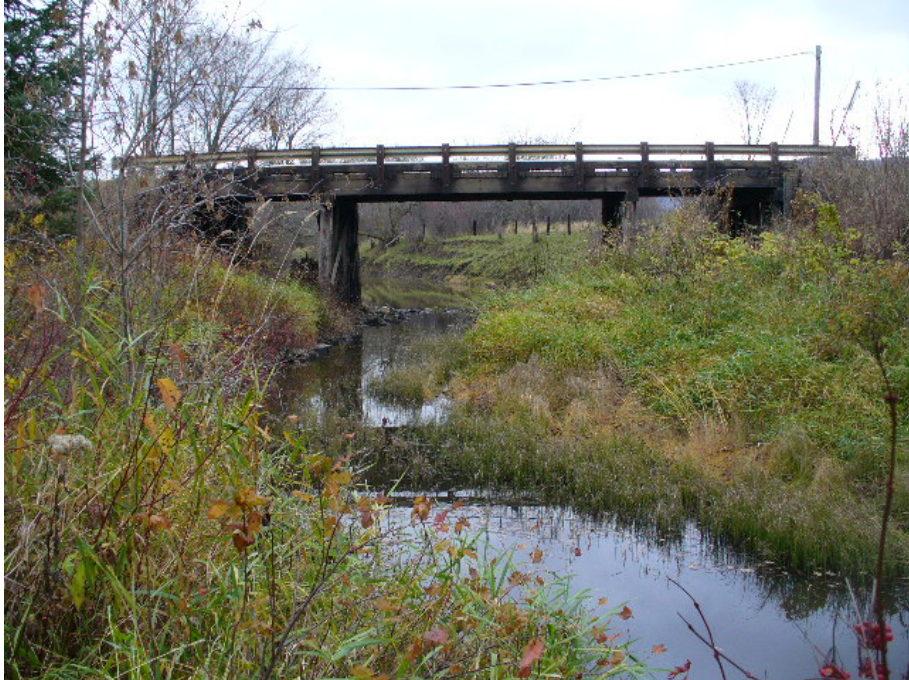
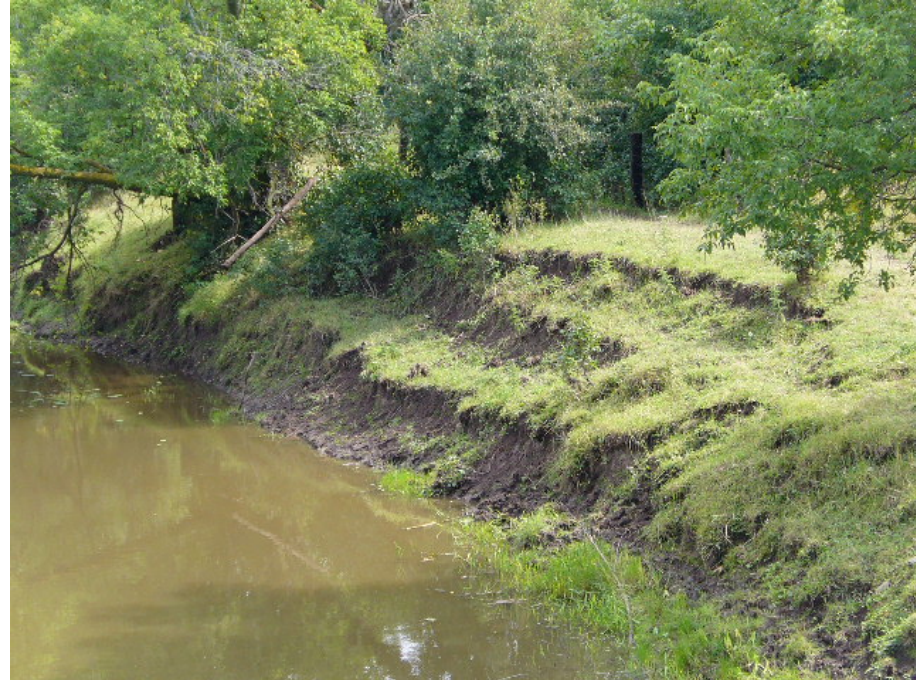
## Bridge 5

Description: This was the only wooden bridge documented. It may require some repair since one support beam was broken and the wooden beams in the riverbed had lost some of their tar sealant. Upstream, there was a lot of vegetation along the river (mixed conifer/shrubs/grasses) and it appeared like the river channel was obstructed by some mound of land (perhaps a beaver dam that has vegetation growing upon it). Downstream, a barbed-wire fence crossed the river channel and had collected a significant amount of debris which indicated the high water mark was at least 2 metres above the current water level. Downstream, there was evidence that livestock had access to the water's edge and the banks on both sides showed some minor erosion. In the picture below, the three tiered undercut bank may indicate different water levels.

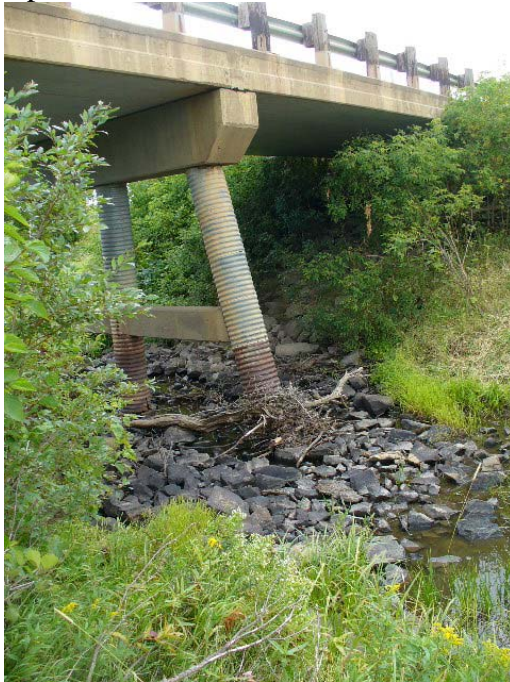
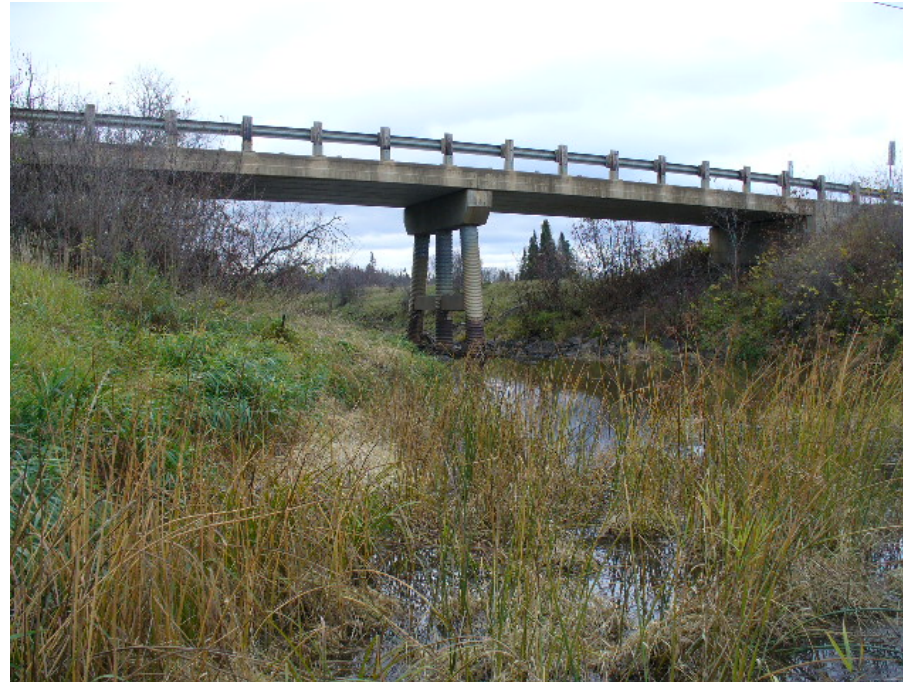
## Bridge 6

Description: This bridge supported one lane local traffic on a dirt road and was built with reinforced concrete. It was in the heart of the area's agricultural activity. Upstream, a private barbed wire fence ran across the river to prevent livestock from escaping underneath the bridge. However, there was no fence preventing access of livestock to the river. There was not very much imported fill and slope was gradual. Upstream, there was minimal vegetative buffer or stream cover. The potential for erosion may be high as livestock can trample the bank and grass was predominant rather than trees/shrubs. Downstream, the riverbank had more stability with mostly deciduous trees and plenty of aquatic grasses. As well, there was a cornfield on the eastern bank which the river cuts through with its large meanders. There was evidence of bear and fox from droppings and a field mouse, a herd of cattle and a horse were observed. According to personal communication with the adjacent landowner, the floodplain extended 84 metres on the west side of the river during flooding.

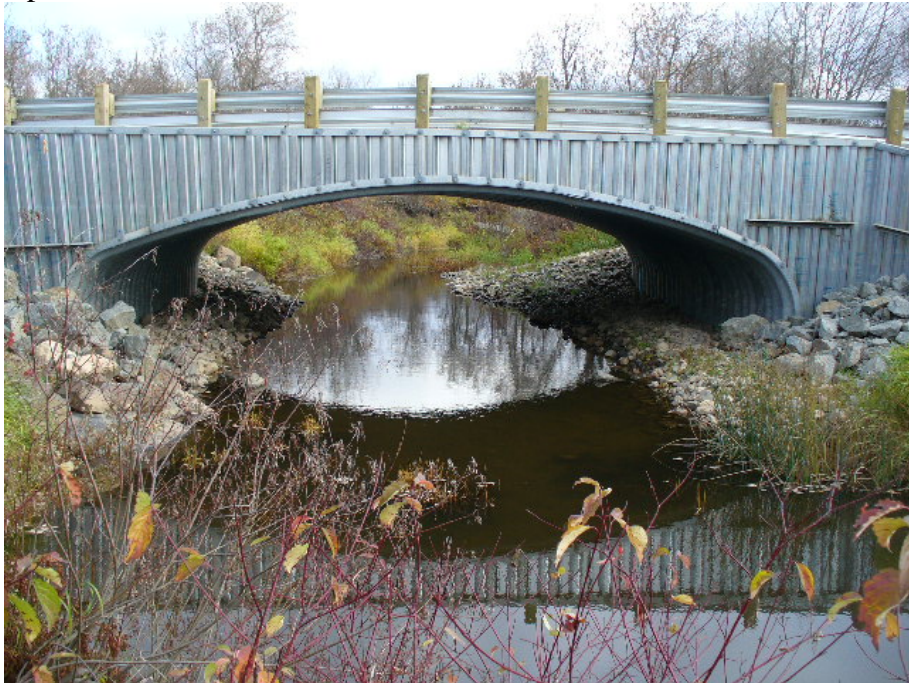
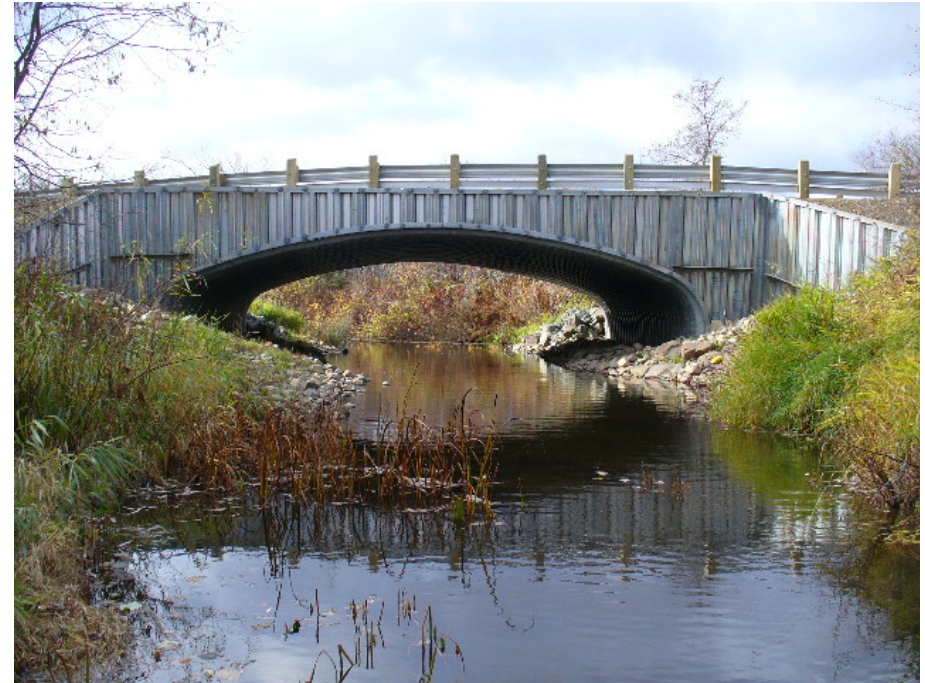
## Bridge 7

Description: The newly constructed Pipe Arch was composed of corrugated steel with wooden railings. Fill, on both sides, was large blast rock. Many fill boulders were more than 1 metre in diameter. Currently there are no sites of active erosion; however there is potential for erosion in the future as the fill was not stabilized by a vegetative buffer zone. The fill went to the water's edge, and upstream on the south bank the exposed soil was so dry that it was cracking. The water level was low and turbid and the flow appeared to be going in the opposite direction probably due to a greater influence by wind direction. The high water mark appeared to be at the same elevation as the road surface. The in-stream fill was sand and/or small pebbles that were iron-rich giving a reddish-brown colour. The river was bordered by mixed hardwood trees and grasses.

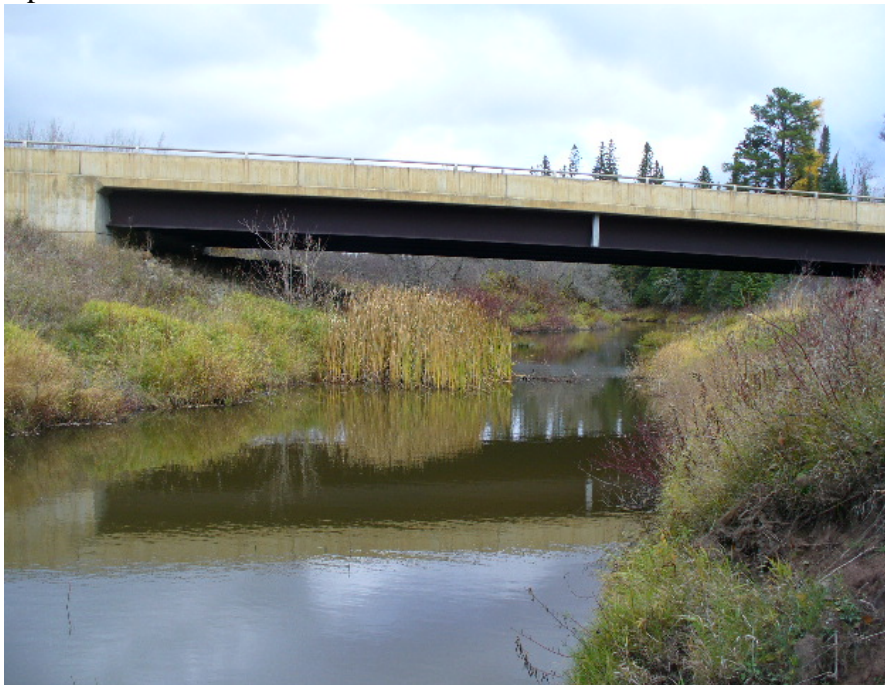
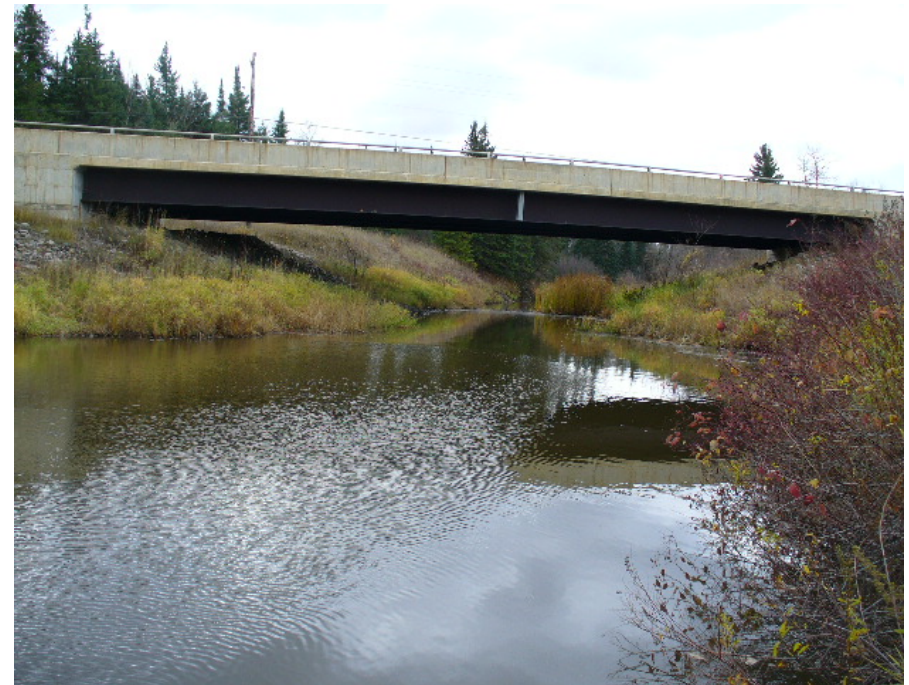
## Bridge 8

Description: This bridge was approximately 5 metres above the river's surface and was characterized by reinforced concrete with steel support beams that appeared to be stable. The width and height of the structure did not appear to alter natural channel characteristics. A significant amount of large blast-rock boulders were used as fill and appeared to be stable. Downstream, the streambank had a gradual slope with vegetation right to the water's edge. Upstream, there was a small creek (diversion channel) running parallel to the bridge on the east side. There was not a lot of visible aquatic life activity. The streambank had mostly conifer species with bulrushes, buttercups, goldenrod and Labrador tea bushes noted.

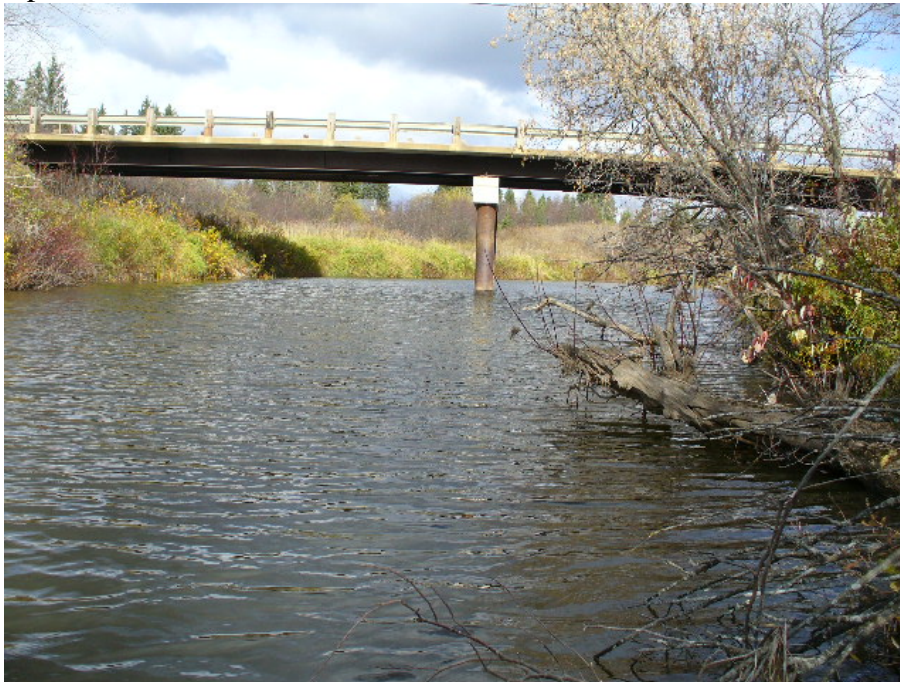
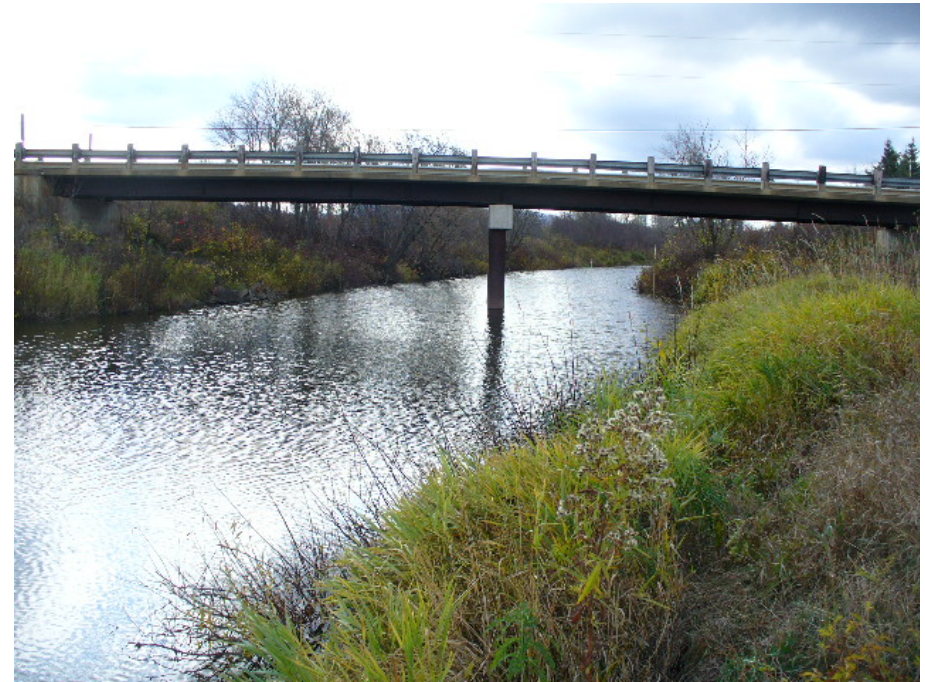
## Bridge 9

Description: The materials used in building this bridge were cement, iron, and wood. The bridge was 4.7 metres above the water surface level at the time of assessment, and appeared to be in good condition. This bridge was considered a high traffic bridge as many vehicles and tractors were noted passing over it. The waters around the bridge were turbid and stagnant but harbored a variety of wildlife. Many birds such as White Throated Sparrows, Finches, Swallows and Ravens were documented. Aquatic wildlife included a large amount of fresh water clams, water striders and fry. Various shrubs and deciduous trees stabilized the river banks.

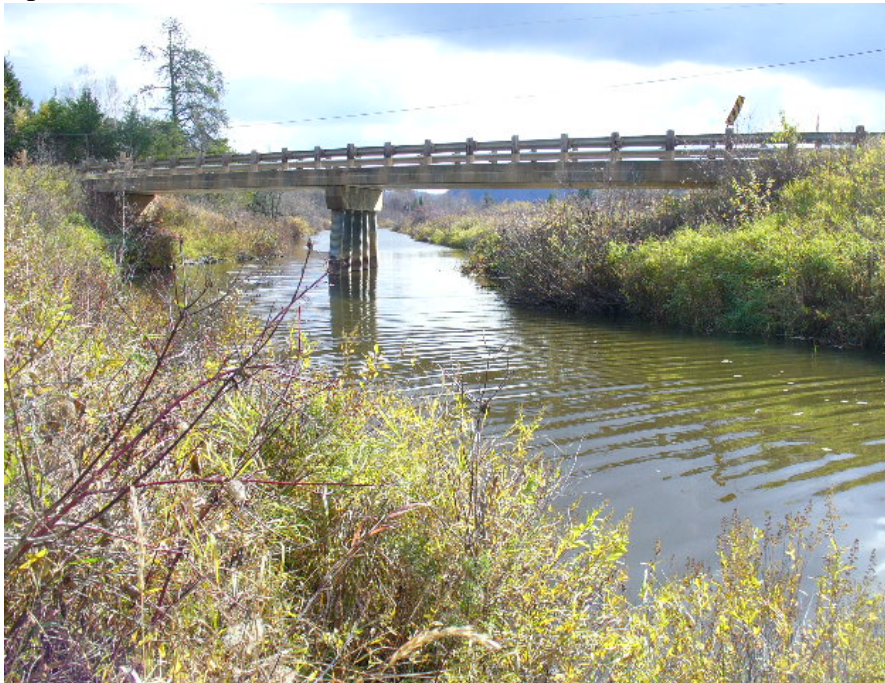
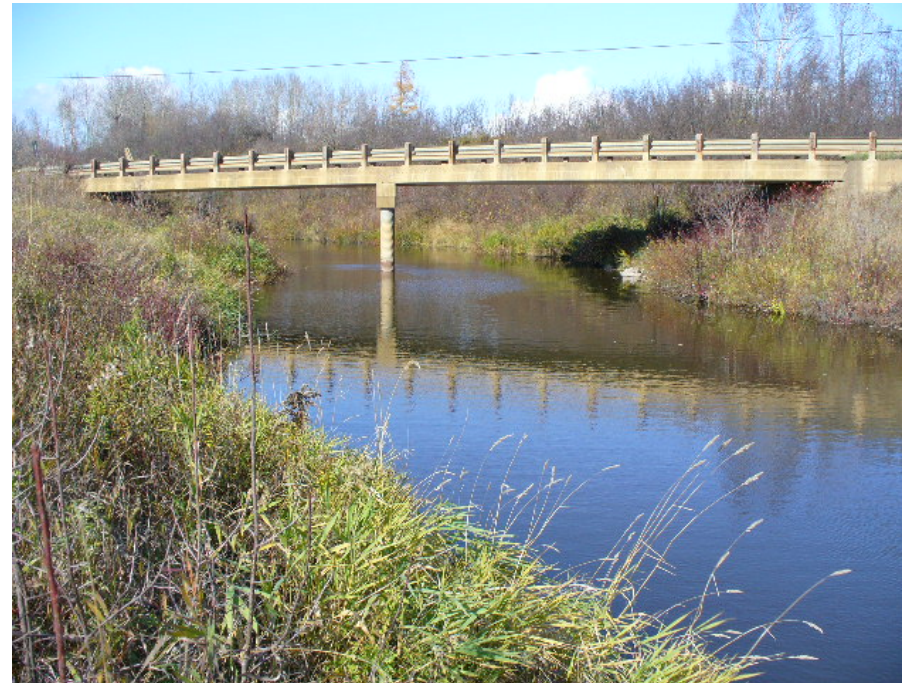
## Bridge 10

Description: This bridge was mostly concrete and cement with corrugated support beams. The support beams appeared to be filled with concrete. The bridge was in good condition and supported the large amount of traffic passing over it. The fill underneath the bridge was a collection of small to medium boulders and shale. The height of the bridge was 3.85 metres above the water level at the time of assessment. Downstream of the bridge had very little stream cover. The river bank was occupied by many low lying shrubs. The upstream banks were characterized by many wild raspberries and Dogwood shrubs. The water height at the stream bank was approximately 1.3 metres deep; as well the waters were very slow-moving and turbid. Wildlife observed included an Oven Bird, juvenile Chipmunk, fry, Water boatmen and various Bees and Wasps.

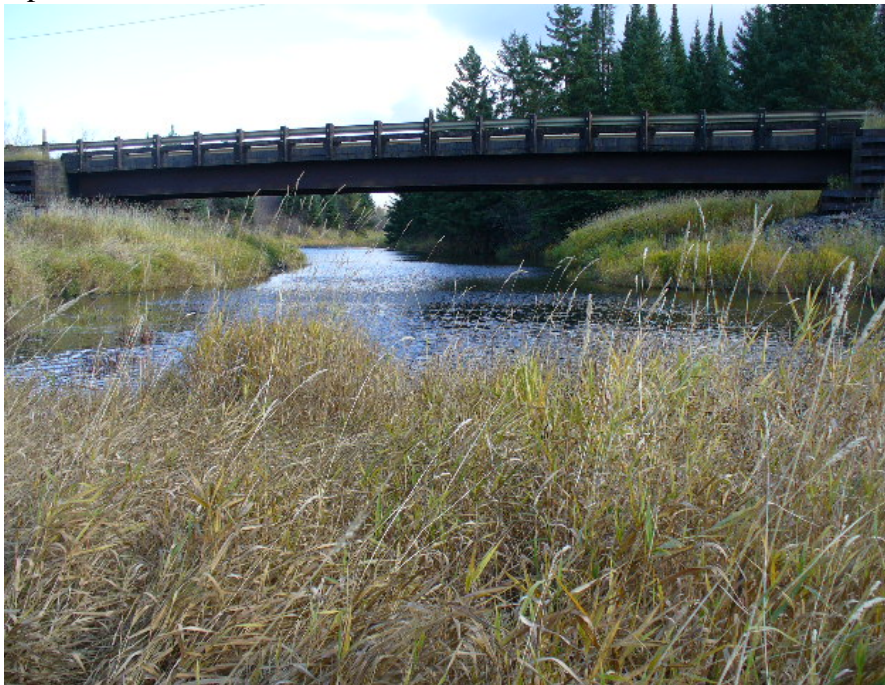
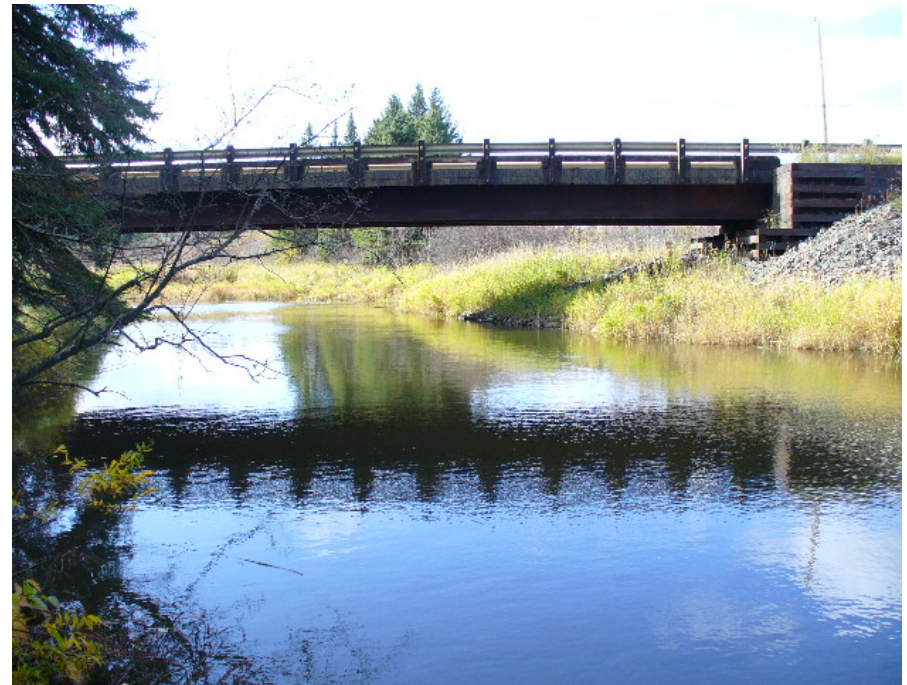
## Bridge 11

Description: This bridge was built mainly of iron, cement and wood. The bridge was approximately 5 metres above the surface of the water at the time of assessment. The fill slopes around the bridge were not very steep and the ecosystem around the bridge was very lively. A variety of wildlife was observed including a Blue heron, a Brown duck, nuthatches, as well as two beavers at work. The water near the riverbank was approximately 1.3 metres deep and very turbid.

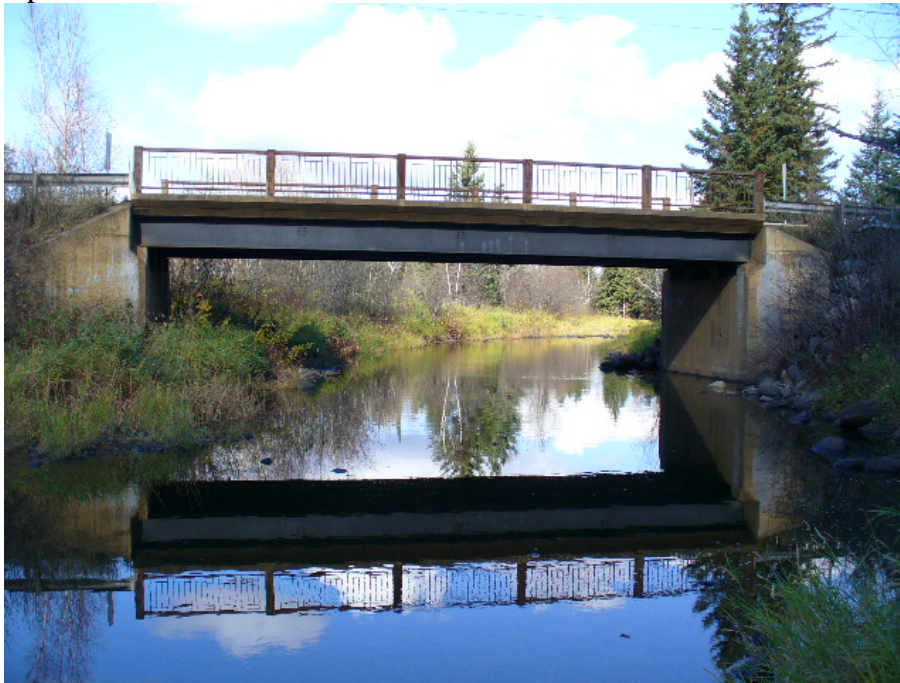
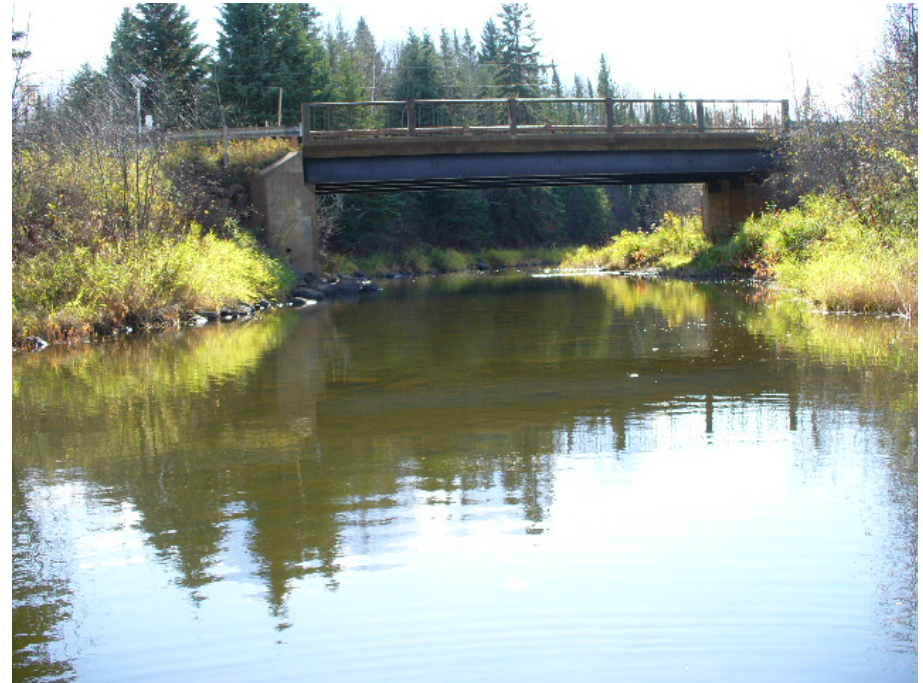
## Bridge 12

Description: This bridge was the location of the Environment Canada and LRCA stream flow and precipitation gauge. The bridge was constructed with concrete and iron and appeared to be in good condition. Upstream, flow was significantly low with most of the in-stream material (boulders and pebbles) exposed. On both sides of the bridge the riparian zone was in good condition with at least 2-5 metres of vegetative border (mixed hardwood). Comparatively, the west side bank had a more gradual slope to the water's edge than the east side. A freshwater clam, minnows and snails were documented.

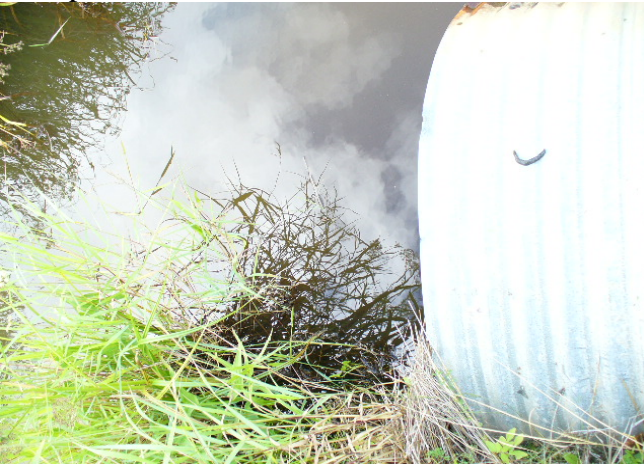
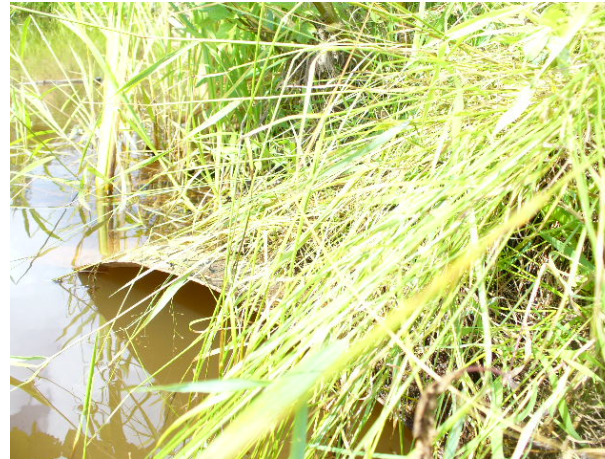
Description: Culverts 1a and 1b were located at the headwater of the Slate River where the river channel was fairly un-established; the area looked more similar to a wetland than a river. The culverts did not appear to have any damage or clogging that would restrict flow, although the current water level was high enough to completely submerge culvert 1b downstream. As shown in the photograph, the downstream end of the culverts were hard to locate because they did not extend beyond the fill; fill had slumped on to the top of the metal culverts and plants were established there. The private property owner whose land was adjacent to this site reported that, during the spring 2008 flood event, the water level was well above the road surface. The high water marks along the bank were higher than both the top of the culverts and the elevation of the road. The culverts ran on a diagonal underneath the road surface and covered 22.65 metres of stream. Flow rate was stagnant and the surrounding vegetation was dominated by aquatic plants, such as cattail, arrowhead and pondweed.

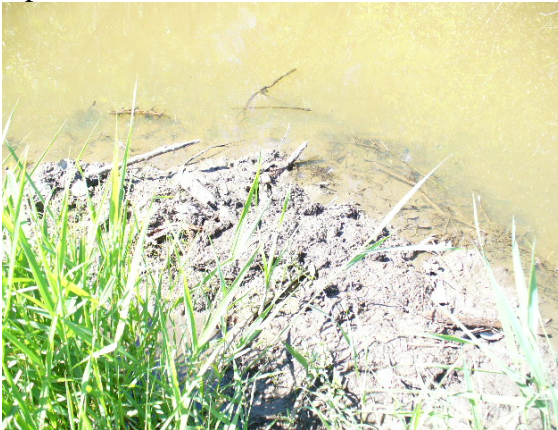
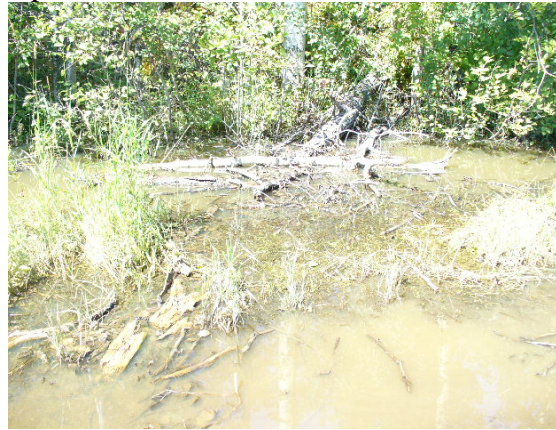
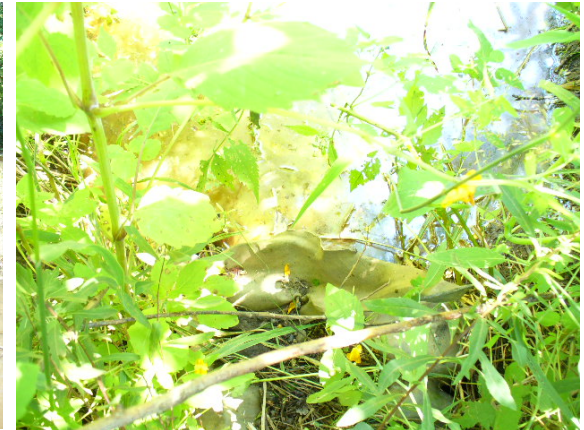
## Culvert 2

Description: Before Highway 61 on Hanna Road there was evidence that a beaver had blocked a culvert coming off of a small tributary. The upstream end had been completely covered in thick mud with plenty of twigs and small logs. The waters of the tributary had overflowed on to the road and into the surrounding forest as a result of the blockage. In the event of heavy rains, this could result in road erosion. Frogs and water spiders were observed in the overflowed tributary. On the downstream end of the culvert the water was a few centimetres deep and stagnant. This end of the culvert appeared to be crushed with a large sharp fragment sticking up. This culvert was in need of repair do to safety and erosion concerns.

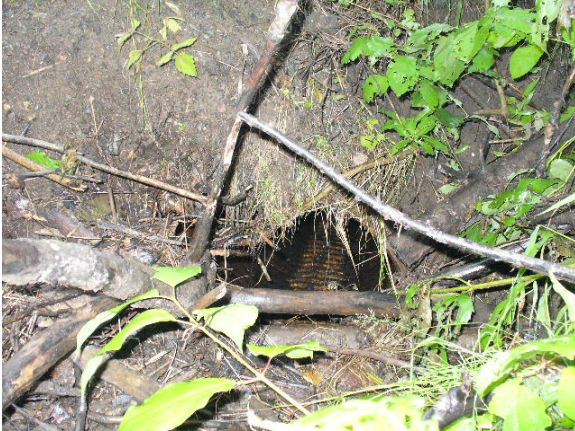
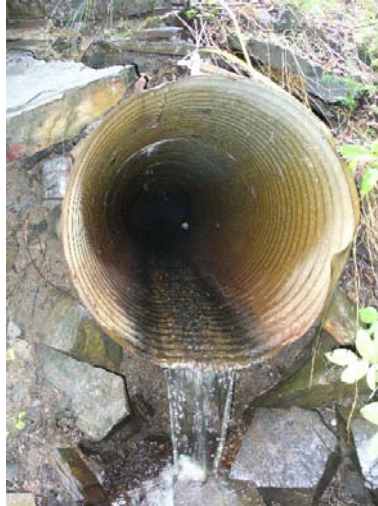
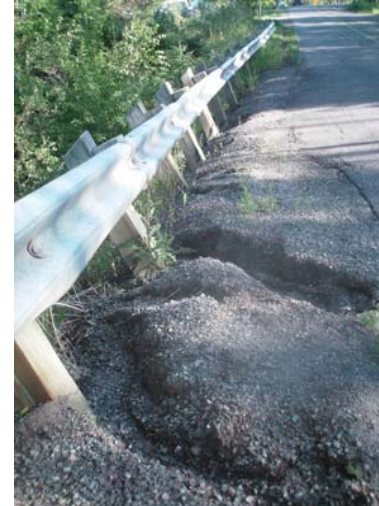
### Culvert 3

Description: This culvert drained a small wetland to the east into the Slate River. The upstream end of the culvert was slightly blocked by woody debris. The blockage did not appear to be caused by a beaver (likely debris collection from the June 2008 flood event) and was not restricting flow. Unlike the upstream side of the culvert that was flush with the streambed, the downstream side of the culvert was perched at least 2 metres above the outlet pool. The outlet pool became a shale terraced waterfall that dropped 18 metres to reach the Slate River gorge. The photograph below documented that unsupported fill was slumping. Fill height over the culvert was significant; 6.7 metres upstream and 8 metres downstream. The fill slope was greater than a 45° angle and had not been stabilized by vegetation.
