Wolf River Watershed Assessment

Wolf River Watershed Assessment Report

August 2009

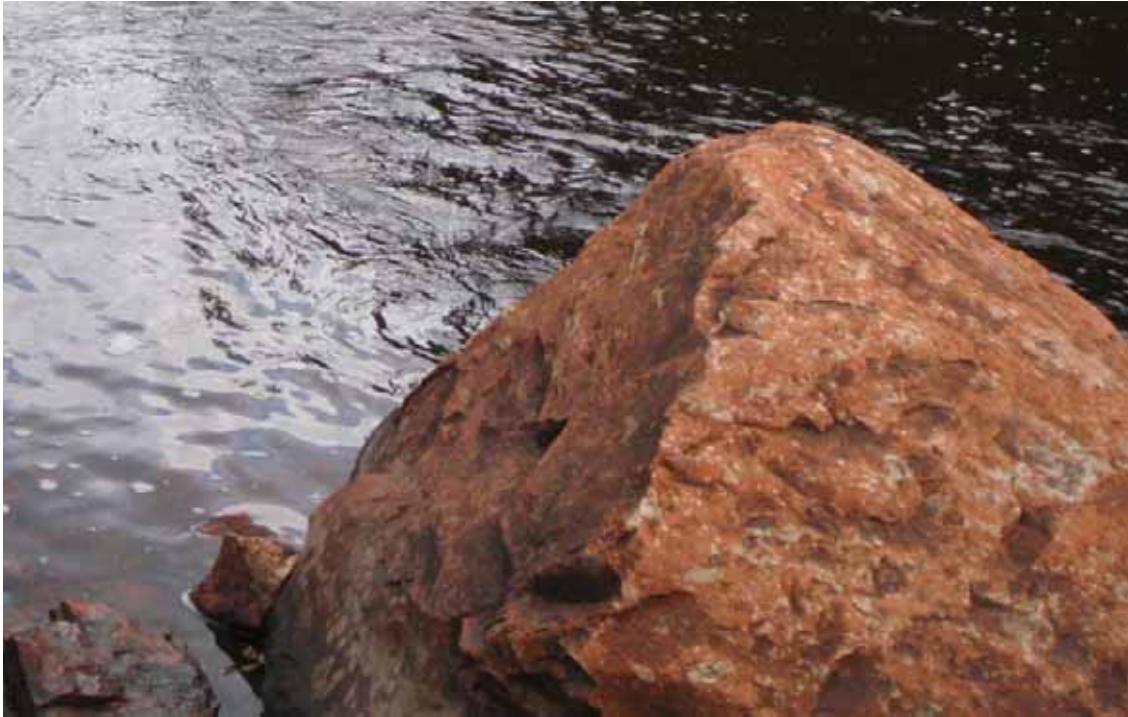
Figure 1: Sibley Group Outcrop Near Site 9 (LRCA 2009)

The watershed is comprised largely of rocks from the Mesoproterozoic era (1.54 billion years ago) Sibley Group of the Southern Province. See Figure 1. These rocks formed when sediment eroded from the Superior Province and washed into a shallow lake on top of an older rock complex (Ministry of Northern Development & Mines, Ontario, 1994). The Sibley Group now contains layers of conglomerate, sandstone, dolomite, shale and greywacke (a variety of sandstone with dark color and poorly-sorted, angular grains of quartz, feldspar, and small rock fragments set in a compact, clay-fine matrix). Diabase

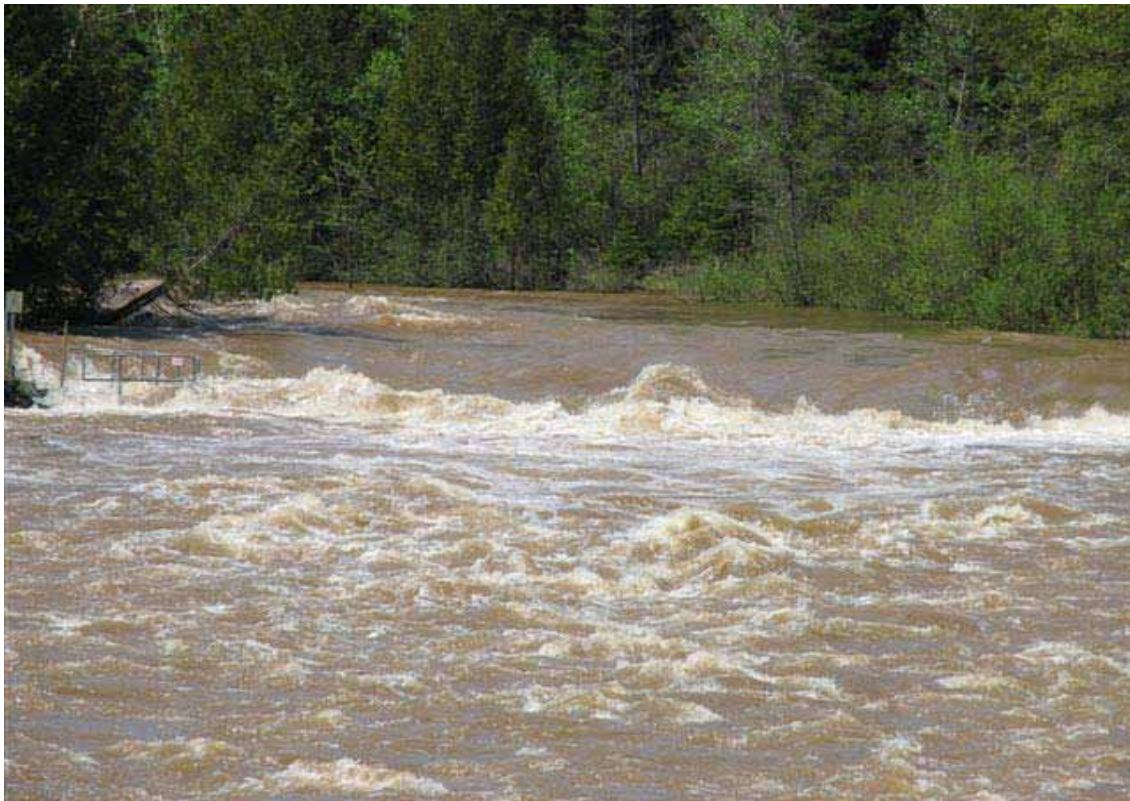
Figure 2: High Water Levels – Wolf River Weir (Ed Chambers 06-09)

On June 6, 2008 a Flood Warning was issued for the LRCA Area of Jurisdiction. Between 56.5 millimeters (mm) and 105 mm were recorded at area gauges. The Regional Storm or the 100-year flood event used by the LRCA to determine the flooding hazard limit is the “Timmins Storm” of 1961 which had 193 millimeters of rainfall in 12-hours. The LRCA also issued Flood Advisories from June 10 to June 12, 2008 as waterways were still high. Wolf River gauge recorded an extreme maximum water level of 191.440 metres above sea level on June 8, 2008. Figure 2 shows the extent of the flooding event.

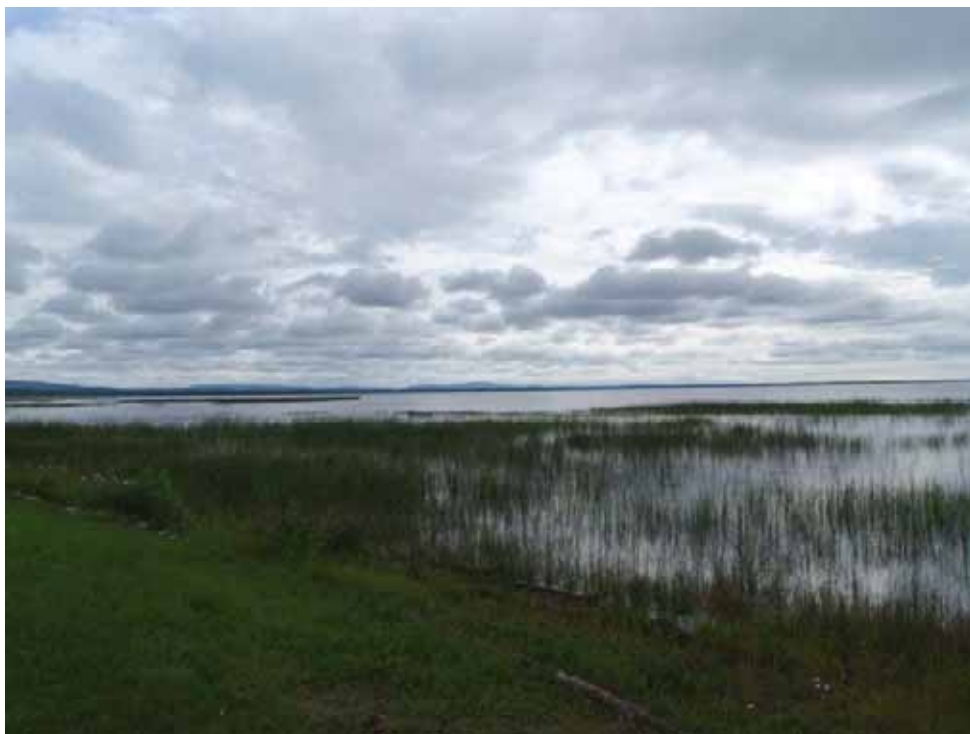
Figure 8: Hurkett Cove (LRCA 2009)

The Wolf River watershed contains 11.9705 km² of wetlands. Wetlands cover 1.64% of the total watershed area. The largest wetland area is 333,608.71 square metres (m²) or 0.334 km², which drains into Lynch Lake in McMaster Township (377738 E 5430510 N). The only evaluated wetland in the watershed is Hurkett Cove Provincially Significant Wetland (PSW) located three kilometers (km) east of the Trans Canada Highway 11/17 on the shore of Black Bay in Lake Superior which abuts the original confluence of the Wolf River. See Figure 8. Hurkett Cove PSW covers 20.83 km². The PSW, as well as the 120 m buffer around the PSW, is regulated under the Development, Interference with Wetlands and Alterations to Watercourses Regulations (Ontario Regulation 180/06 under the Conservation Authorities Act) Map 12 illustrates the PSW location.

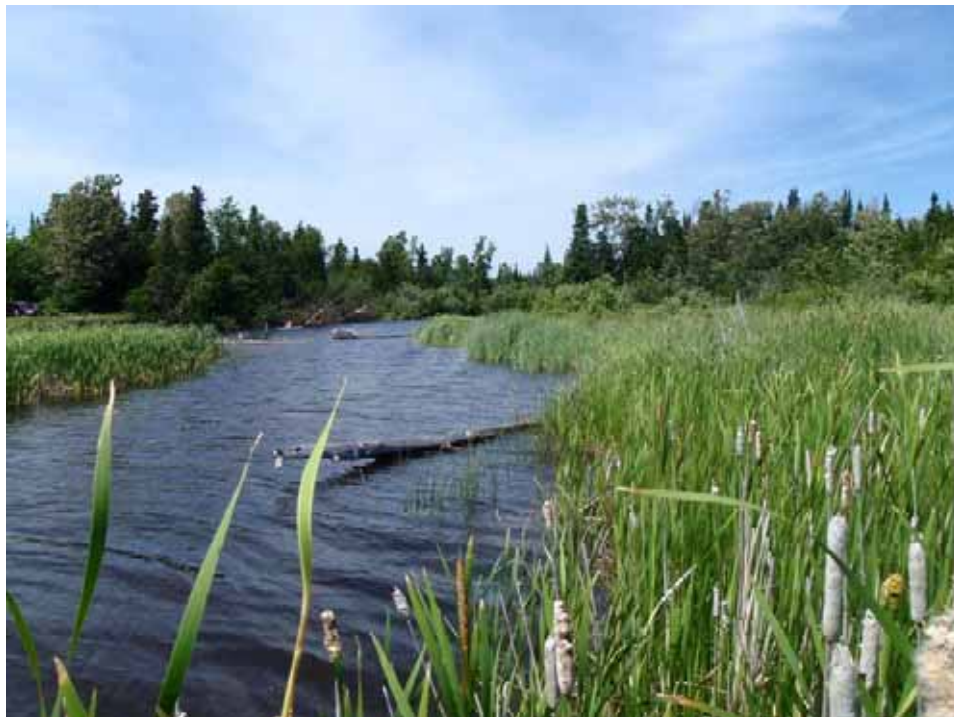
Figure 10: New Southern Confluence Wetlands (LRCA 2009)

As documented by LRCA staff, at the time of assessment, the new southern confluence had accumulated a substantial amount of interesting features. Most noteworthy are the formation of a well defined wetland delta and the formation of a narrow land bridge (See M-13). The wetland delta is a result of materials (trees, sand and silt) carried out into Lake Superior during the channel formation of the new confluence. As evidence of the rapid velocity experienced during the new confluence formation, the remains of whole trees angled towards Lake Superior can be found underwater with roots intact. Vegetation within the delta is predominantly cattails with very few shrubs and grasses. LRCA staff documented an abundance of birds within the area. Aerial photographs (See M-13) reveal that the delta is growing, with the possibility of a merge with the nearby Provincially Significant Wetland found at the original northern confluence.

Possible consequences of the further southerly movement of the confluence could include the isolation of property (by means of island formation), property damage (small trailers and a cabin were found in the area) and increased siltation of the shoreline which could accelerate the growth of wetlands.

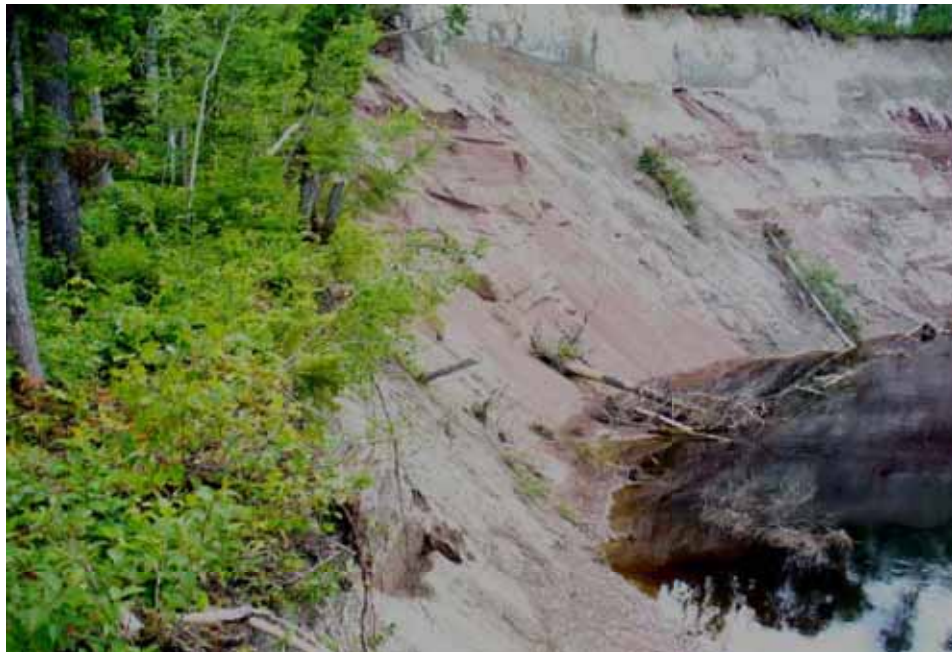
Figure 12: Bank Failure Prior to Remediation (LRCA 2008)

As observed by LRCA staff in the summer of 2009, stream bank erosion is a prominent feature of the Wolf River. A permit was issued in 2008 by the LRCA to a private land owner for erosion protection along a stretch of river off of Mon Abri Lane. The work was required to reduce the rate of erosion along the banks of the Wolf River. See Figures 12 and 13.

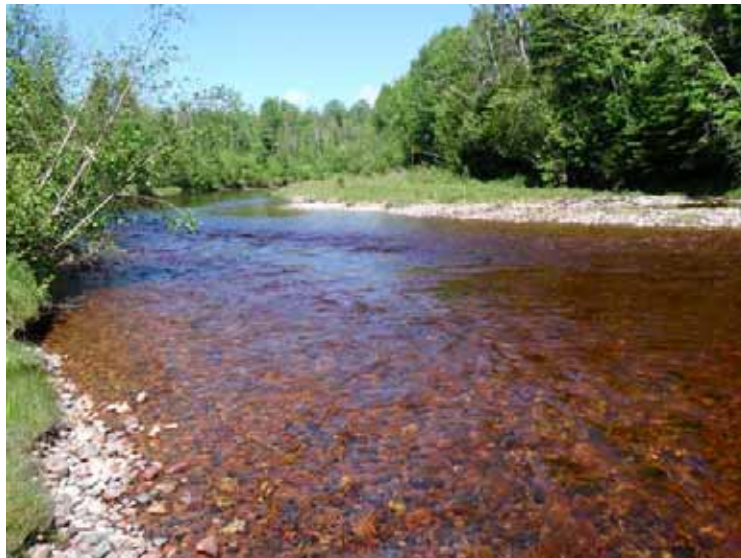
Figure 14: Benthic Sampling Riffle #1 (LRCA 2009)

In collaboration with EcoSuperior Environmental Programs, benthic macro invertebrate samples were collected on June 23, 2009 at Site 4 – Wolf River Campground. Samples were collected following the Ontario Benthos Biomonitoring Network (OBBN): Protocol Manual (Jones et al. 2007). Three sub-samples were collected at representative riffle-pool-riffle transects using a 500µm mesh D-net and the Traveling Kick & Sweep Method. Samples were rinsed, placed in glass jars, covered with the preservative ethyl alcohol and delivered to EcoSuperior Environmental Programs, 212 Miles Street East, Thunder Bay for identification and enumeration at a later date. Figures 14, 15 and 16 show the riffle-pool-riffle sub-sample locations and in-stream cobble substrate. Appendix L contains the completed OBBN Stream Field Sheet for Site 4 and results (raw results) from the benthic macro invertebrate samples. In addition, the OBBN Stream Field Sheet was used as a template for each Wolf River sample site (Sites 1-10) to classify the in-stream substrate, riparian vegetative community, aquatic macrophyte, algae and organic matter areal coverage.

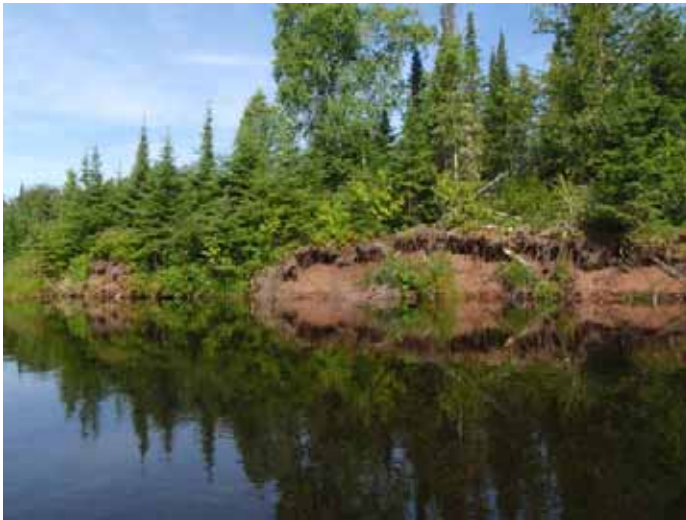
Site 1
Erosion and bank undercutting.

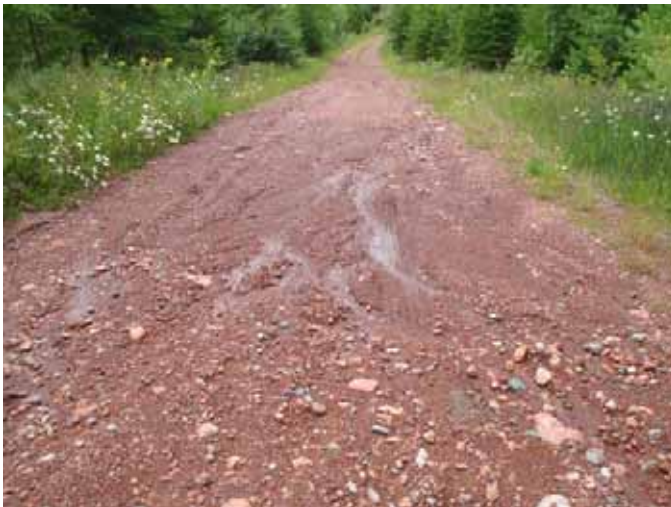
Site 6
Rills forming after rain on slope near sample Site 6.

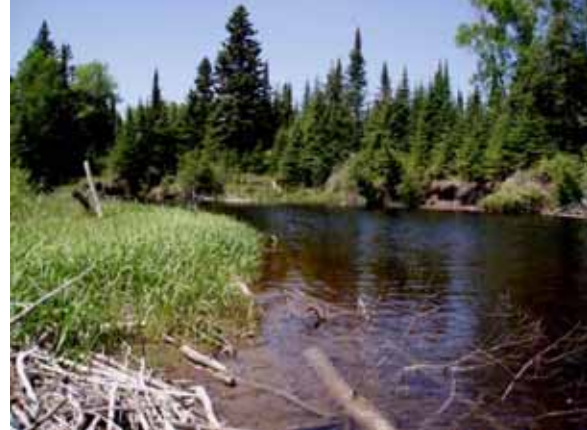
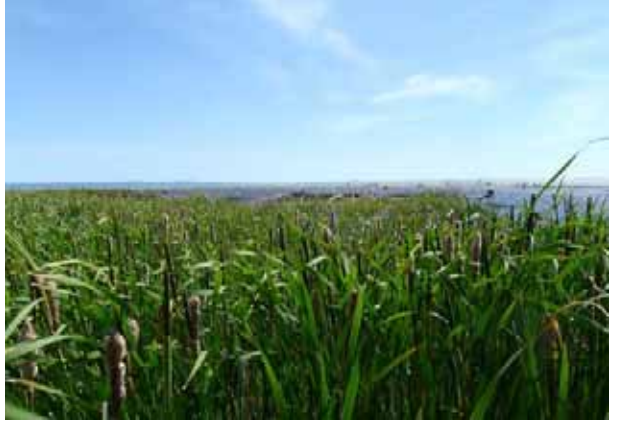
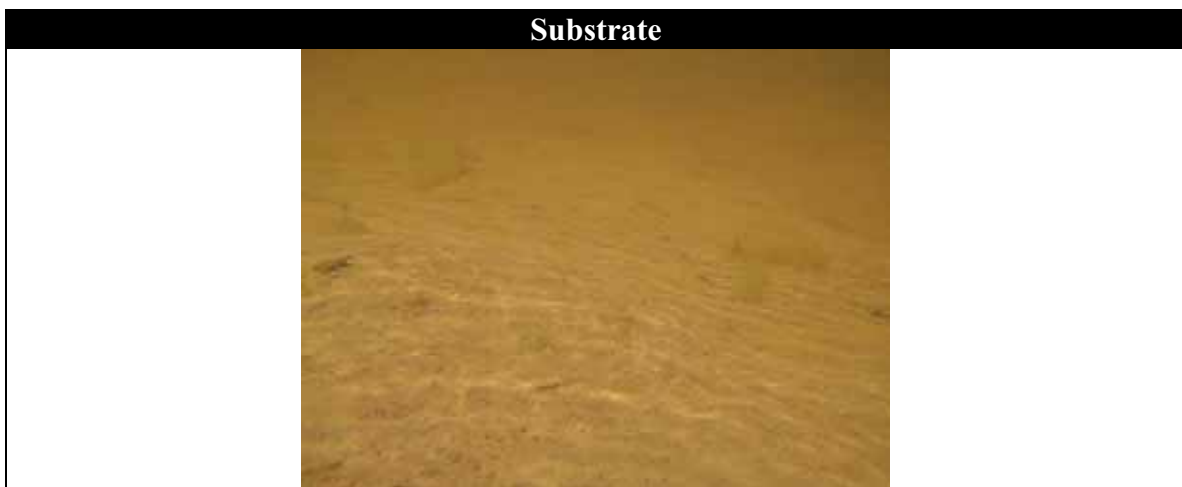
Site 1 – New Confluence	
Upstream	Downstream

Immediate of the river mouth, small sections of well developed wetlands can be found. Red-winged black birds appear to be the dominant species in the area. The wetlands, becoming less developed, continue out into Lake Superior for approximately 175 m. The section of the wetlands furthest out into the lake consist predominantly of old trees, remains from the confluence divergence, and small amounts of aquatic macrophytes set on a sandy bottom. The main inhabitants of this wetland niche are Herring Gulls and Cormorants.

Away from the river mouth, wetlands quickly change to sandy banks featuring active erosion. Large amounts of submerged woody debris can also be found near the river banks. The debris has been documented as provide shelter for fish and habitat for both Spotted Sand Pipers and American River Otters. Substrate is dominated by a sand/silt mix.

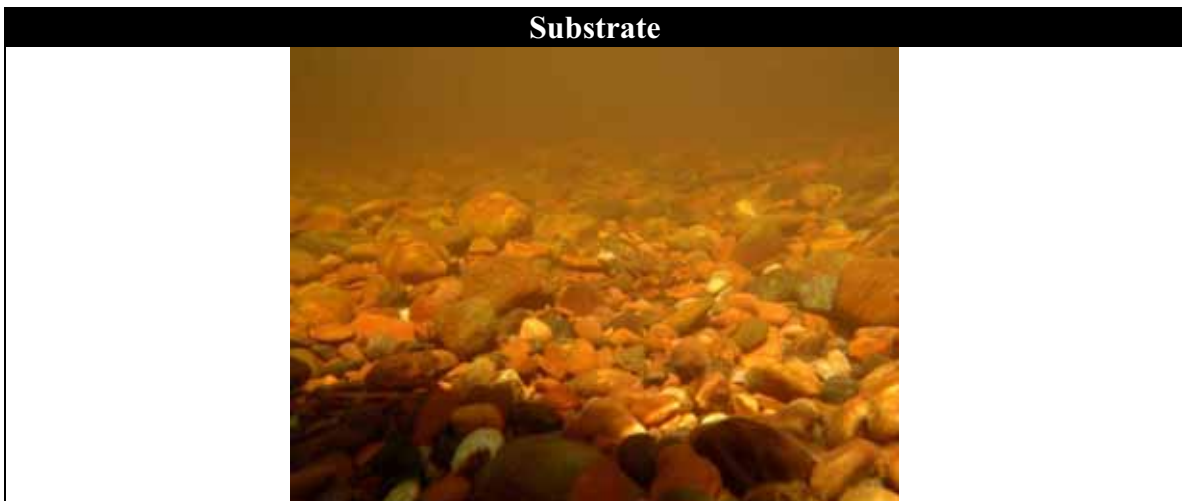
The upstream and downstream segments of the river channel possessed large amounts of woody debris and fallen trees. Both piles of debris appear to be causing elevated sandbars, by interrupting stream flow. This did not appear to be affecting stream health as the sandbars were causing the formation of small deep channels with riffles. Various fish species have been documented utilizing these channels. The common substrate upstream and downstream of the sandbar was a gravel cobble mix.

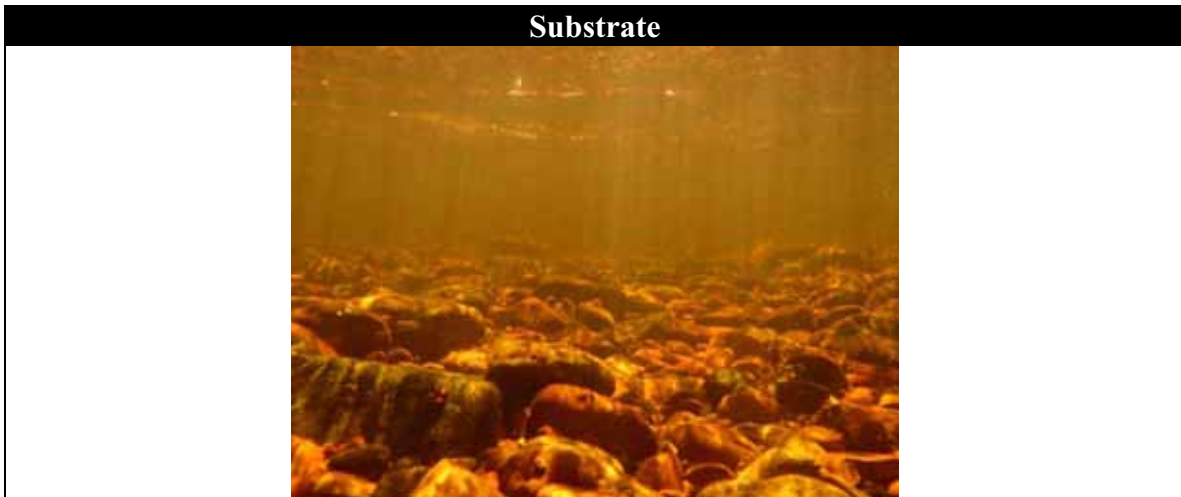
The meander bend closest to Site 4 acts as a transition zone for the river's substrate. In this location the substrate quickly changes from fine sand and clay to cobbles. The substrate transition zone is a product of the rapid drop in velocity, standard of an inner meander bend, which quickly deposits the eroded sediment from a bank further upstream. Cobbles, the dominant substrate of the area, are covered by the sand creating a substrate defined by roughly 80% sand/clay and 20% cobbles. This mixed substrate lasts for approximately one metre, and then quickly becomes composed of nearly 98% cobbles.

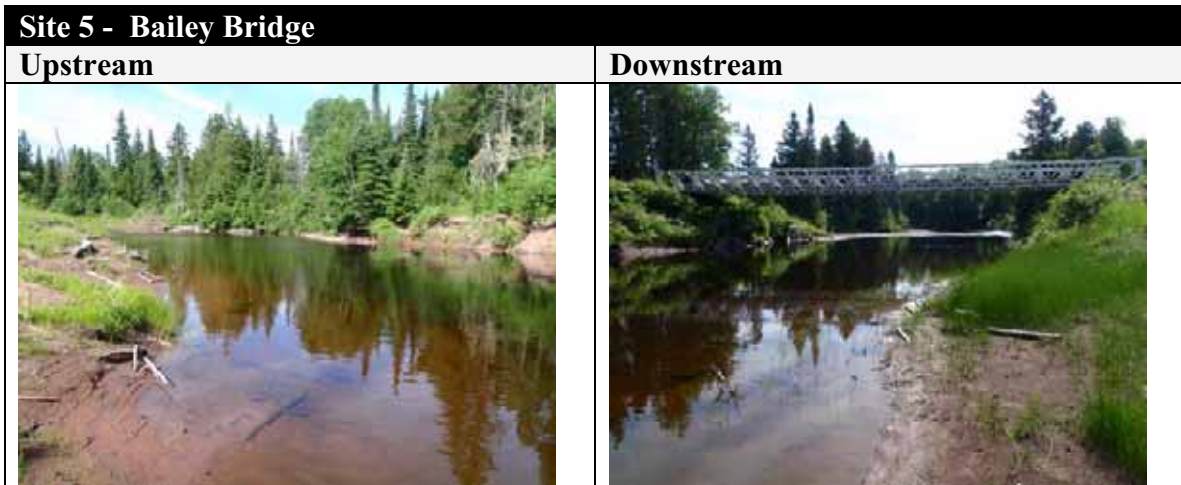
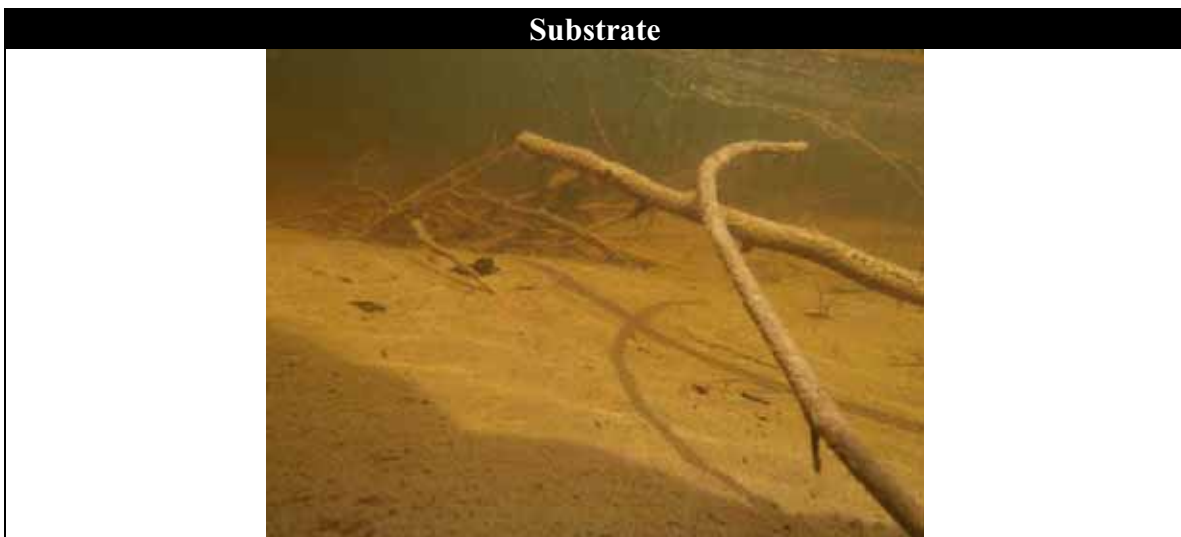
The stream banks and substrate up stream of the bridge are characterized by fine to medium sized sand that is well sorted. The sand appears to be a product of eroding stream banks. Downstream of the bridge the substrate quickly changes to cobbles. This is presumably because the fill under the bridge has been preventing erosion and therefore no large amounts of sand have been entering the river. Additionally, the banks on either side of the bridge are well vegetated preventing further erosion hazards.

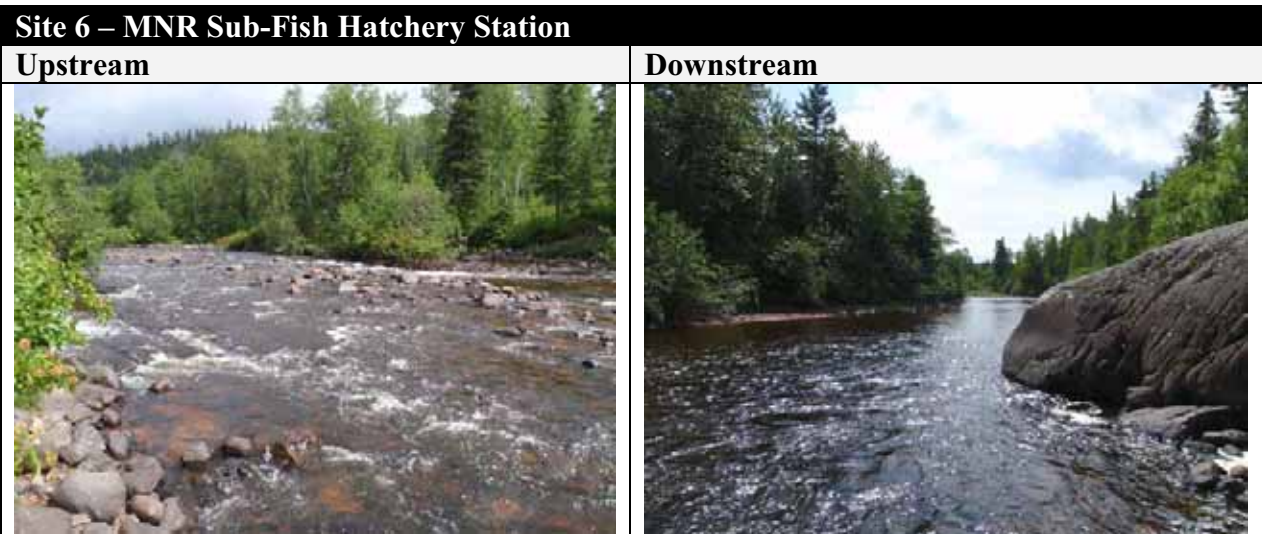
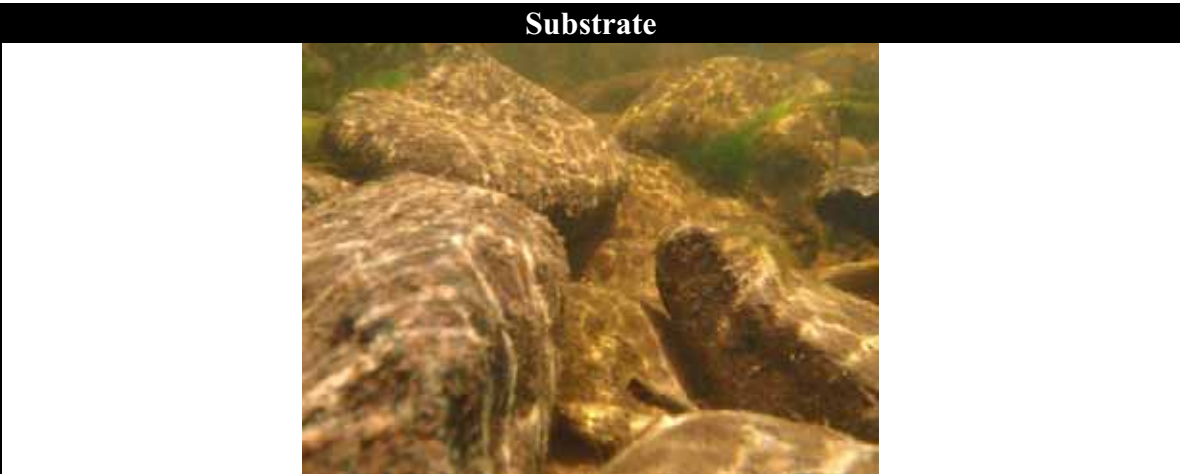
Site 6 is characterized by a set of rapids immediately up stream of the sample site. Also of interest is the large bedrock outcrop that creates a pool frequented by brook trout. The bank opposite of the sample site is well vegetated and has evidence of minimal erosion. The Site 6 bank consists of fill and is vegetated by grasses with few shrubs. Groundwater seepage into the river is visible beside the bedrock outcrop. The sub-station adjacent to Site 6 uses the cold groundwater as a natural means of replenishing their fisheries pond.

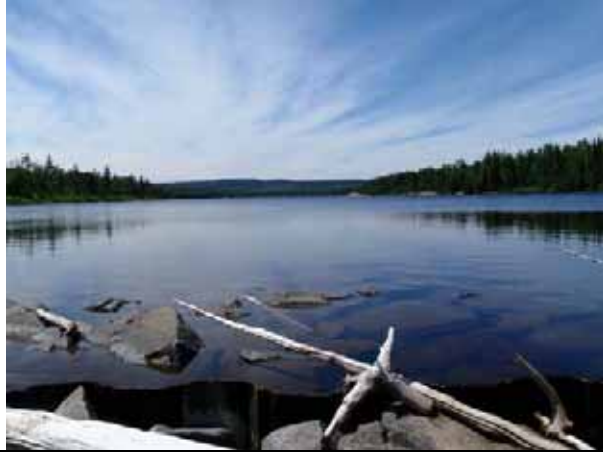
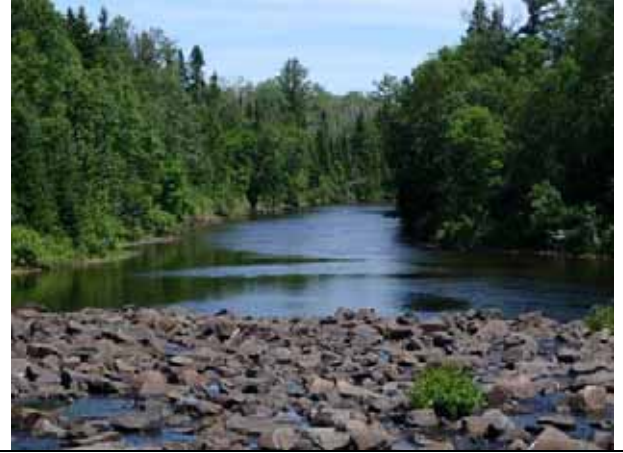
Site 7 – Wolf Lake Dam

Sampling was conducted within the immediate area of the Wolf Lake Dam. Either side of the Dam is bordered by fill consisting of large boulders. The fill extends at least 2 metres into the lake. Downstream fill extends approximately 75 metres. Water drainage over the dam is governed by water levels in the lake as well as being heavily affected by wind. The top of the dam also possessed a variety of woody debris. Natural lake substrate can be observed from the shores and consists primarily of cobbles.

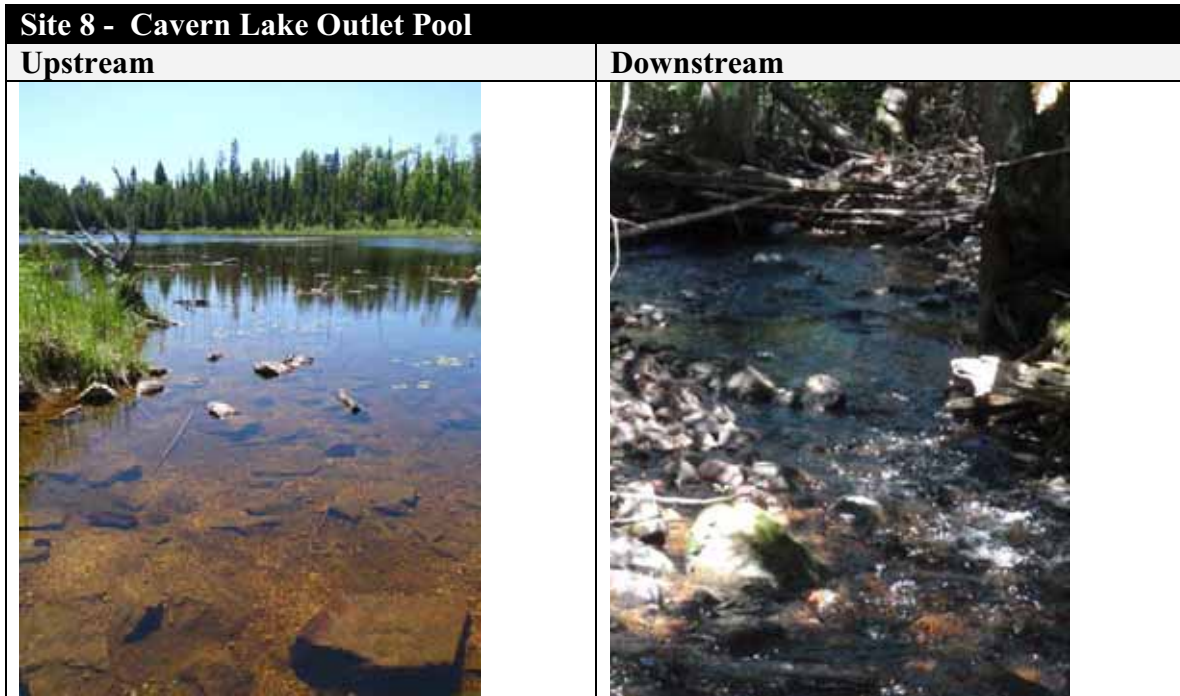
Site 8 is an outlet pool and part of the Cavern Lake tributary system. The outlet pool is bordered by marshy land and possessed two beaver dams, one at the headwaters the second where the pool overflowed onto Cavern Lake Road. The substrate in the immediate area of the sampling site was a mixture of fine organic matter, sand, gravel and boulders. Downstream substrate material consists of cobbles. After flowing over Cavern Lake Road, water from the outlet pool flowed into a swamp, then formed a separate cobble stream which meandered throughout the surrounding forest.

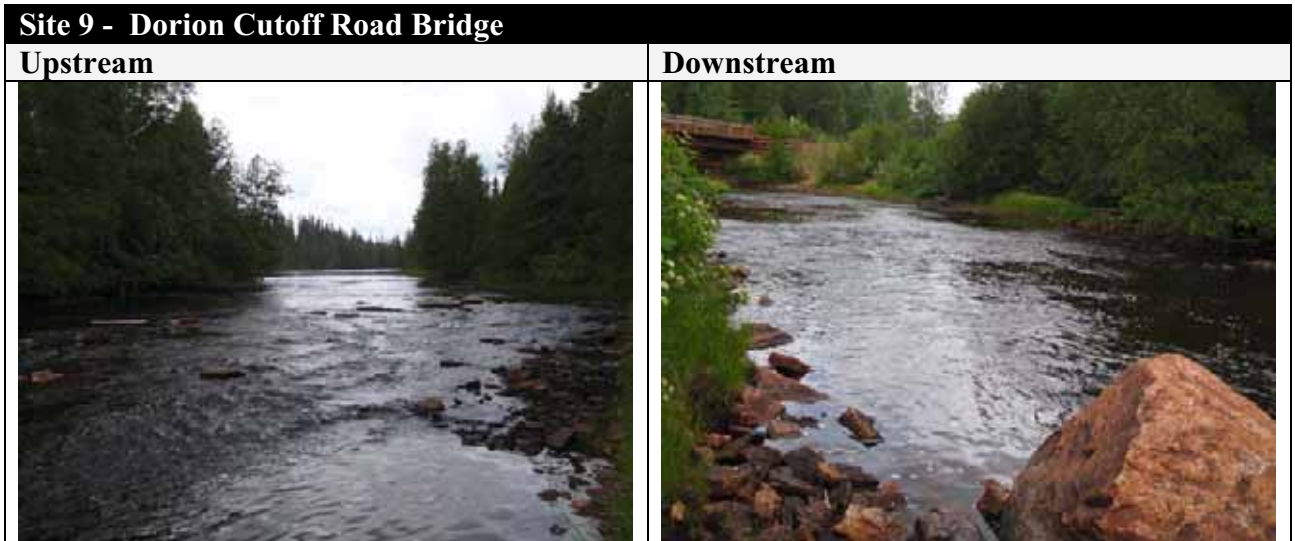
Site 9 is characterized by frequent exposed bedrock, large gravel and boulders. River substrate also is characterized by exposed bedrock and gravel. Due to the resilience of the bedrock, very little erosion was observed at this site. A point of interest at Site 9 is that the site is an exposed part of the Sibley Formation and the ancient oxidized iron particles characteristic of the formation were clearly visible.

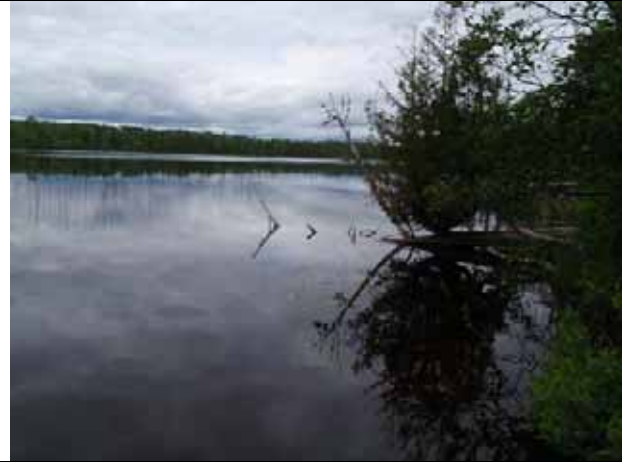
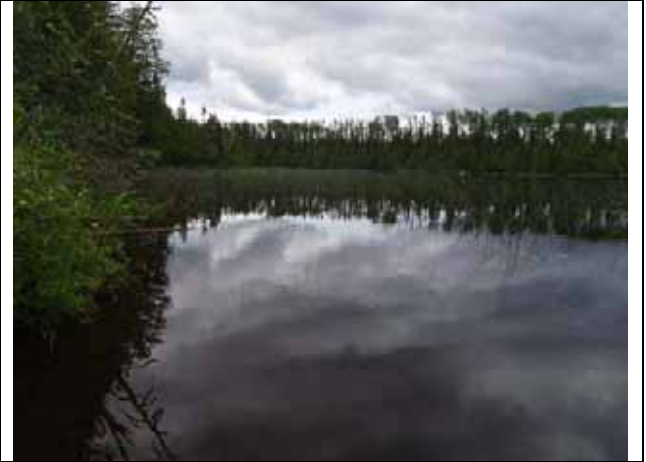
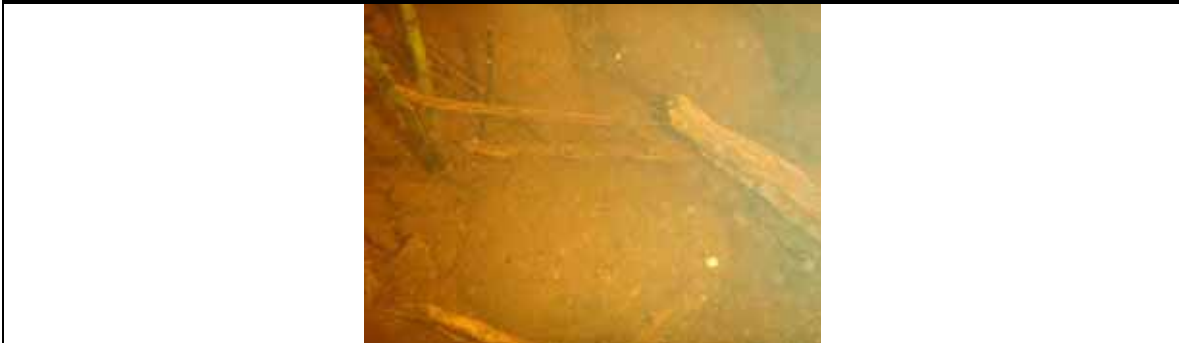
Site 10 – Upper Clearwater Lake

The banks of Upper Clearwater Lake were very well vegetated and are responsible for the lack of erosion in the area. However, the large amount of onshore vegetation has created a thick layer of organic matter overlying exposed boulder pavement. The boulder pavement can be found by disturbing the layer of decaying organic matter. Additionally the water of the lake had taken on a dark tea color as a result of the organic dyes found in the vegetation. The tea coloration and in water material do not seem to have a negative impact as the area was abundant with wildlife.

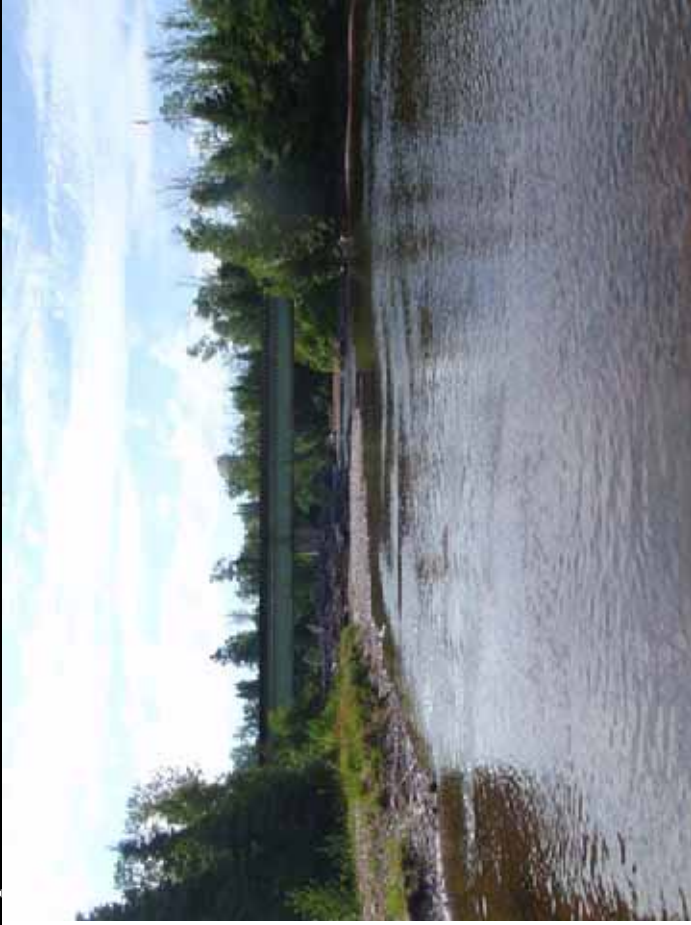
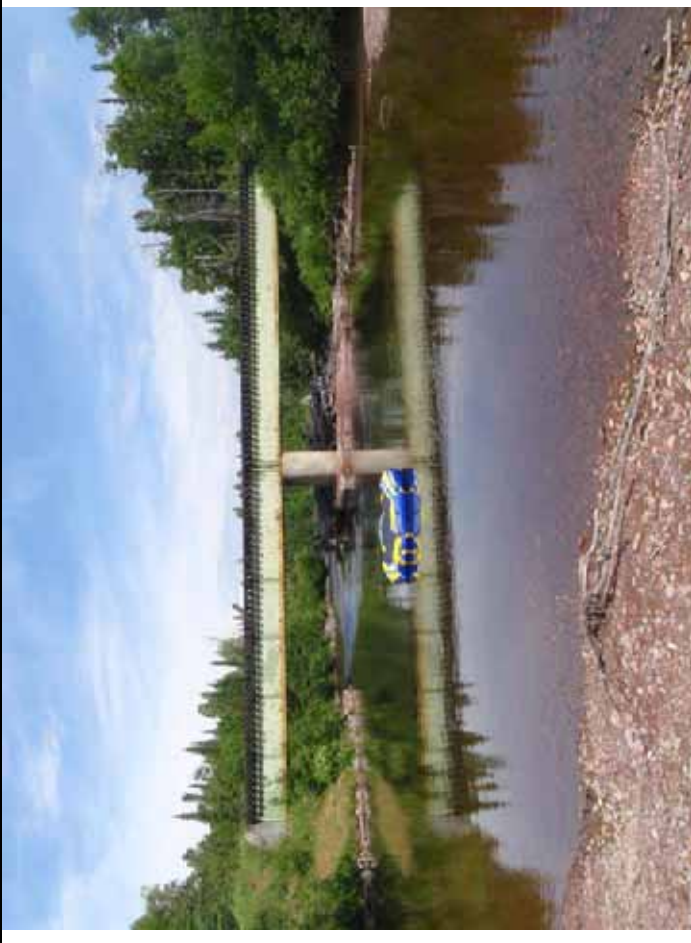
Description: Abandoned CNR Rail Bridge. Constructed in 1977, decommission date is unknown. Bridge consists of wooden rail-tails overlying a steel base. The bridge is supported by concrete pillars and concrete side supports. The support pillars are in good condition with no visible cracks in the concrete. Fill on either side of the bridge consists of crushed rock and the area is heavily vegetated. The wooden tails have experienced some weathering, brought on by age, but are still functional. This is evident by the crossing of CNR employees on a work truck.

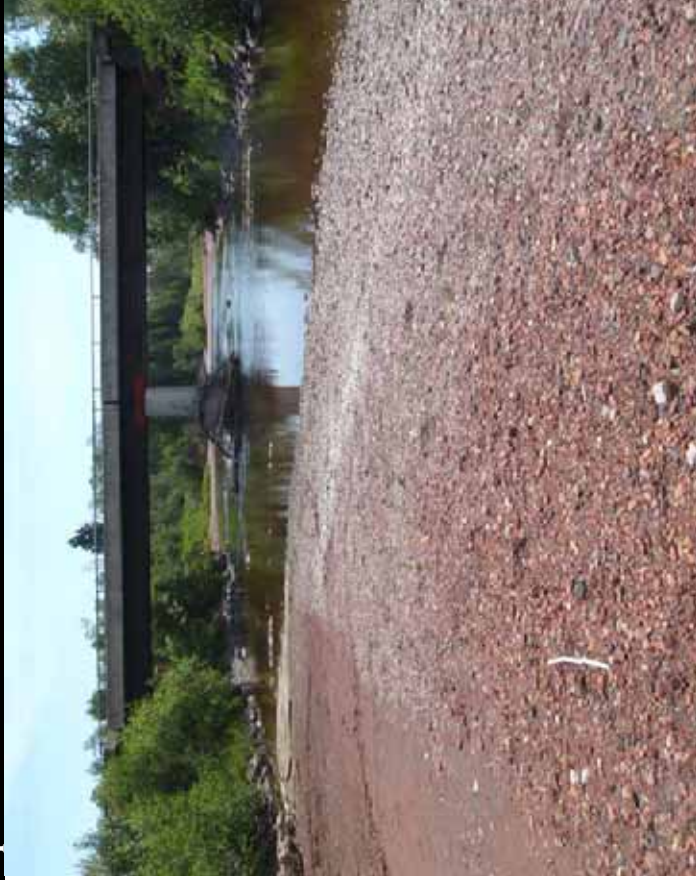
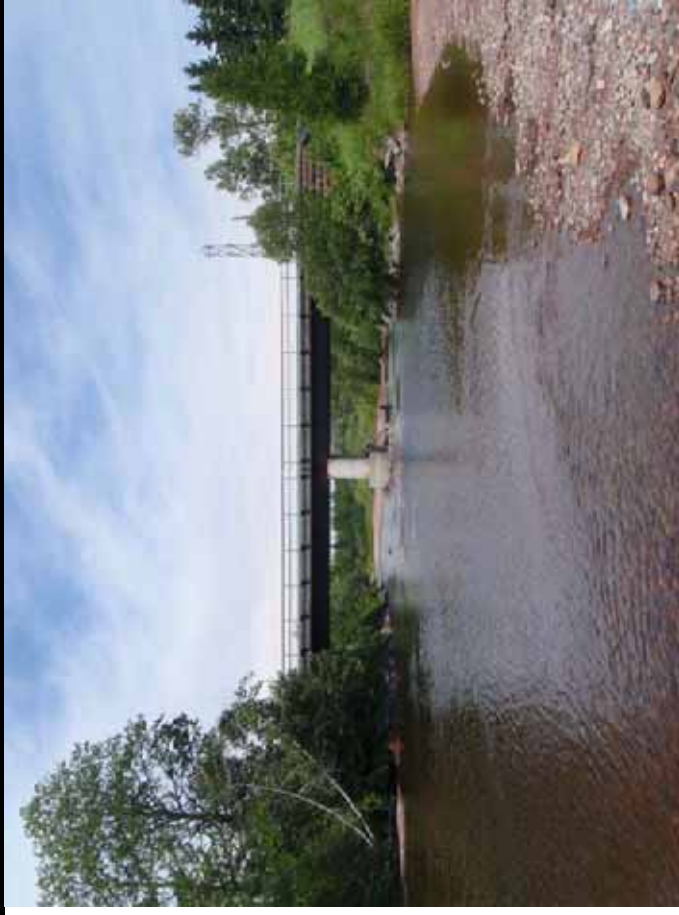
Bridge 2

Description: Operating CPR bridge. Construction date was unknown at the time of Report. Bridge is constructed of concrete supports with brick siding. Wooden and steel tracks were laid down on gravel reinforced by concrete siding. Downstream side of bridge harbored a walkway for pedestrians/rail workers. The walkway consisted of a steel grate with steel safety bars. Fill for this site is large crushed imported boulders. The top sides of the bridge are abutted by large rectangles made of metal fencing and filled with large pieces of gravel.

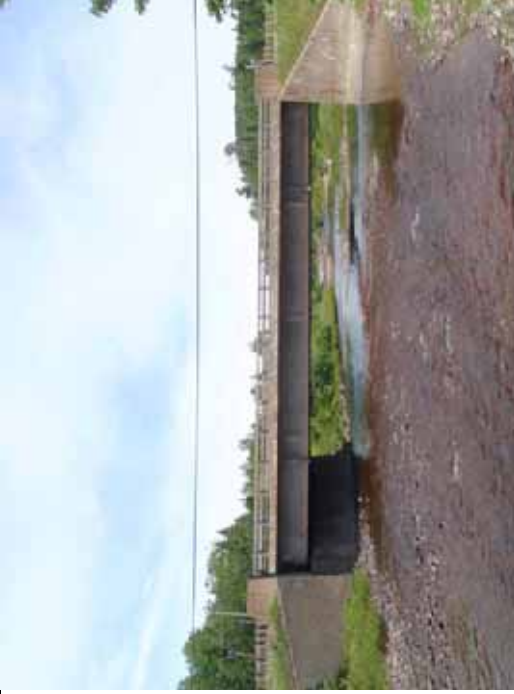
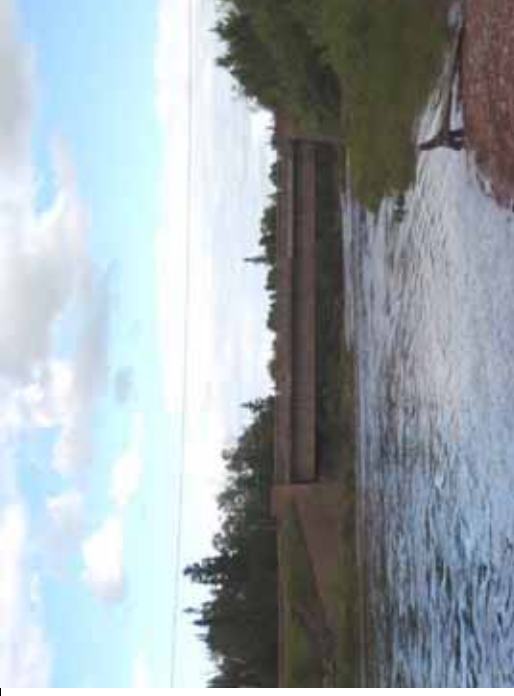
Bridge 3

Description: A Concrete bridge with steel side rails and asphalt surface. The bridge is in good condition with no signs of cracks in the concrete. No fill has also been placed under the bridge; the wingwalls are angled to prevent erosion directly into the river. There is no dense vegetation within the immediate area of the bridge. Sides of the bridge are occupied by grasses and thistles.

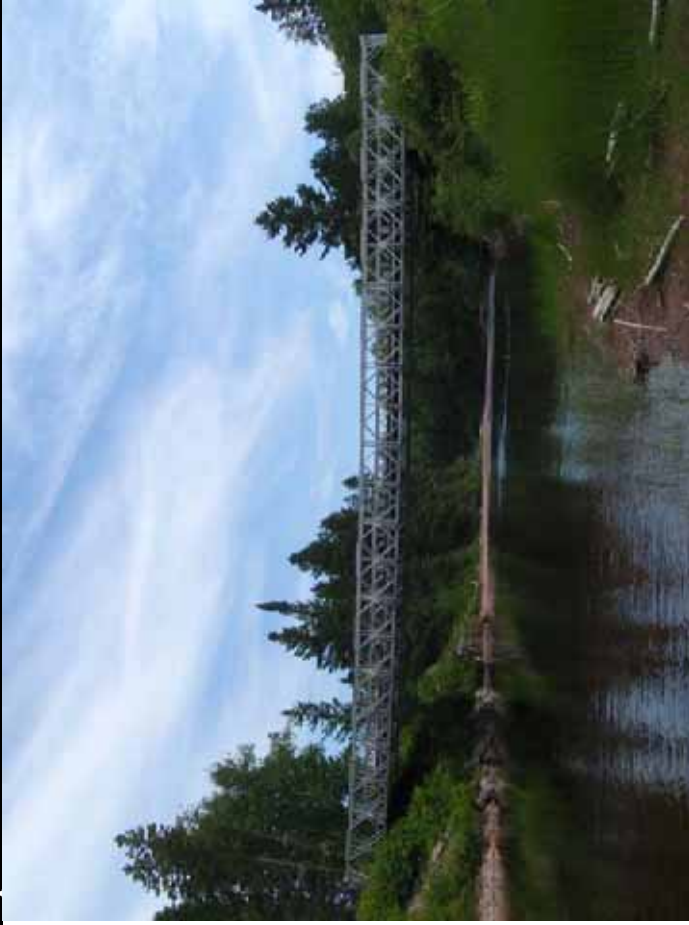
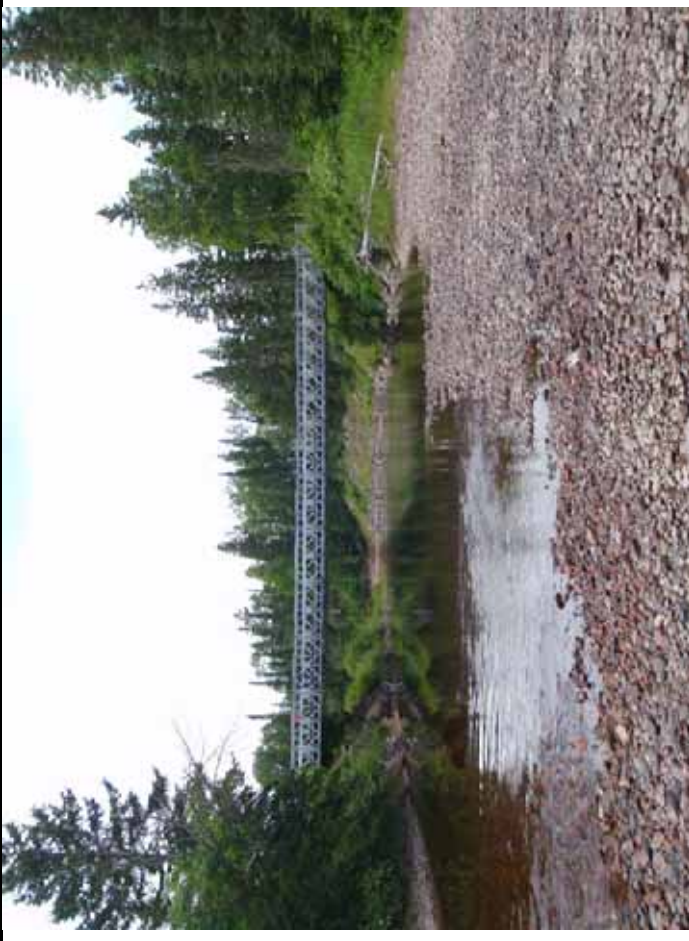
Bridge 4

Description: Fairly new bridge built on private property by local resident concerned about the river's health. This bridge is classified as a bailey bridge. Fill consisted of large imported boulders with vegetation occupying voids.

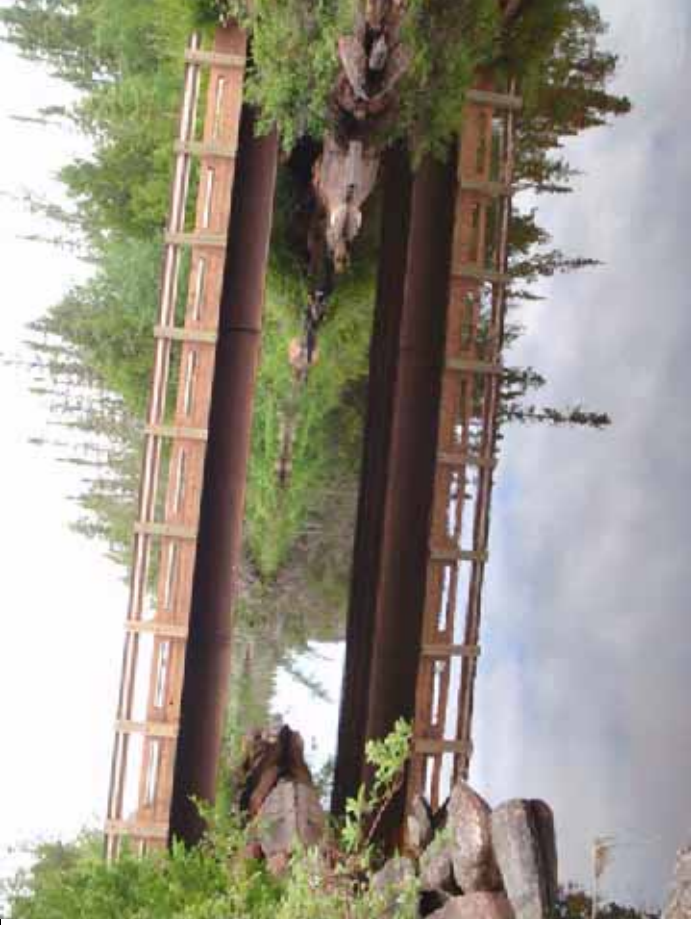
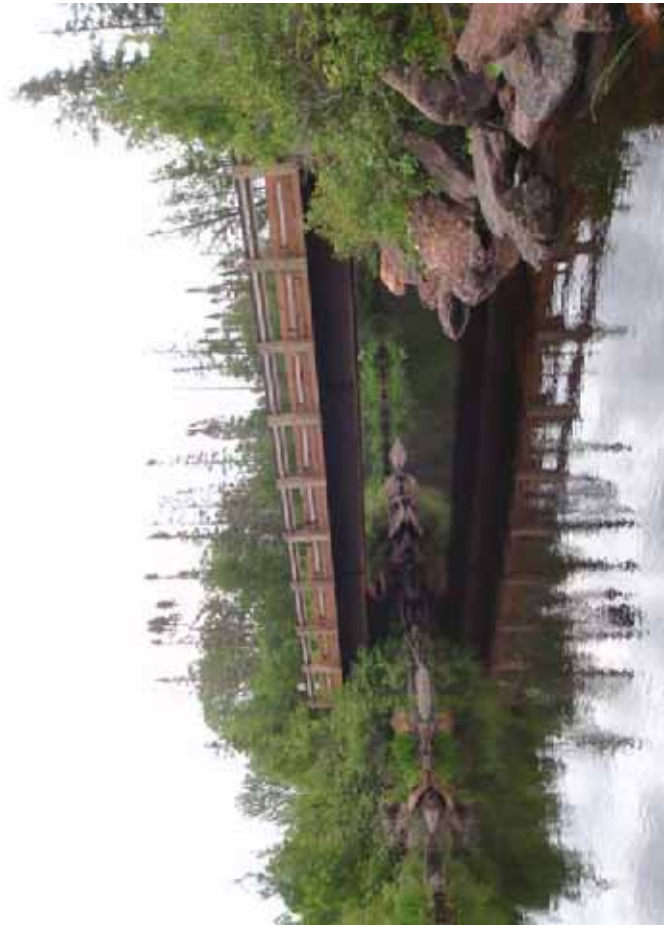
Bridge 5

Description: Bridge crossing the Wolf River within the mid-watershed. Bridge construction consists of wood, iron and steel. Fill consists of large boulders originating from parent material surrounding the bridge. The wood components do not appear to be subjected to rot. Mild rusting is occurring on the underneath of the bridge.
