Wolf River Watershed Assessment

Wolf River Watershed Assessment Report

August 2009

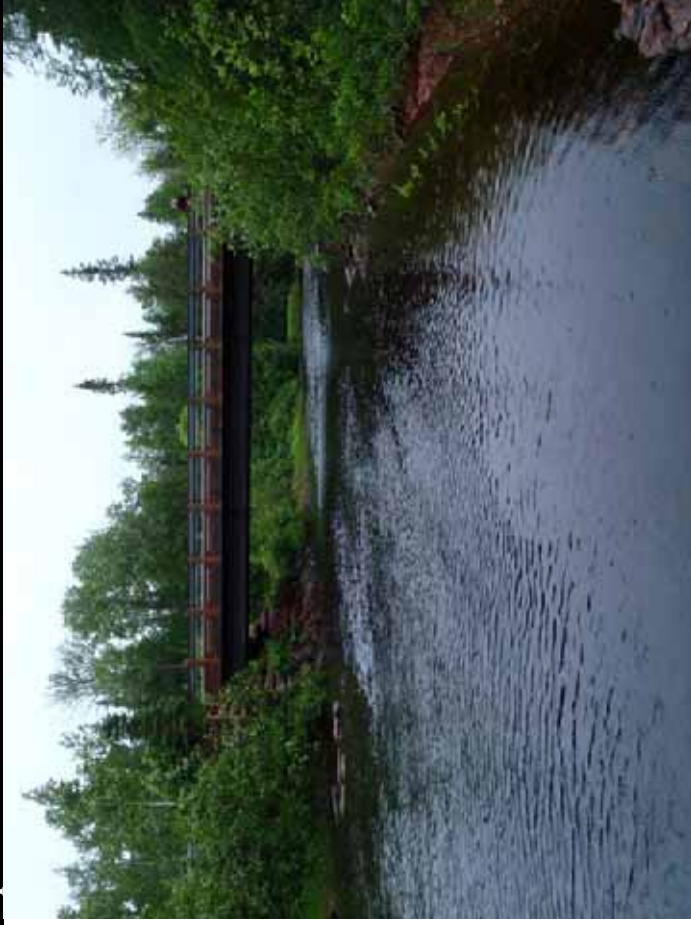
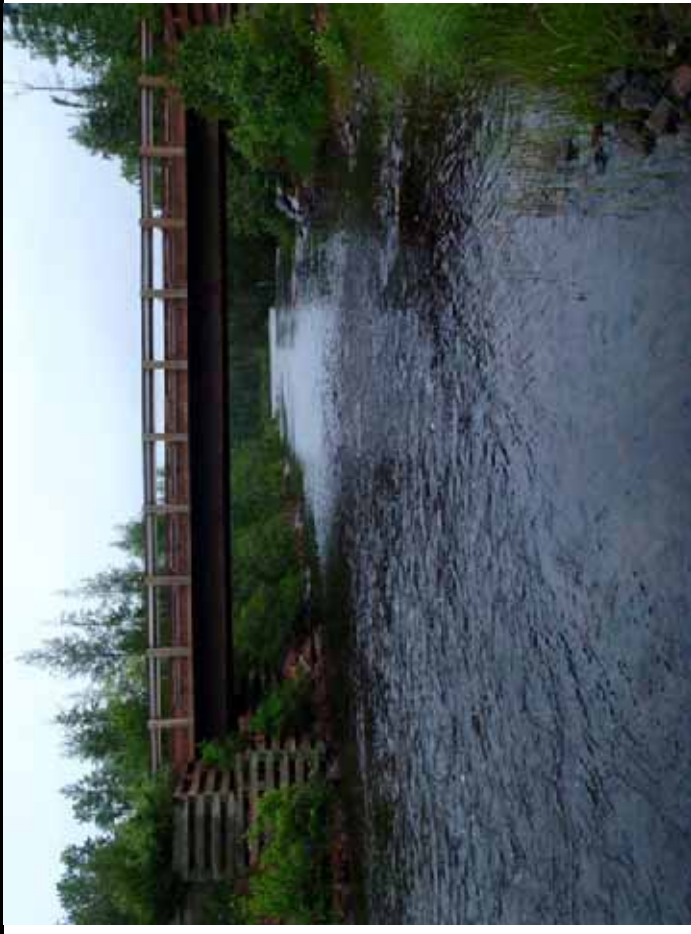
Bridge 6

Description: Bridge crossing the Wolf River in the upper watershed. Construction materials consist of wood, steel and iron. Bridge supports consist of pressure treated wood cribbing. The cribbaging is filled with local gravel and sand. The sides of the bridge have been experiencing some mild erosion. The path of the erosion indicates the sediment has been reaching the river. Vegetation cover around the bridge is adequate.

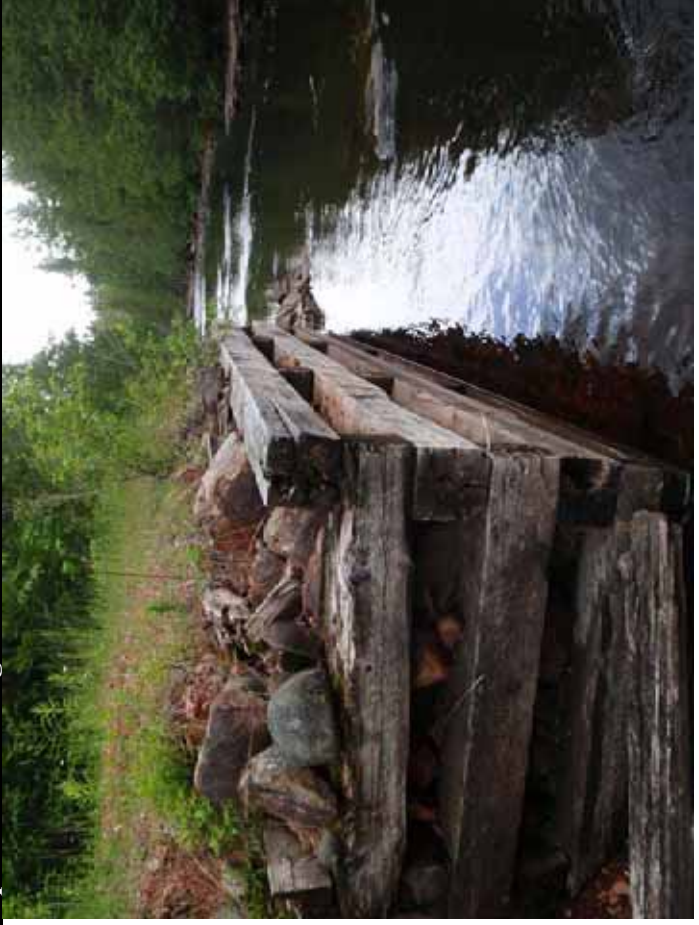
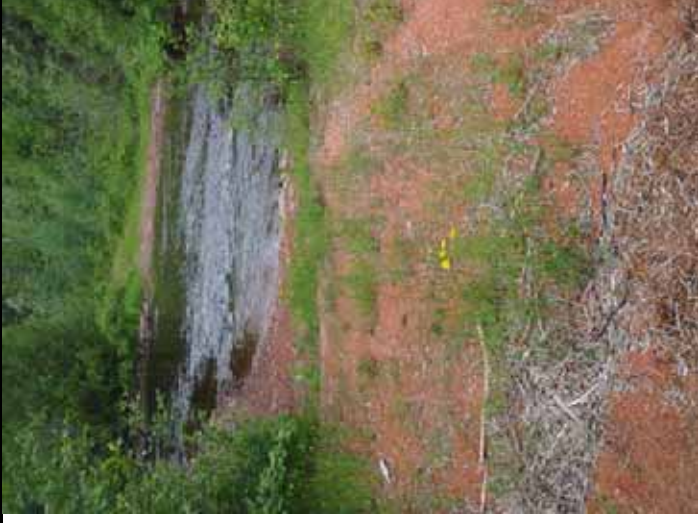
Bridge 7

Description: Presumably once used for forestry activities, only the side cribbing of this bridge remains. Pieces of debris have been observed on river banks suggesting that the low level of this bridge allowed it to be subjected to damage caused by high water levels. The failure of this bridge does not appear to be hindering the flow of traffic as evident by a road way crossing the shallow part of the river. This is of concern as vehicles crossing directly into the water have the potential to expose this segment of the river to larger amounts of petroleum hydrocarbons and erosion.
