# Brule Creek Watershed Assessment

Written and Published by the Lakehead Region Conservation Authority  
2007

Simon Shankie (Water Resource Technician Assistant)  
Tyson Villa (Water Resource Technician Assistant)  
August 2007

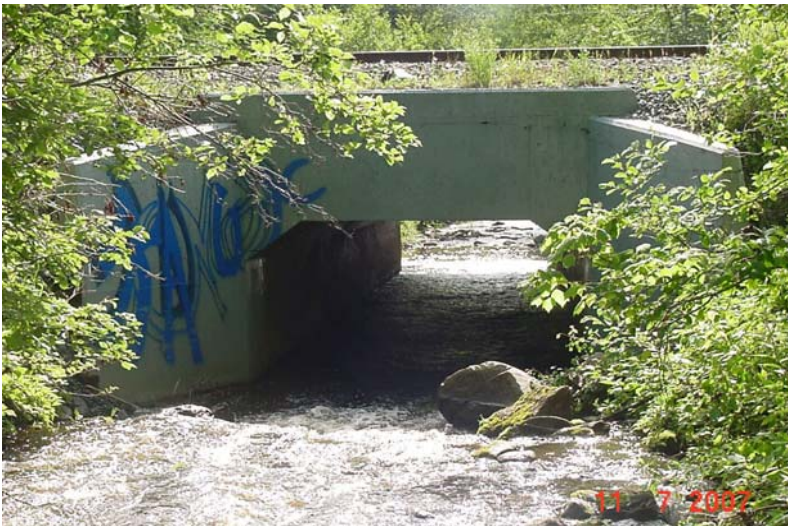
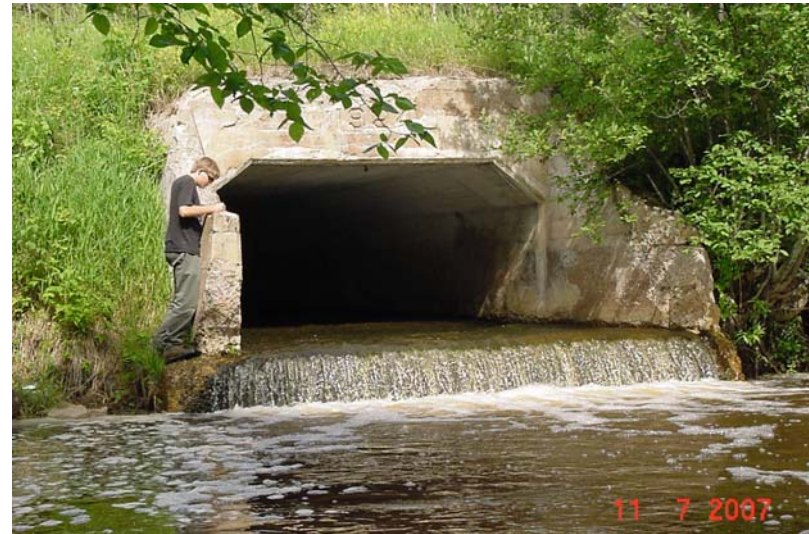
**Description:** This concrete culvert was created by the CN railway to accommodate train passage over the creek. This culvert covered 25.4 meters of stream and had an opening width of 99 centimeters. Concrete wings held back rubble and stones while provided a funnel for incoming water. The culvert was perched and drained into a medium depth pool that continues to the Kaministiquia River. Water flowed quickly through this culvert due to the wide and rocky streambed. Vegetation was dominated by tree species with some shrubs and grasses along the bank.

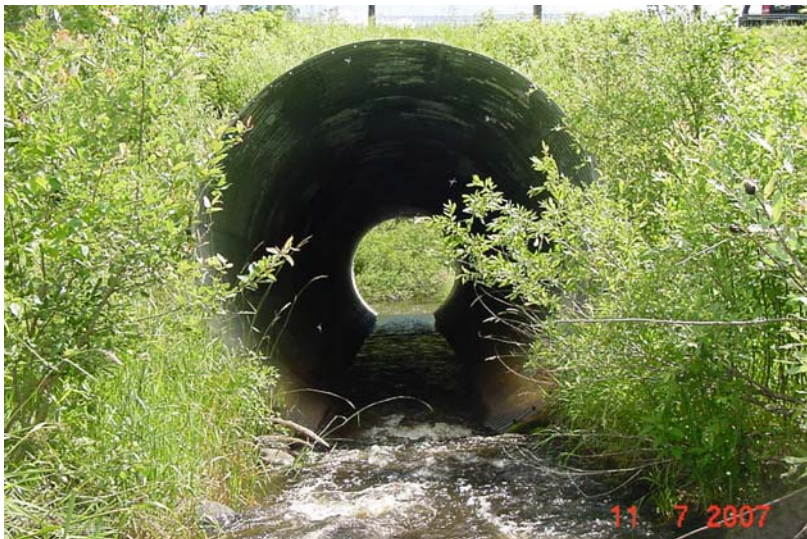
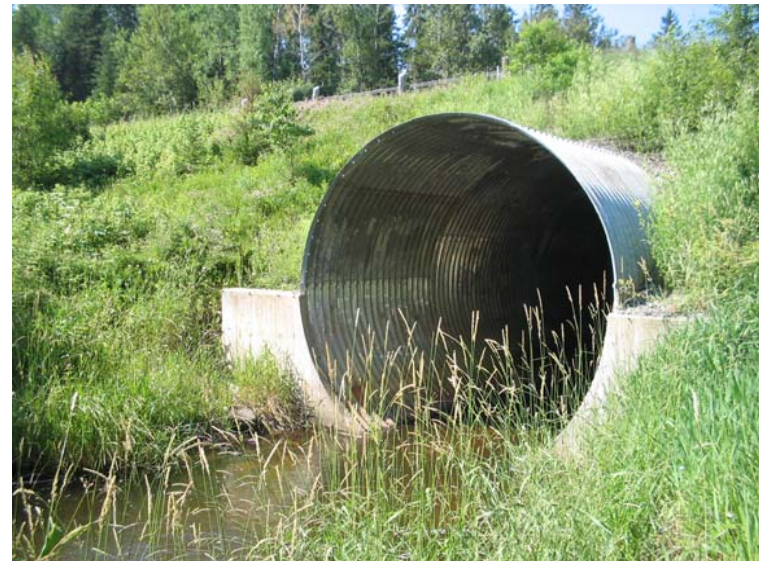
**Description:** This was the largest culvert in the watershed; it covered 30.2 meters of stream and had an opening width of 429 centimeters. The river was composed of a rocky bottom with sandy substrate. Light riffles on the upstream side and grasses and shrubs on both banks characterize this area. The road was relatively high above the water and the fill angle was steep but well vegetated with no signs of erosion. Overall, it was in very good repair.

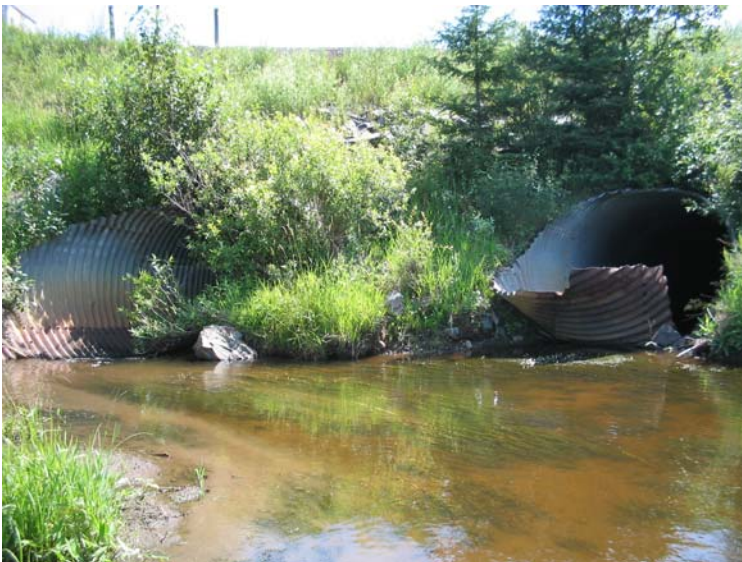
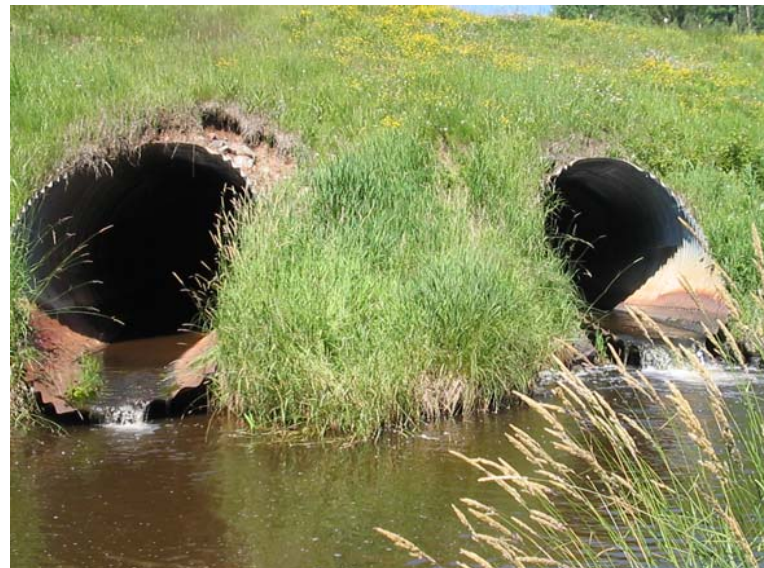
**Description:** Culverts 3a and 3b were two of the longest culverts in the watershed, and allowed water to flow beneath Highway 11/17. Culvert 3a covered 54.4 meters of stream and had an opening width of 272 centimeters. Culvert 3b covered 52.9 meters of stream and had an opening width of 292 centimeters. The south culvert (3b) had been damaged and the bottom end was bent up, which restricted the flow through the culvert. Culvert 3a takes in the bulk of the flow and the watercourse had diverted itself to compensate. The inflow pool was sandy and clayey with long waterweed patches. Downstream, the culverts flow into a medium depth pool with rocks and sandy substrate. Tall grasses surround the banks, which prevent any erosion from occurring. There are large rocks inside the culverts, indicating higher flows previously.

the highway immediately upstream of the site. Both culverts 3a and 3b exhibited signs of advanced rusting, to the point where water was flowing through a rusted-out hole in the base of culvert 3a.

The culverts along Brule Creek were, for the most part, in good condition with minor damage to them. The damage consisted of small dents to corners, or rust holes on the upper surface. A special note should be made about Culvert 3b along Highway 11/17, where the entire base of the culvert on the upstream side was bent upwards, which considerably restricted the flow. Also, the downstream end of Culvert 3b had rusted and created a hole in the bottom of the culvert that diverted flow from the creek. During the assessment, an engineering team was seen evaluating the damaged culvert. There were very few signs of erosion along the banks of the crossings, as the banks were stony and impervious or covered in vegetation.

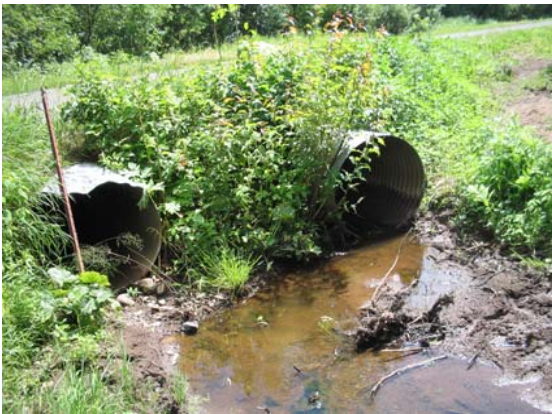
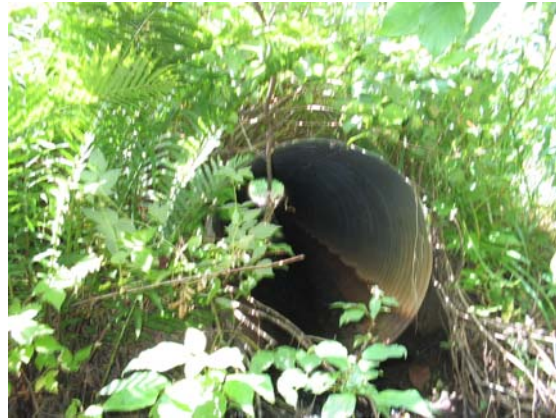
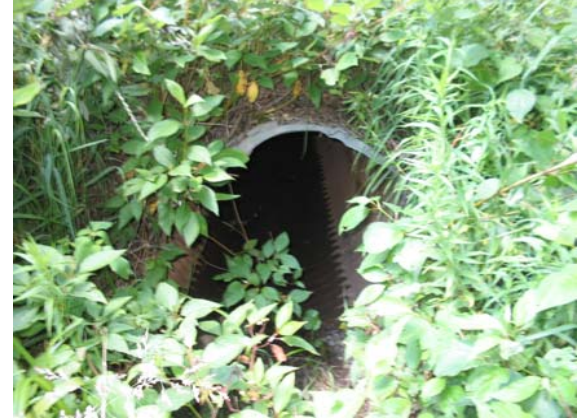
**Description:** Two nearly parallel culverts move water across this low traffic residential road. The north culvert (4a) was dry at the time of measurement and covered 9.8 meters of stream. Culvert 4b covered 12.3 meters of stream and both culverts had an opening width of 91 centimeters. All flow passed through the south culvert. The upstream end was very overgrown with vegetation, and a single photo of both could not be obtained. The culverts were in good condition, although the north culvert at the inflow end was bent down at the top.

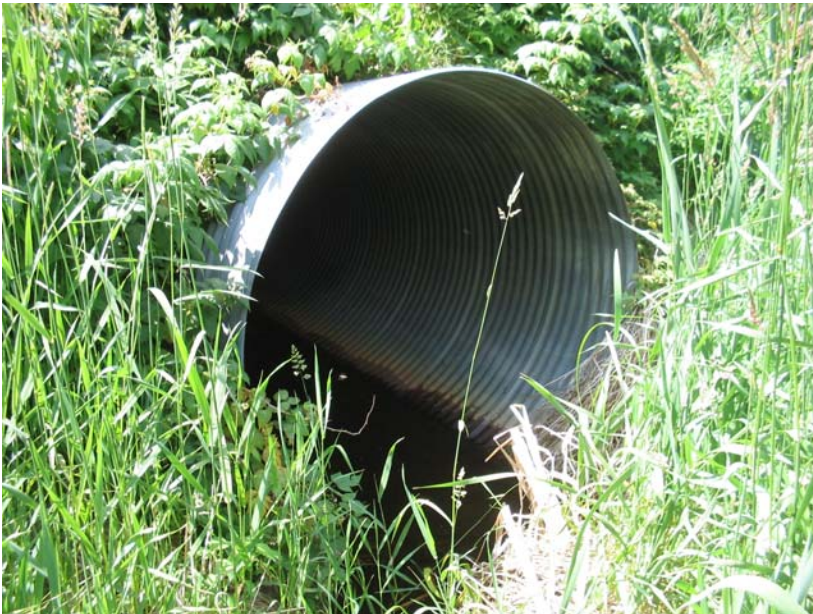
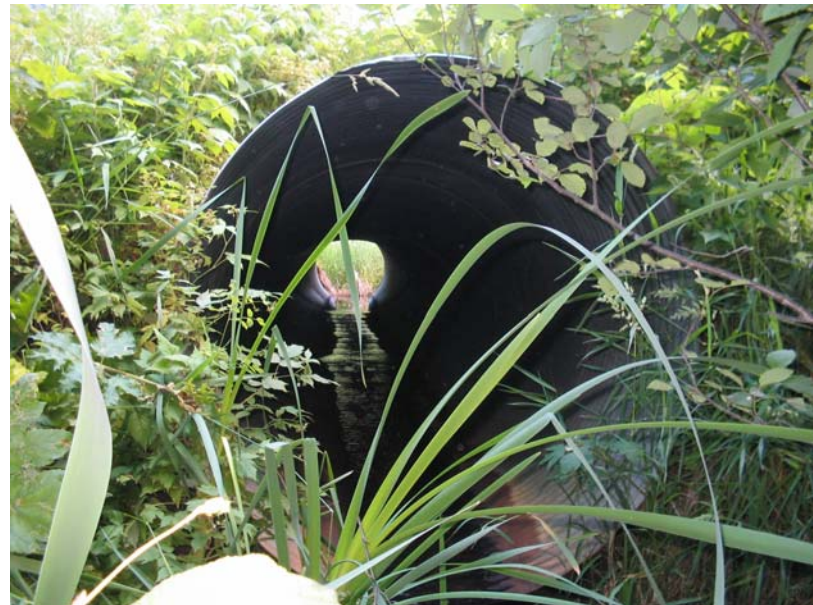
**Description:** Culvert 5 was surrounded on both sides by thick vegetation and was marked by a painted wooden post on the side of the road. It covered 18.2 meters of stream and had an opening width of 183 centimeters. Tall grasses surrounding both ends made its visibility very low. The flow going through the culvert was extremely slow and the upstream end was nearly choked with grasses growing in the streambed. Both ends were shaded by alders and shrubs and close to 90% covered. The inside middle of the culvert was bent down, possibly due to heavy traffic on the road.

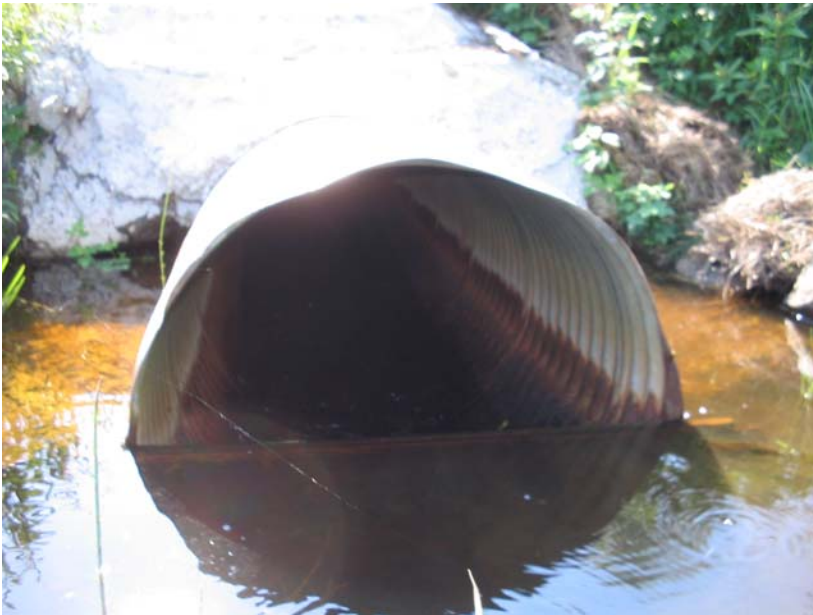
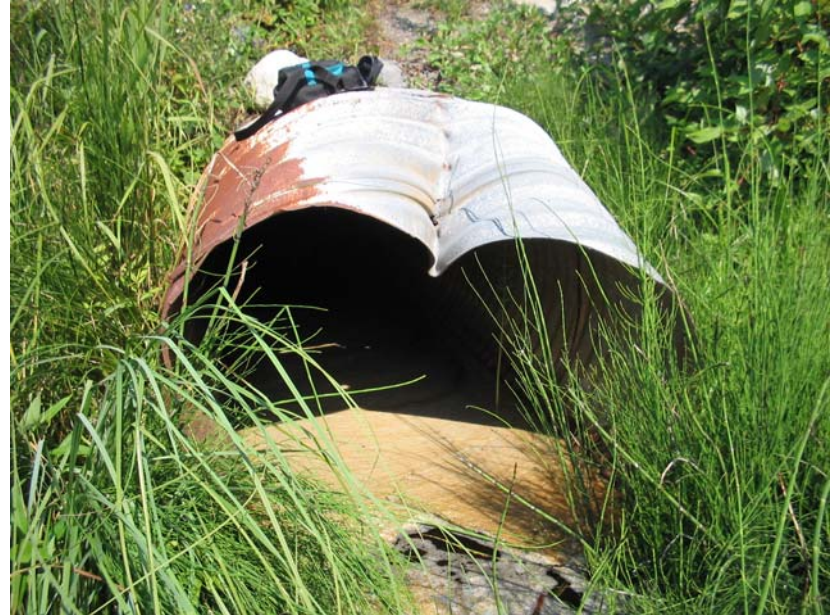
**Description:** Located on private property, permission was granted to document this culvert for the report. The culvert covered 17.7 meters of stream and had an opening width of 109 centimeters. The upstream end was a marshy pond with lots of wildlife and plant growth. The farmer had placed a board on the upstream end to raise water levels in the pond. While this did not seem to cause a problem, during storm events it may restrict flow through the culvert. The culvert was surrounded by concrete and was in good condition, except for a bent upper portion on the downstream side.

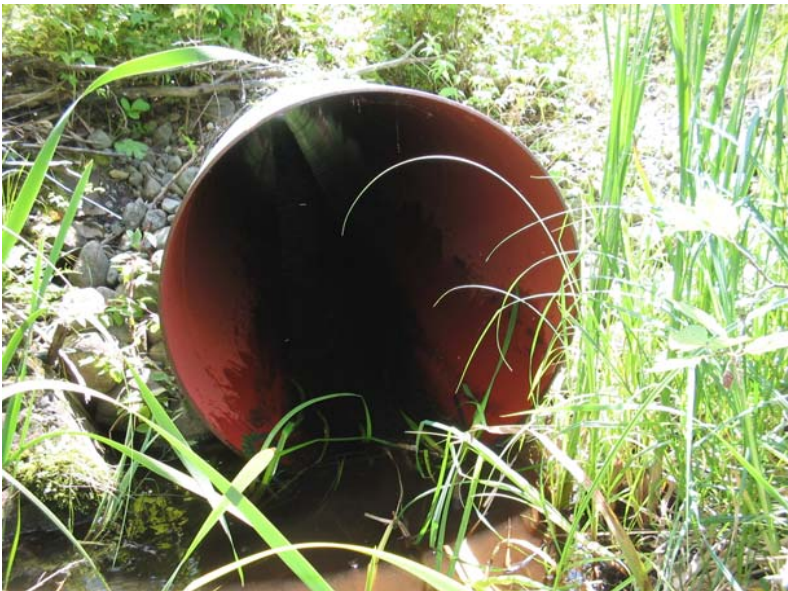
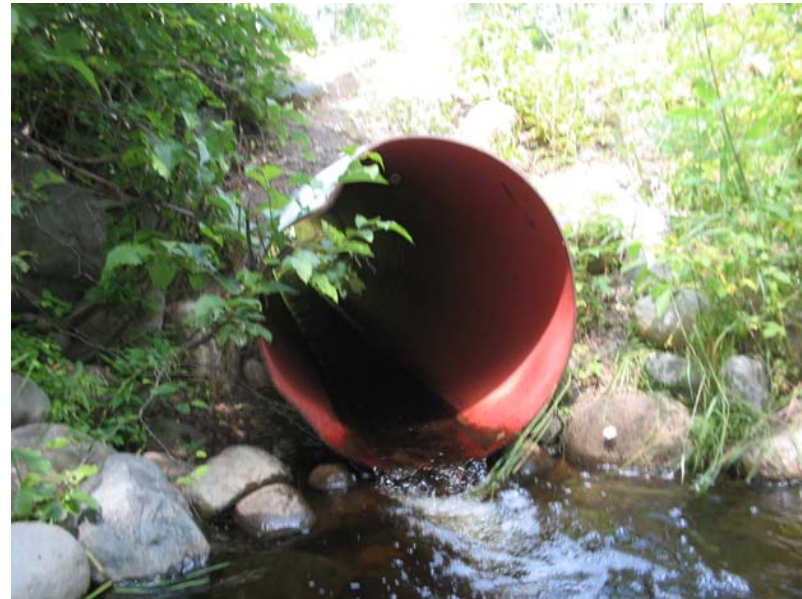
**Description:** This culvert was solid steel, instead of the standard corrugated aluminum alloy. The culvert covered 16.2 meters of stream and had an opening width of 91 centimeters. It was painted lime green on the outside and pink on the inside. The inside paint also came off on surfaces that contacted it. This culvert drains out of a marshland north of Mokomon Road. Flow was very slow and drains into a pool with a rocky bottom. The outlet end had a dent on the corner, but the rest of the culvert was in excellent condition. Banks around this culvert were rocky, with some vegetation, and the banks were stable.

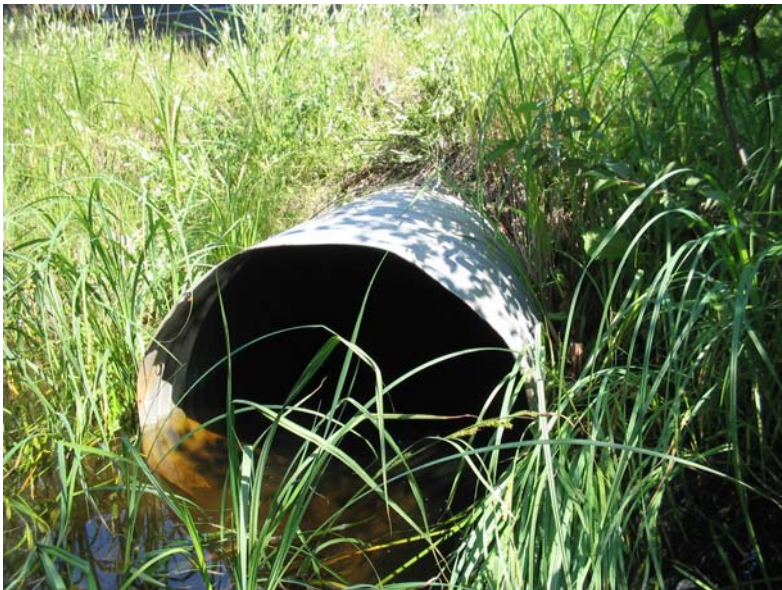
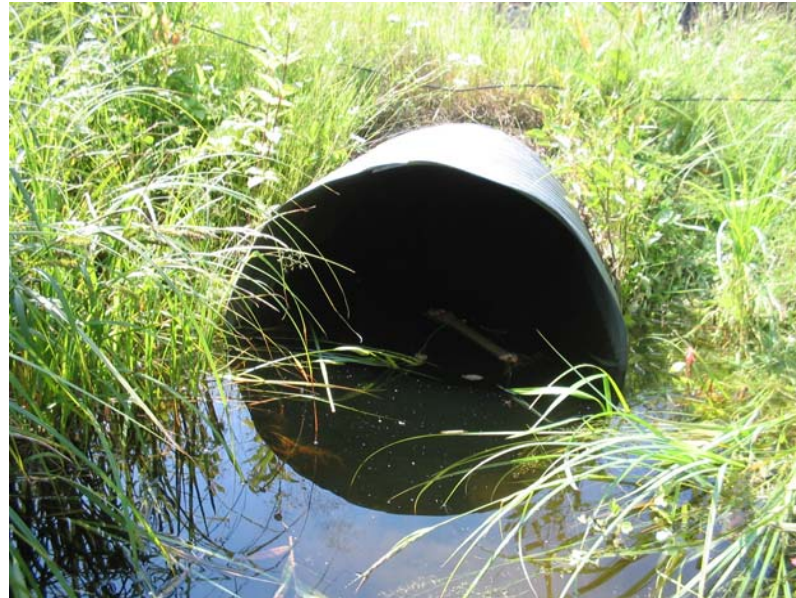
**Description:** This culvert had been blocked downstream by a thick beaver dam. As a result, there was no flow going through this culvert, and the water level seemed to be at its highest point. It covered 15.6 meters of stream and had an opening width of 91 centimeters. Vegetation was thick on both sides and was growing in and around the water. The river bottom was muddy with lots of organics, and mud had begun spilling into the bottom of the culvert as well. Banks on both ends of this culvert were stable due to the high amount of vegetation.

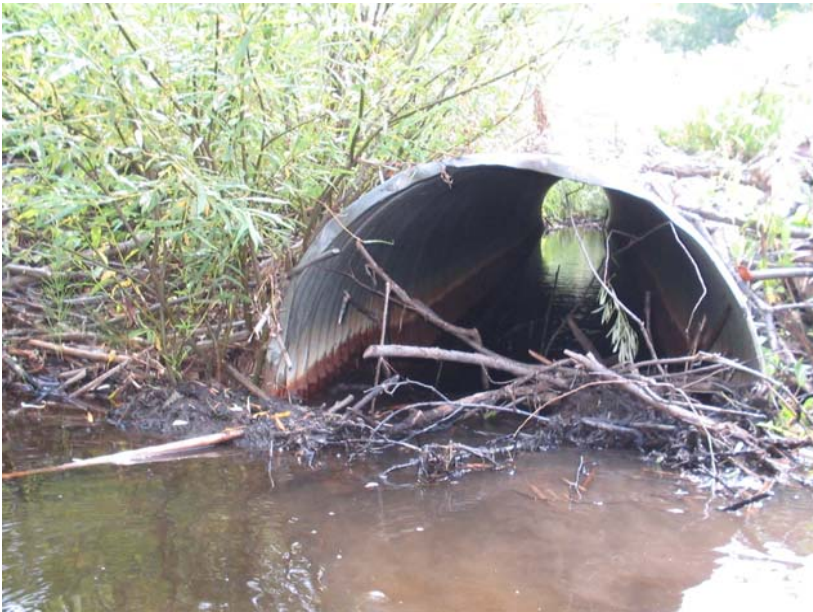
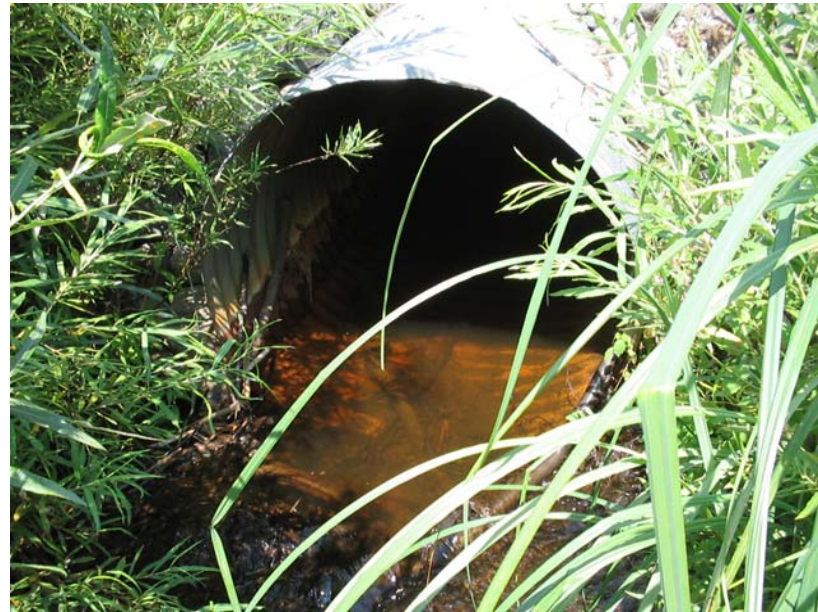
**Description:** This culvert had been blocked by a beaver dam at the inflow end. Also, further up the creek, another large dam had created a wide marshland. The water at this culvert was muddy and thick, with algae and grasses present around and in the water. The outflow end had very little water flowing through it and there were lots of loose twigs and sticks, possibly from the dam, all along the bottom of the stream. The culvert covered 13.2 metres of stream and had an opening width of 76 centimetres. The culvert was in good condition, but rusted on the bottom end. The banks were stable, vegetated and there was no evidence of erosion.

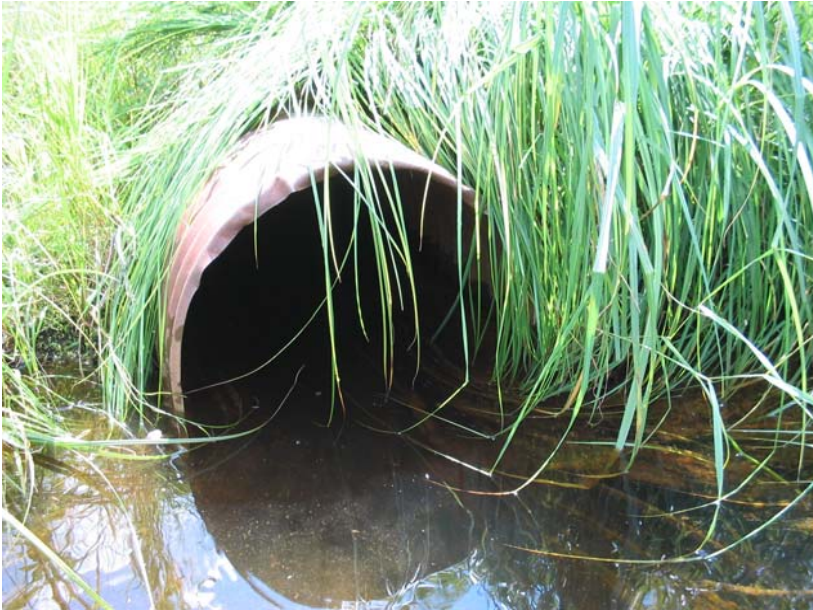
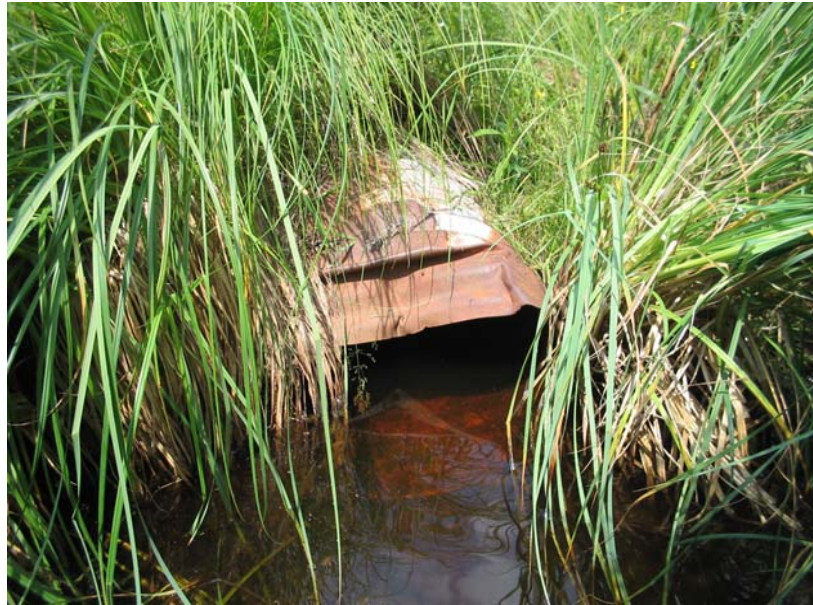
**Description:** This culvert was very close to culvert 9 and was also influenced by the beaver dams in the area. It covered 12.1 meters of stream and had an opening width of 91 centimeters. Sticks and twigs surround the culvert, however did not seem to interfere with the flow. There was an oily substance located on the surface of the water, which may have been iron bacteria. The culvert was in poor condition, with rust almost all the way up, and the outflow end was damaged at the top. Slow flow had pushed muddy substrate into the culvert, which covered the bottom. Thick grass and shrubs surround this culvert and help to stabilize the bank.

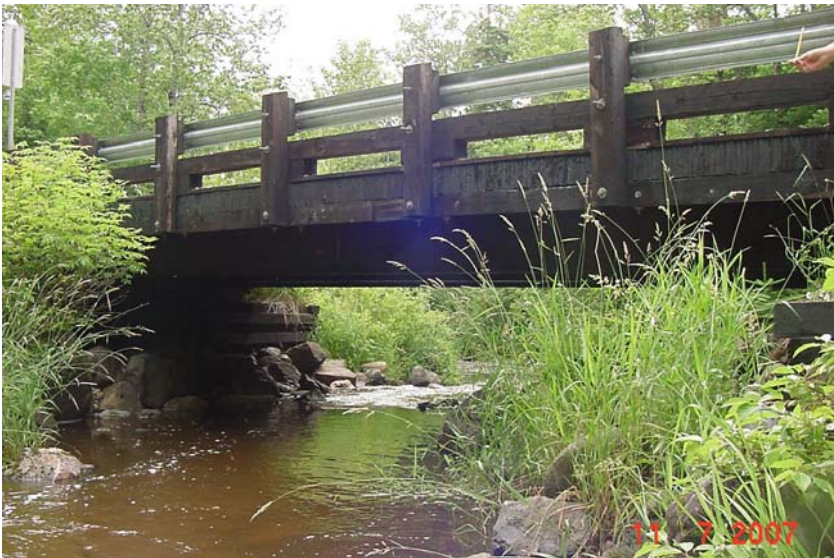
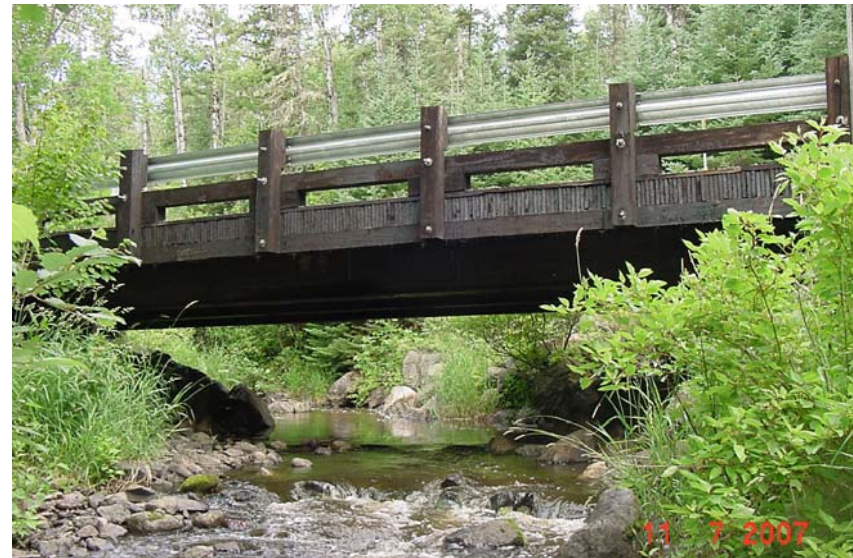
**Description:** Bridge 1 is the last crossing located on Mokomon Road closest to the CN railway and is well marked with both signs on the bridge and signs on the road. Riffles are present on the downstream end due to large rocks and stones in the water. Grasses and shrubs cover the banks but do not reach the water's edge because of the stony shore. Upstream there are two fallen logs partly submerged in the river but otherwise there is no plant matter in the river. Mid canopy trees shade the river up and downstream, but are not shown in the photo. The bridge is in good repair; however the wooden road surface is beginning to splinter.

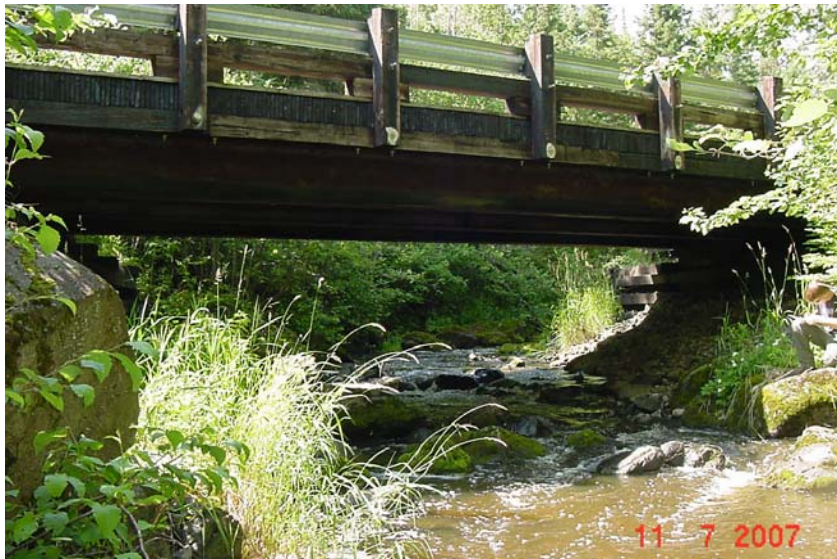
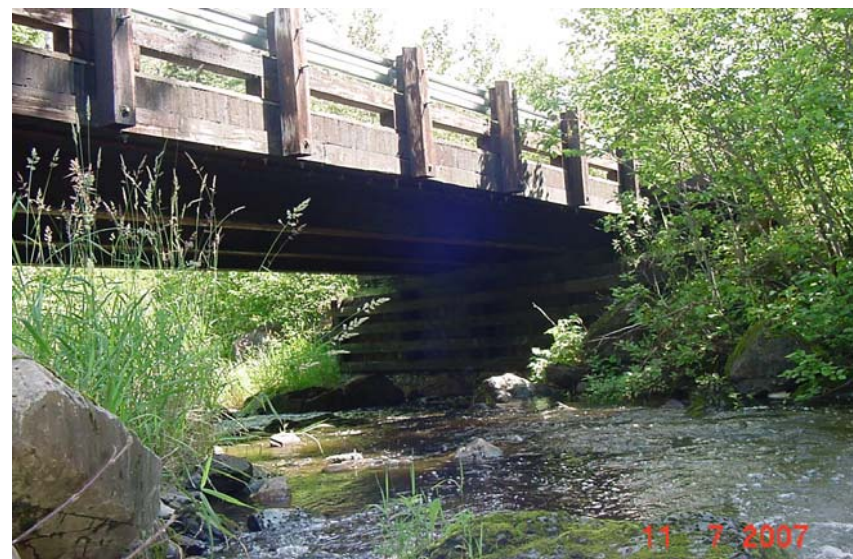
**Description:** The second bridge crossing on Mokomon Road is located just east of the highway 11/17. Large stones and boulders in the river make riffles larger than at Bridge 1; flow seems faster but otherwise it is similar to Bridge 1. Moderate mid canopy cover and grasses cover the shoreline and the banks are stable with stones and rocks. Also well marked with bridge and road signs.

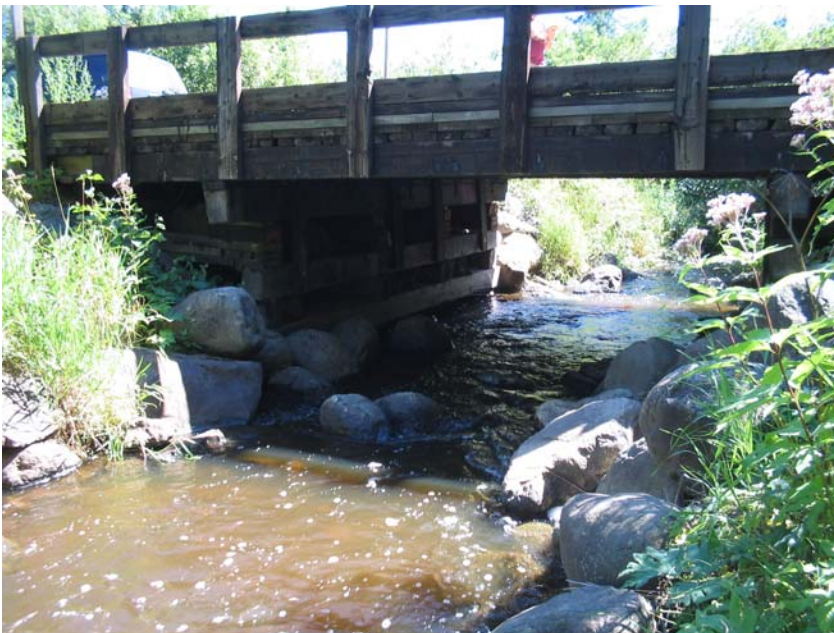
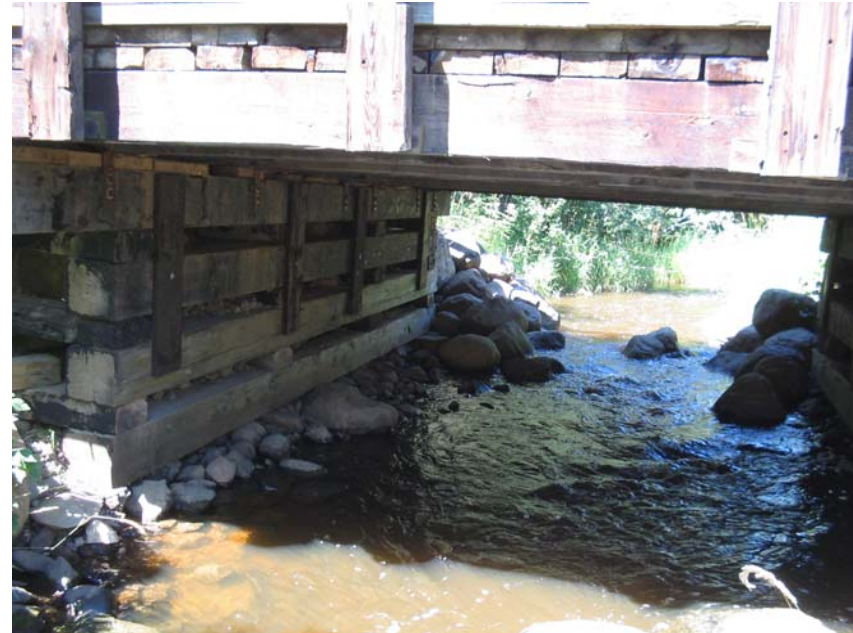
**Description:** Bridge 3 is well marked with both signs on the road and signs on the bridge. The bridge itself is in good repair and has a steady medium flow going through it. Upstream flow becomes constricted due to the rocks and stones in the stream bed. Cover on both sides was approximately 20% from surrounding vegetation. No evidence of erosion was observed on the banks.

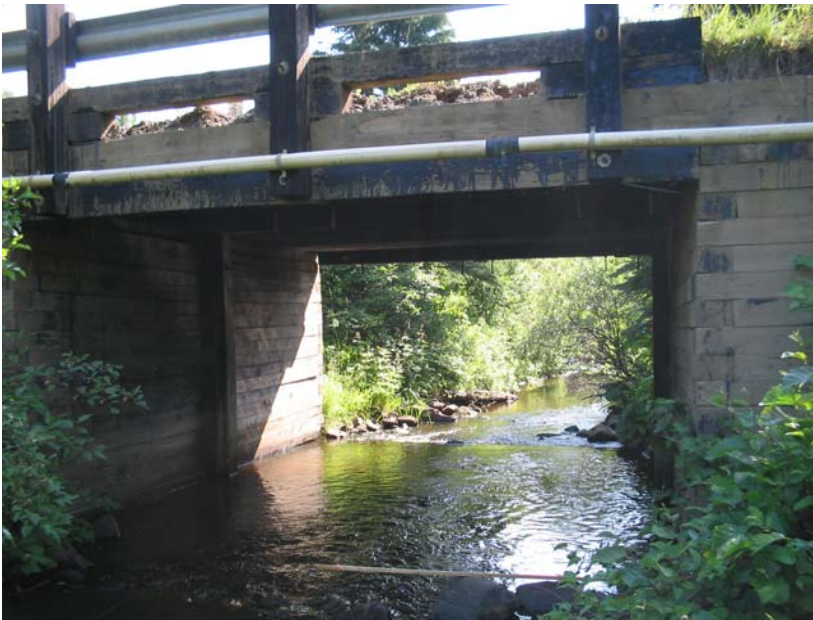
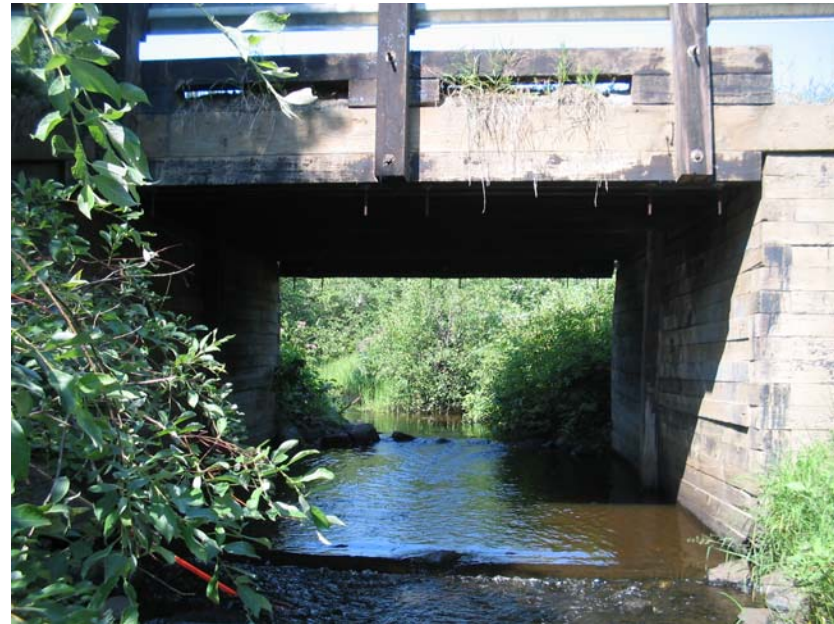
**Description:** Well marked with reflective signs, this bridge is in good condition. Two fallen logs upstream may slow flow, and the banks are stony with larger boulders downstream and about 30% cover. Under the bridge, support beams are submerged and lay across the river. There was lots of in stream vegetation upstream and a collapsed and ripped silt fence is lying on the bank, although it does not appear to have an effect on how much sediment is entering the stream. Gravel material on the bridge surface is eroding into the stream.

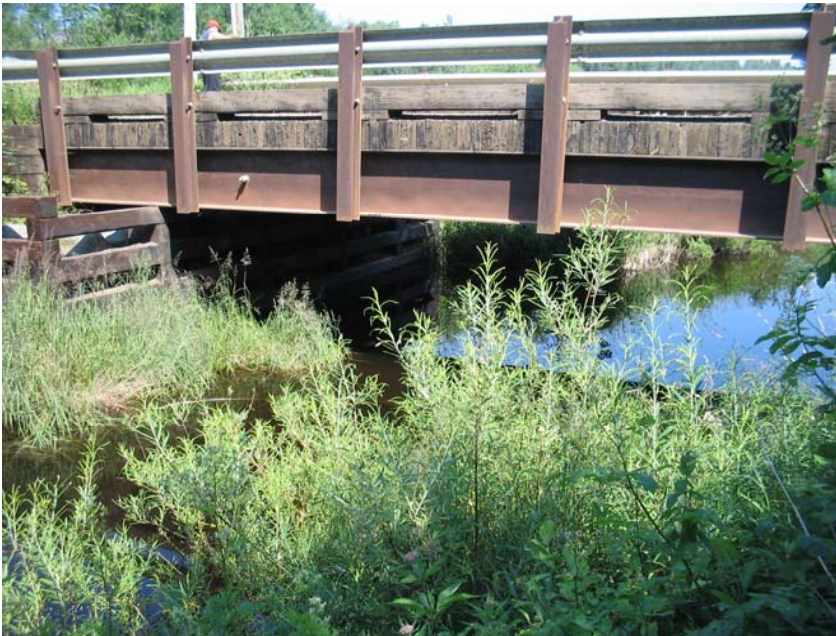
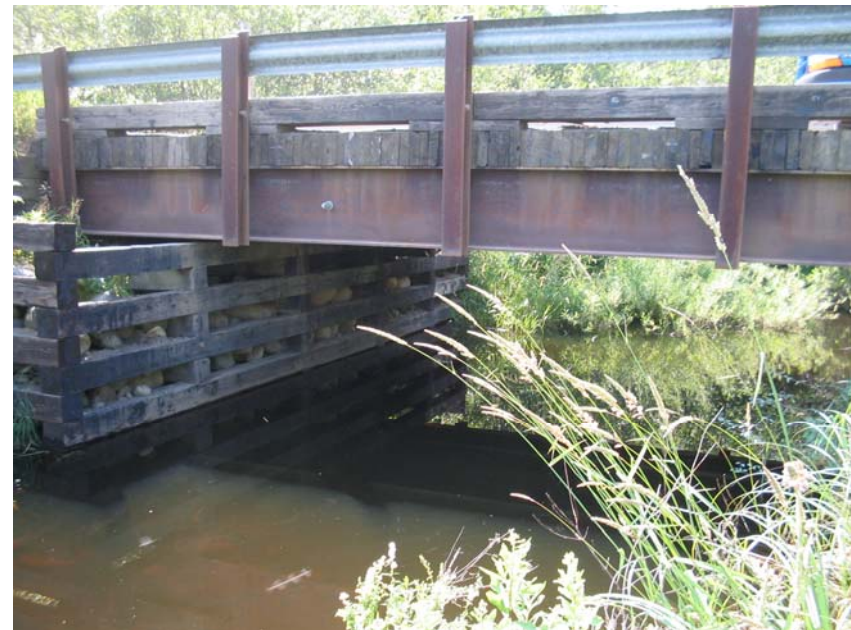
**Description:** Bridge was in excellent condition, and supports a large volume of water slowly flowing through it. It is the only paved bridge in the watershed and is also well marked. River bottom is deep and filled with mud and organics, evidence of branches and trees as well as large paving stones or boulders. There is vegetation up to and on the stream bank, with some trees growing over and into the water. Bank stability was good. Some wood rot was observed on the deck, however did not seem to affect bridge stability.
