**MOSQUITO CREEK
FLOODPLAIN MAPPING UPDATE STUDY
GENERAL REPORT**

DRAFT – REV B

KGS Group 19-3065-001
March 2020

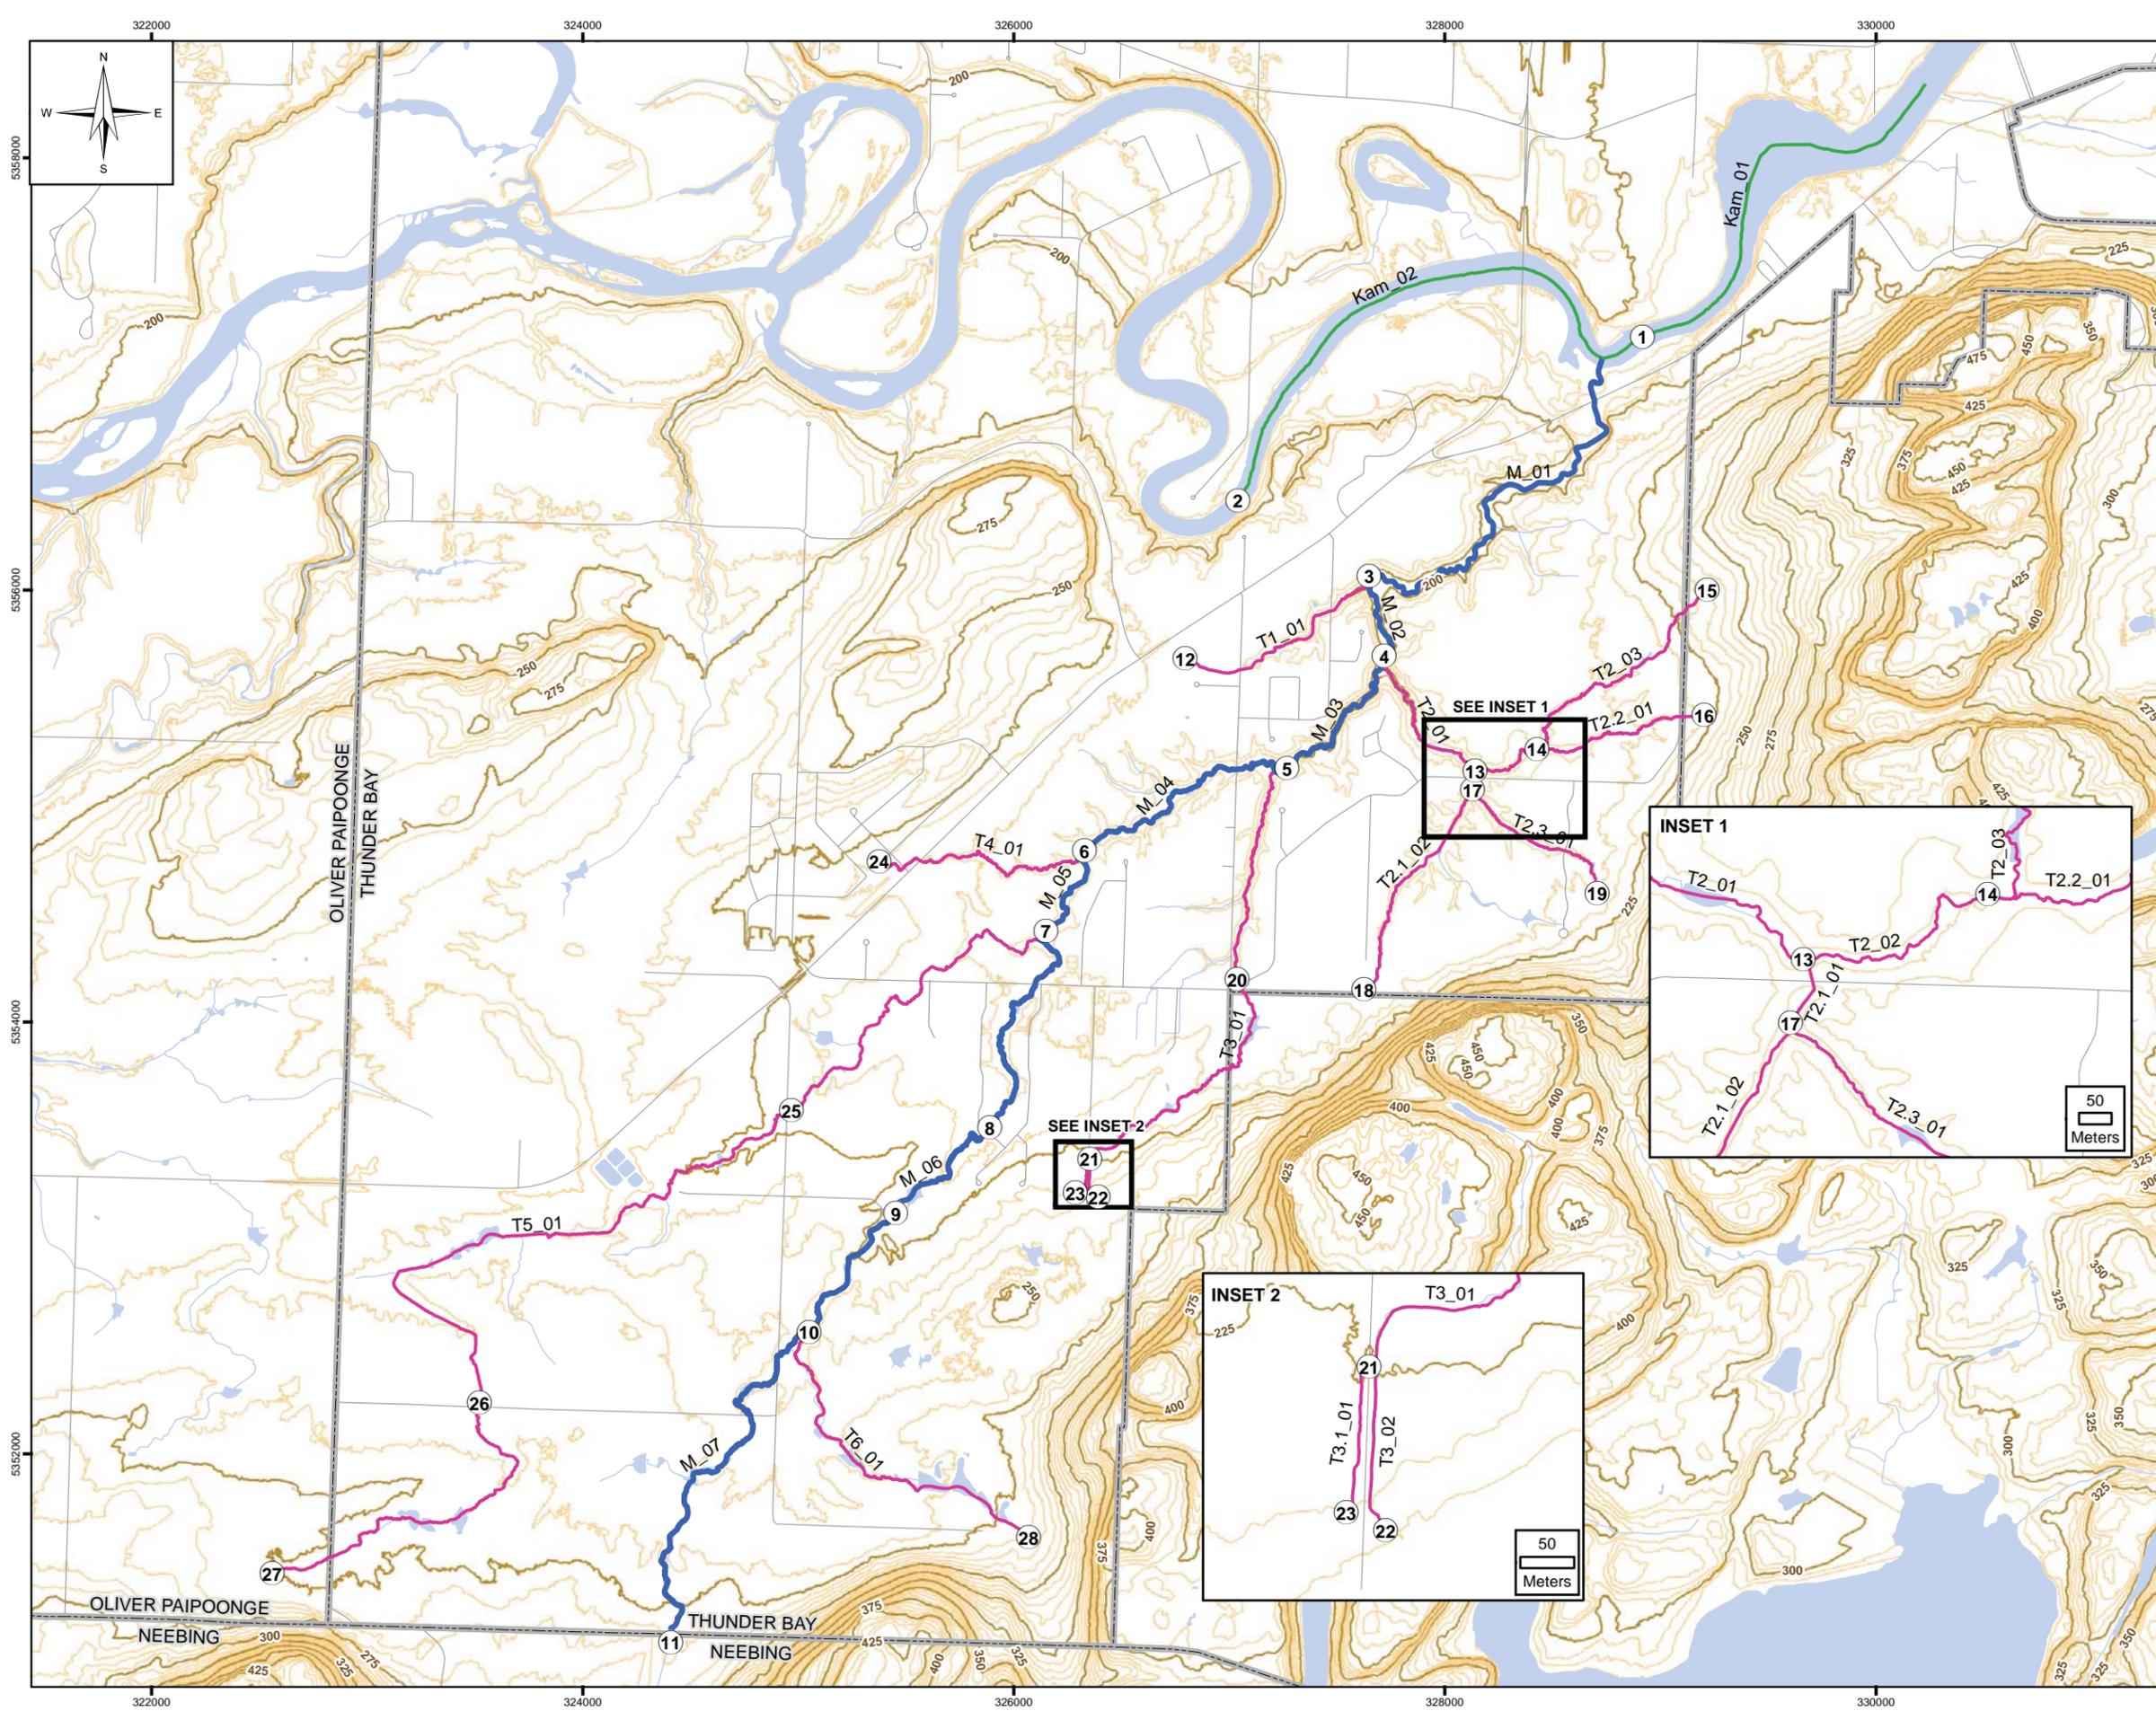
The Mosquito Creek watershed is shown in Figure 1. The creek is a major tributary of the Kaministiquia River. It originates from the Municipality of Neebing, and flows northeast into the Kaministiquia River at a location downstream of the Hwy 61 crossing in Thunder Bay. The main branch of the creek is approximately 15 km long and its channel width is typically 2 to 8 m. The drainage area of the Mosquito Creek watershed is approximately 31 km² as delineated with GIS tools.

The labelling system shown in Figure 1 was used to identify the river branches and tributaries in the hydraulic model prepared as part of this study. In Figure 1, the main branch of Mosquito Creek has been labelled as “M”. The labels assigned to the tributaries of Mosquito Creek include the letter “T” and a number indicating the order in which they join the creek. The ordering numbers were assigned in the direction from downstream to upstream. There are also a few second order tributaries, which are identified by the name given to the tributary that they join, followed by a dot and a consecutive number.

It must be noted that there are numerous small tributaries in the watershed that are not labelled in Figure 1. This is because only the tributaries with drainage areas larger than 125 ha were included in the hydraulic model, as per the requirements of this study.

The model includes all the river reaches highlighted in Figure 1. Cross sections were extracted from the DEM and localized survey data described in Section 2.1. The cross sections were spaced at maximum intervals of 200 m, but in most cases with a more detailed discretization, particularly at locations of observed changes in geometry and at crossings.

Model Location		Figure 1 Reference ID	Flow (m ³ /s)						
Branch	Station (km)		Regional Flood	100 Year	50 Year	25 year	10 Year	5 Year	2 Year
Kam_01	9800	1	477	477	477	477	477	477	477
Kam_02	12432	2	477	477	477	477	477	477	477
M_01	2137	3	46.21	23.18	19.66	16.4	12.5	9.5	5.4
M_02	399	4	45.63	22.87	19.39	16.18	12.33	9.37	5.33
M_03	809	5	32.54	22.53	19.38	16.42	12.98	10.37	6.31
M_04	1233	6	28.15	22.07	19	16.11	12.76	10.21	6.24
M_05	503	7	22.86	11.93	10.11	8.4	6.37	4.8	2.56
M_06	1248	8	11.84	6.02	5.14	4.37	3.46	2.76	1.63
M_06	2008	9	11.79	5.61	4.75	3.92	2.93	2.17	1.1
M_06	2812	10	11.01	5.24	4.44	3.66	2.74	2.03	1.03
M_07	2105	11	5.26	2.57	2.16	1.78	1.33	0.98	0.5
T1_01	1100	12	0.58	0.31	0.26	0.22	0.17	0.13	0.07
T2_01	807	13	12.93	6.09	5.08	4.16	3.05	2.23	1.09
T2_02	384	14	5.16	2.31	1.91	1.54	1.11	0.79	0.37
T2_03	1301	15	2.3	1.04	0.86	0.69	0.5	0.36	0.17
T2.2_01	875	16	2.68	1.19	0.98	0.79	0.56	0.4	0.18
T2.1_01	96	17	6.87	3.31	2.77	2.27	1.69	1.25	0.63

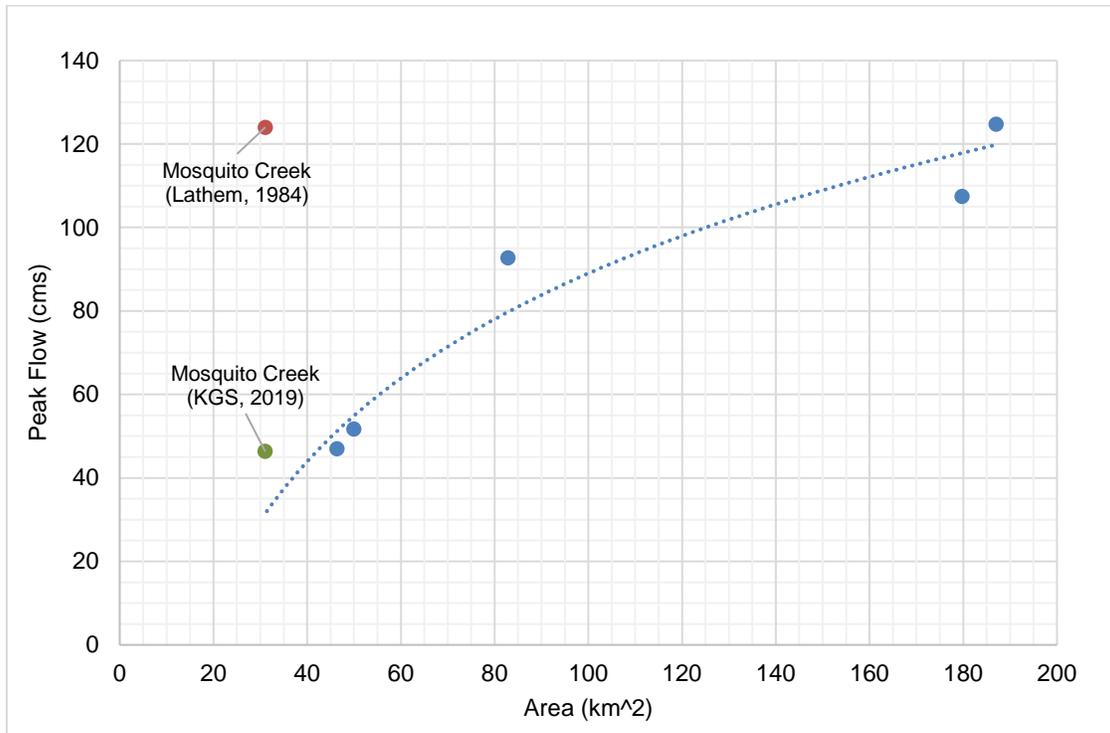
FIGURE 2
COMPARISON OF REGIONAL STORM FLOOD PEAK FLOWS FOR WATERSHEDS NEAR MOSQUITO CREEK

The peak flow values for the Regional Storm Flood previously obtained (124 m³/s in the 1984 study and 122 m³/s in the 1996 study) are too large when compared with the results obtained in this study. To put these values in perspective, KGS Group compared to the results obtained in recent studies of the McIntyre River (HMM, 2015), Neebing River (KGS, 2018) and McVicar Creek (KGS, 2018), as well as those for the Slate River, obtained as part of the Kaministiquia River study (KGS, 2019d). In all these studies the hydrologic models were calibrated and validated using recorded flow data at various gauging stations. The comparison clearly showed the peak flows from previous studies of the Mosquito Creek as outliers. Figure 2 shows a graphical representation of peak flows for the Regional Storm Flood as related to drainage area for watersheds in the region. It shows the results obtained for Mosquito Creek in the previous studies, as well as those obtained in this study.

The peak flow values obtained in this study for the Regional Storm Flood align better with those obtained for other watersheds in the region, and therefore were adopted. The values recommended as representative of peak flood flows for Mosquito Creek at the confluence with the Kaministiquia River are listed in Table 4. They correspond to the maximum of two values: the results obtained with the hydrologic modelling and those obtained with Regional Flood Frequency Analyses. Details are provided in the study’s hydrologic report (KGS, 2019b).
